# Pre-Construction Road Condition Survey Suitability Report

Gelli Bwch Farm. Jersey Marine

**Prepared By:** MP Whelan

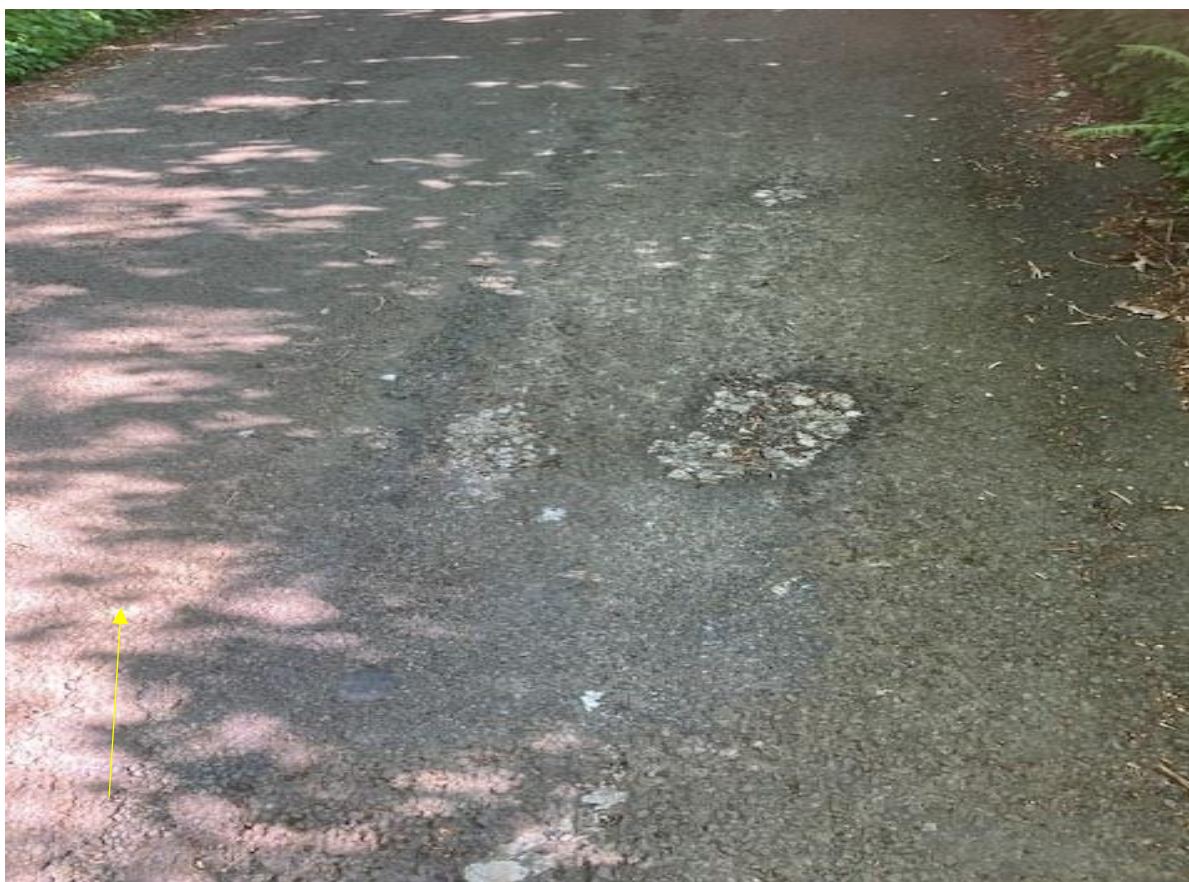
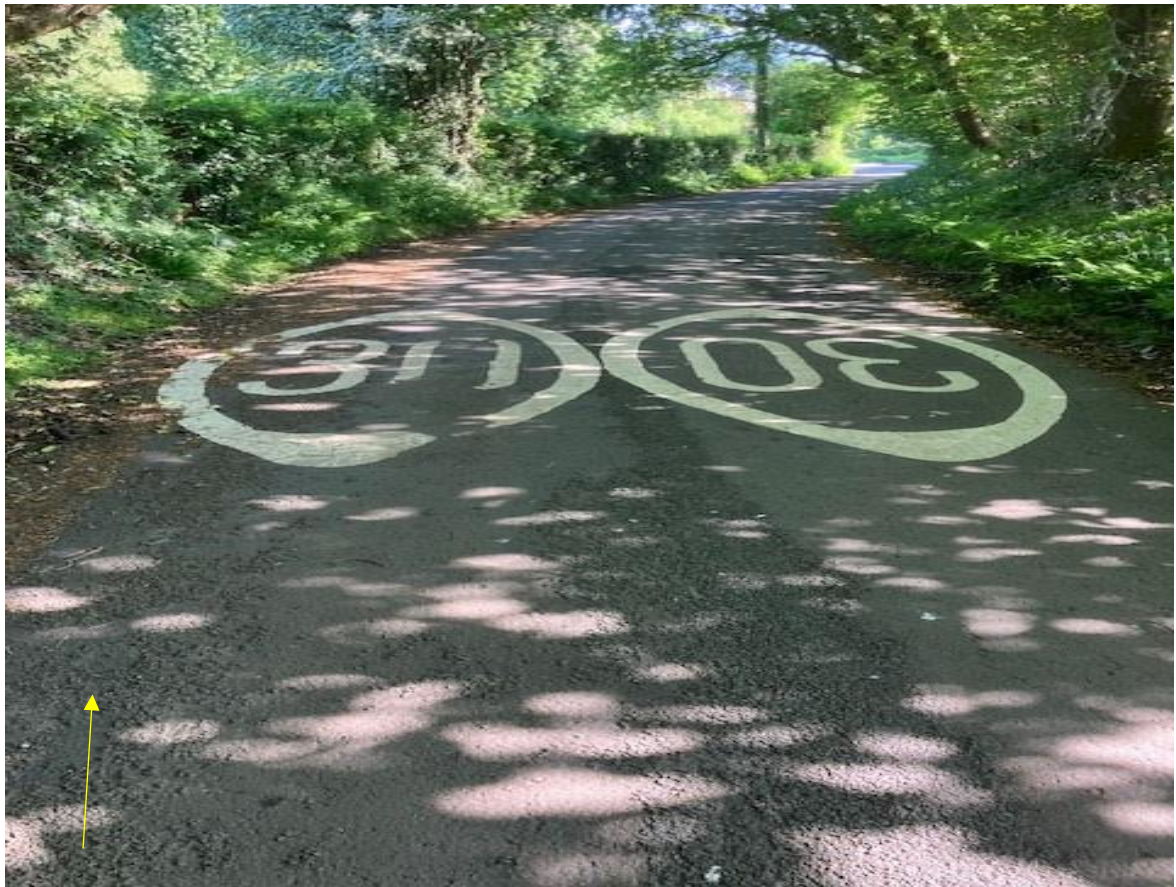
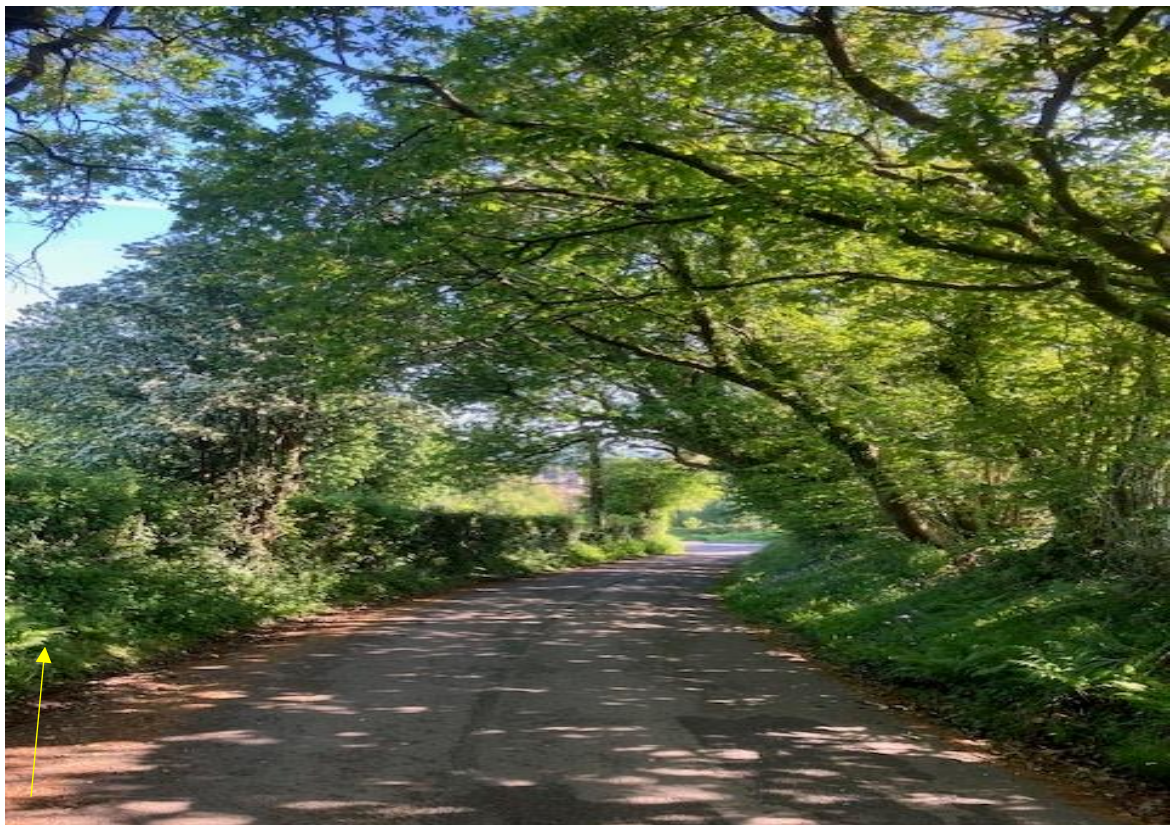
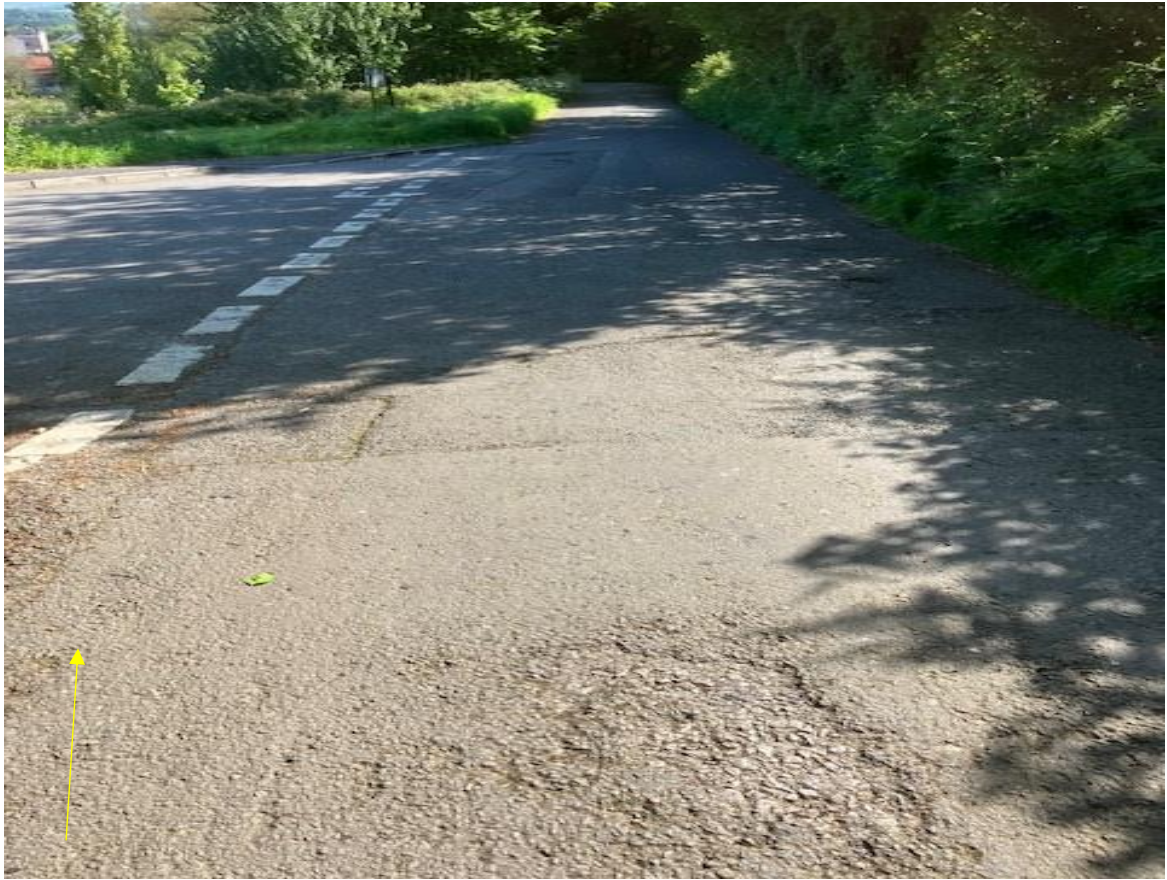
Various repairs have been carried out on top of existing tarmac

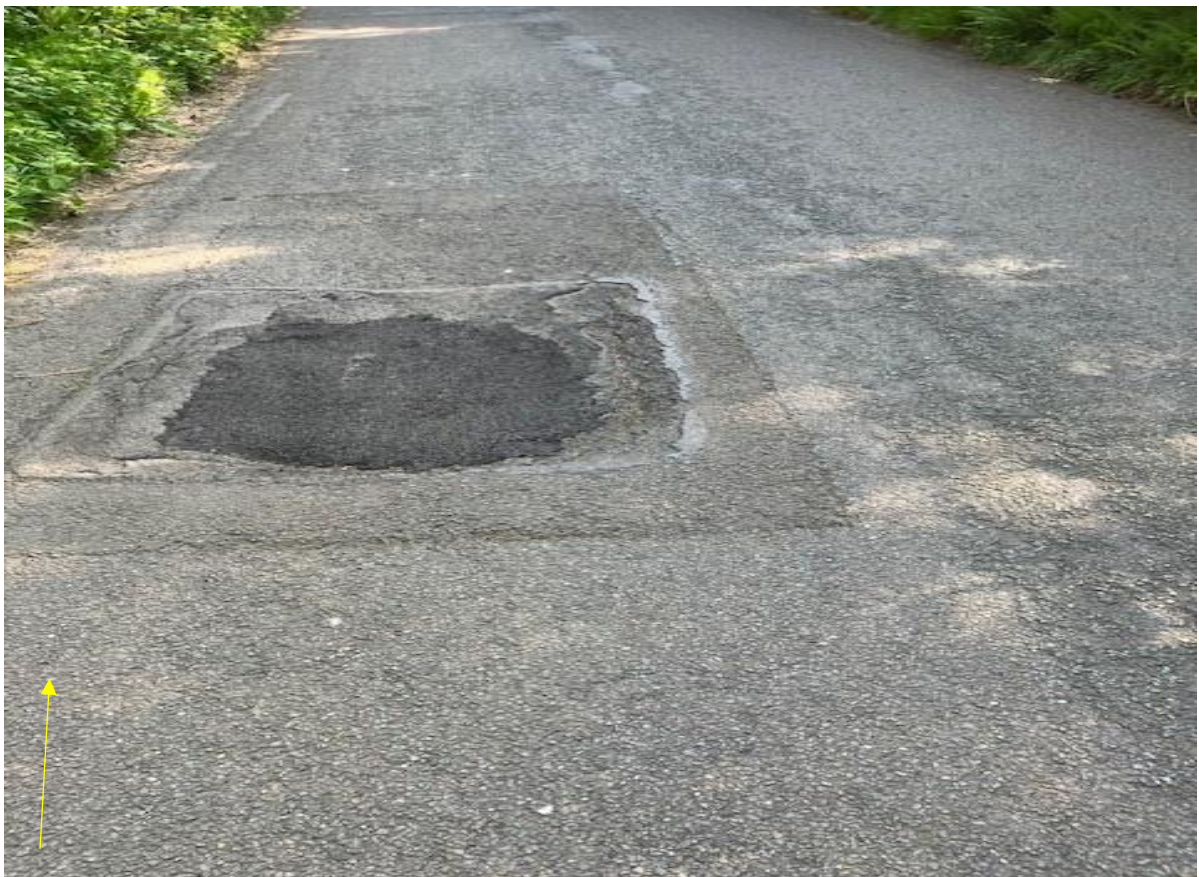
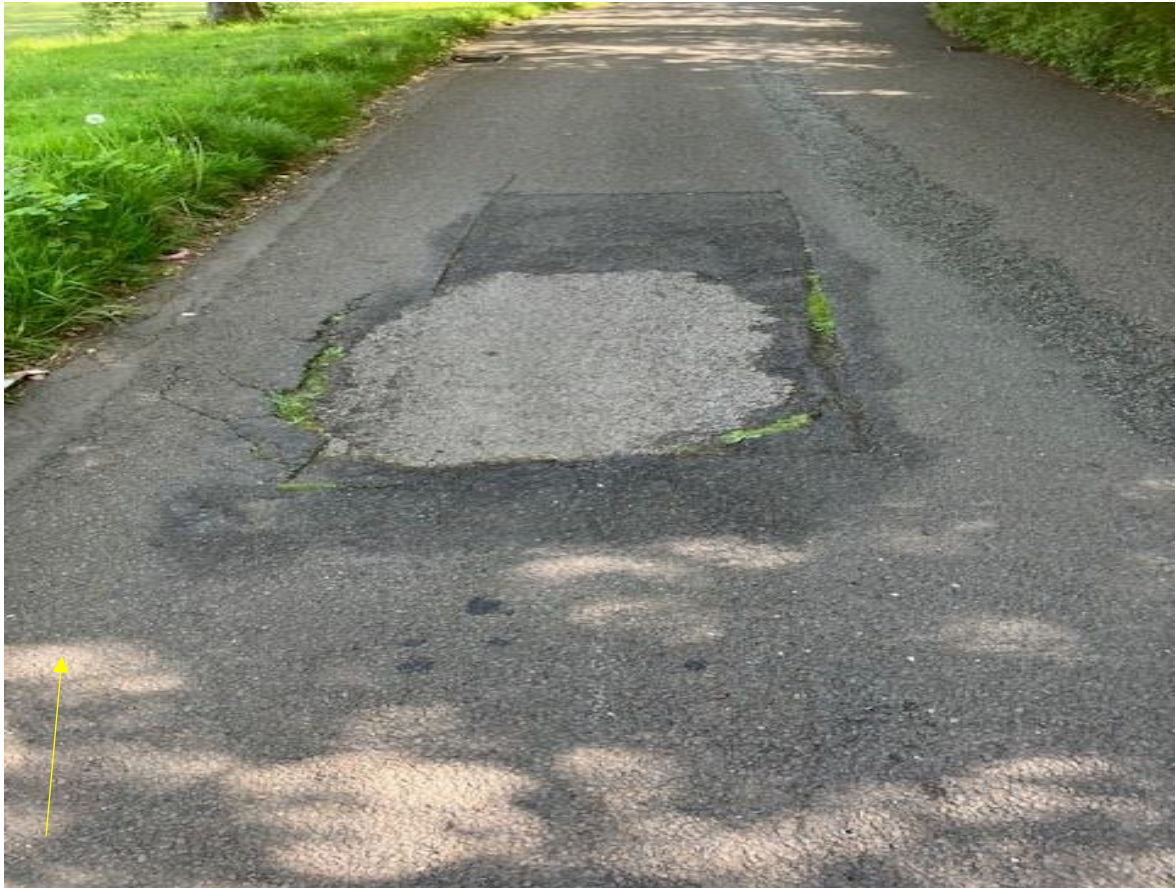
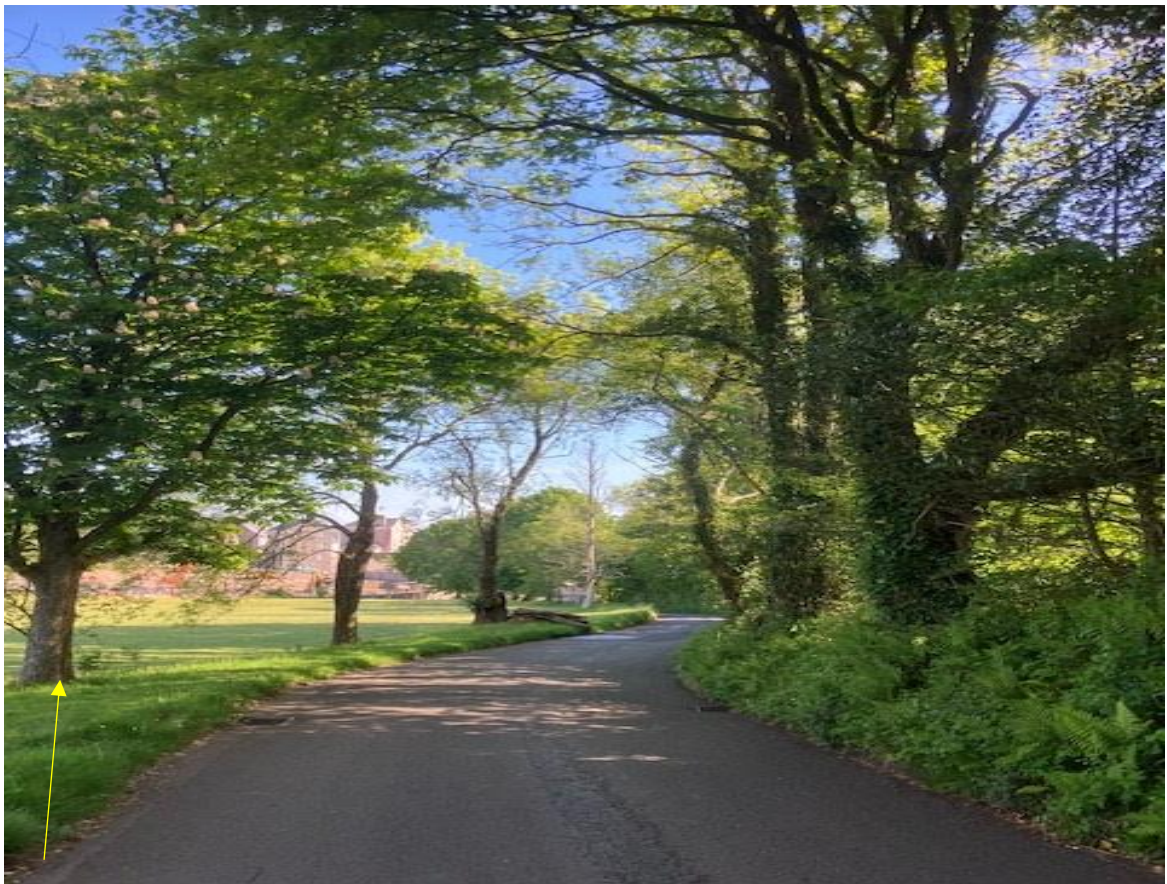
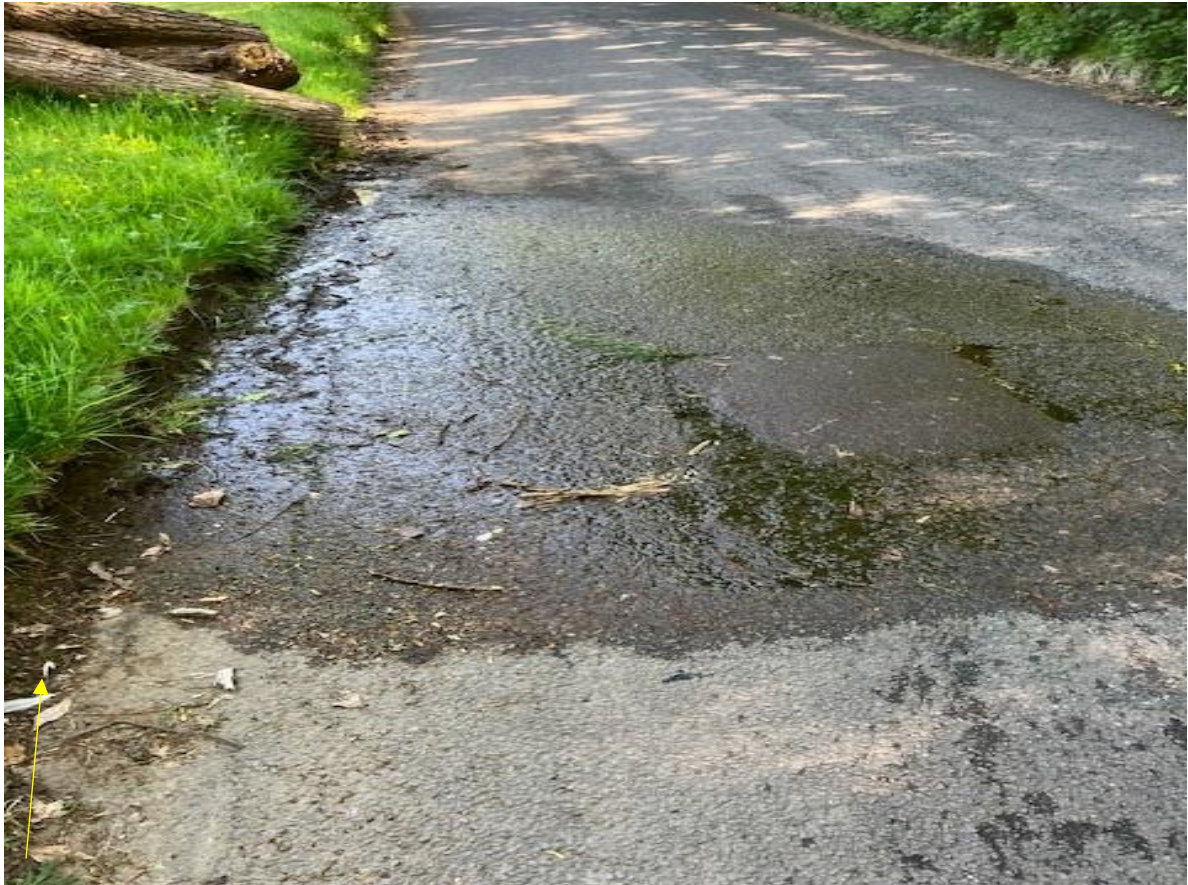
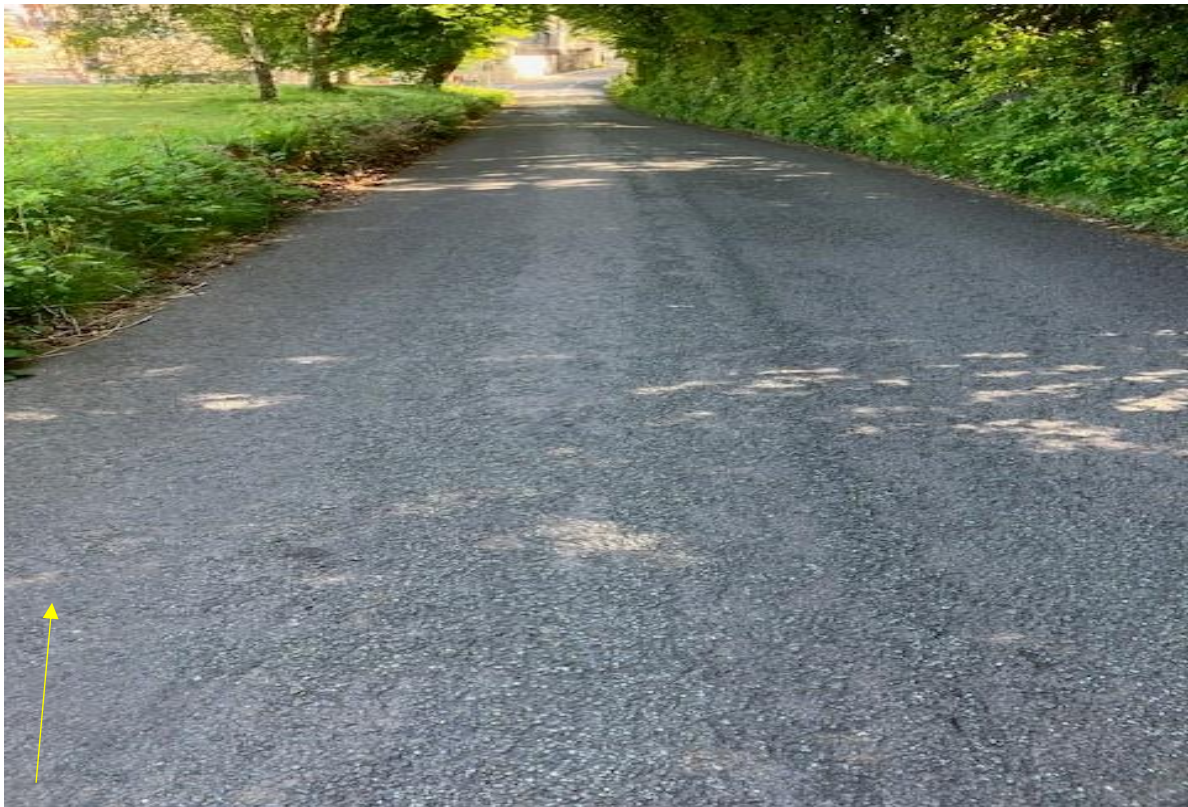
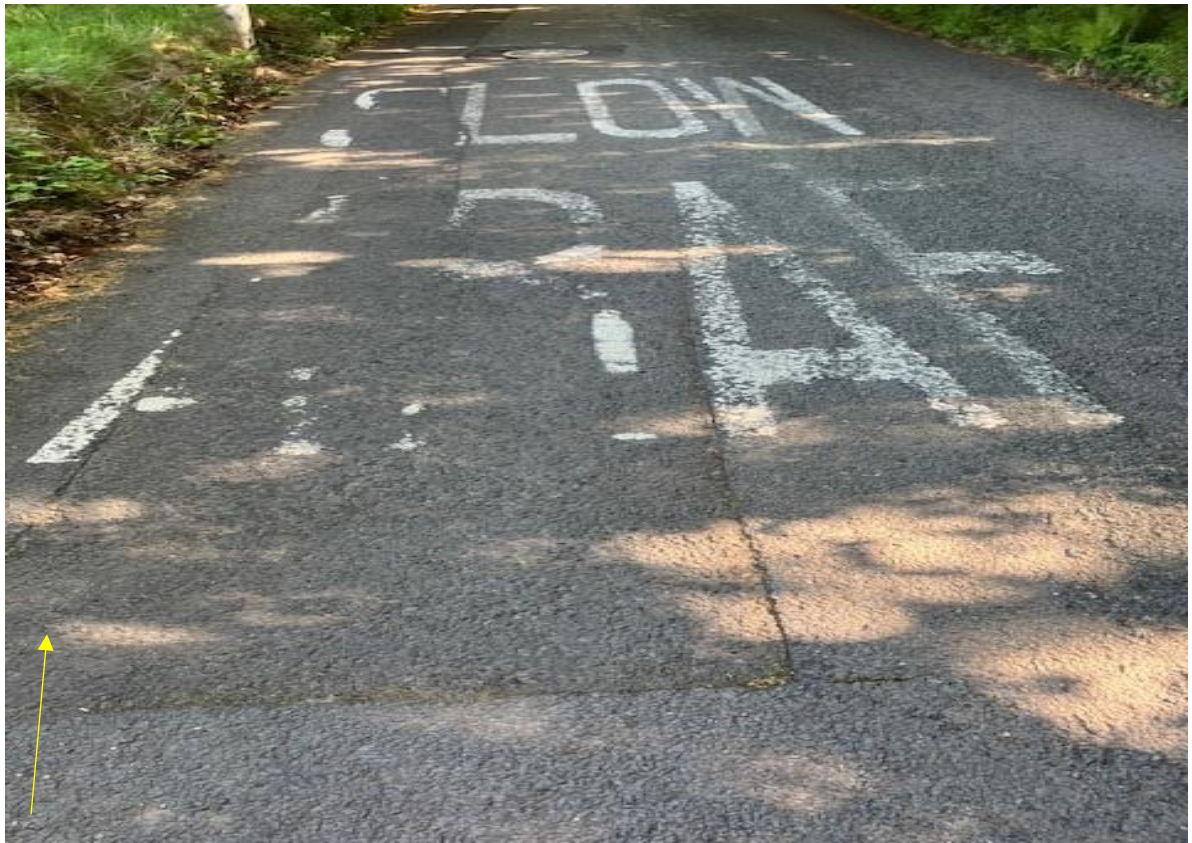
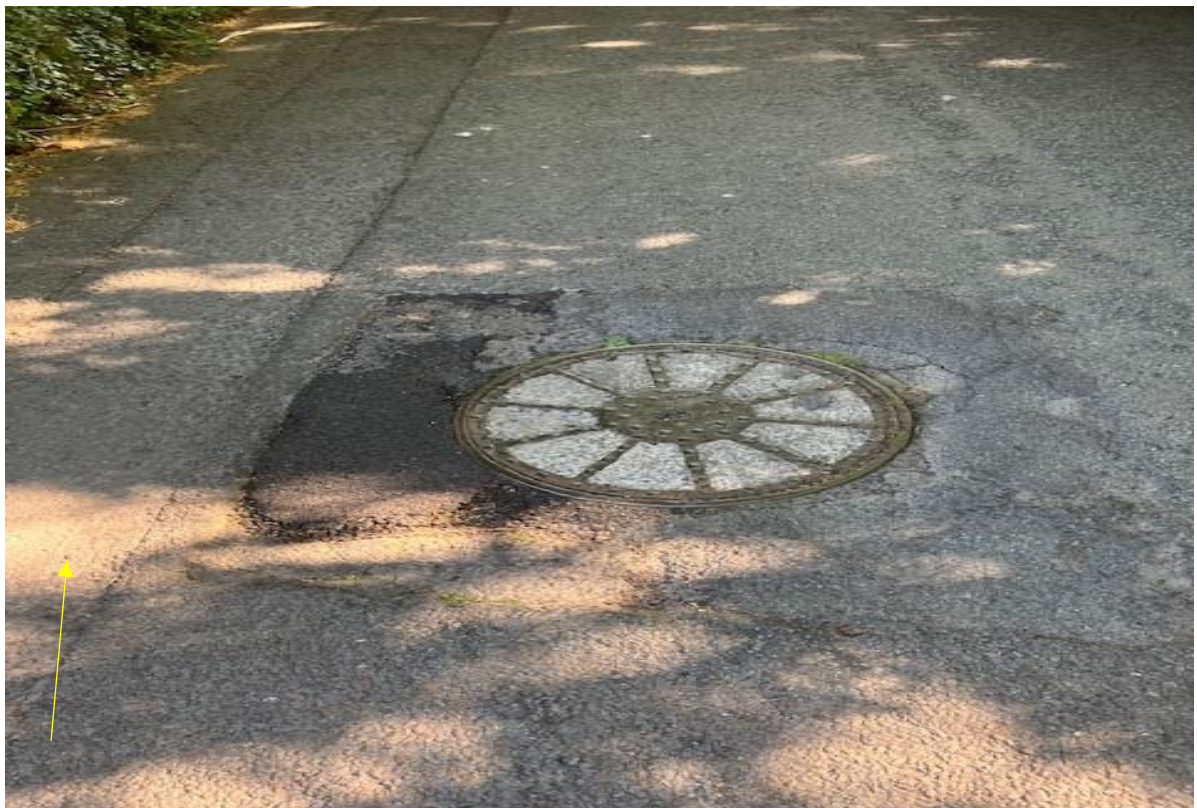
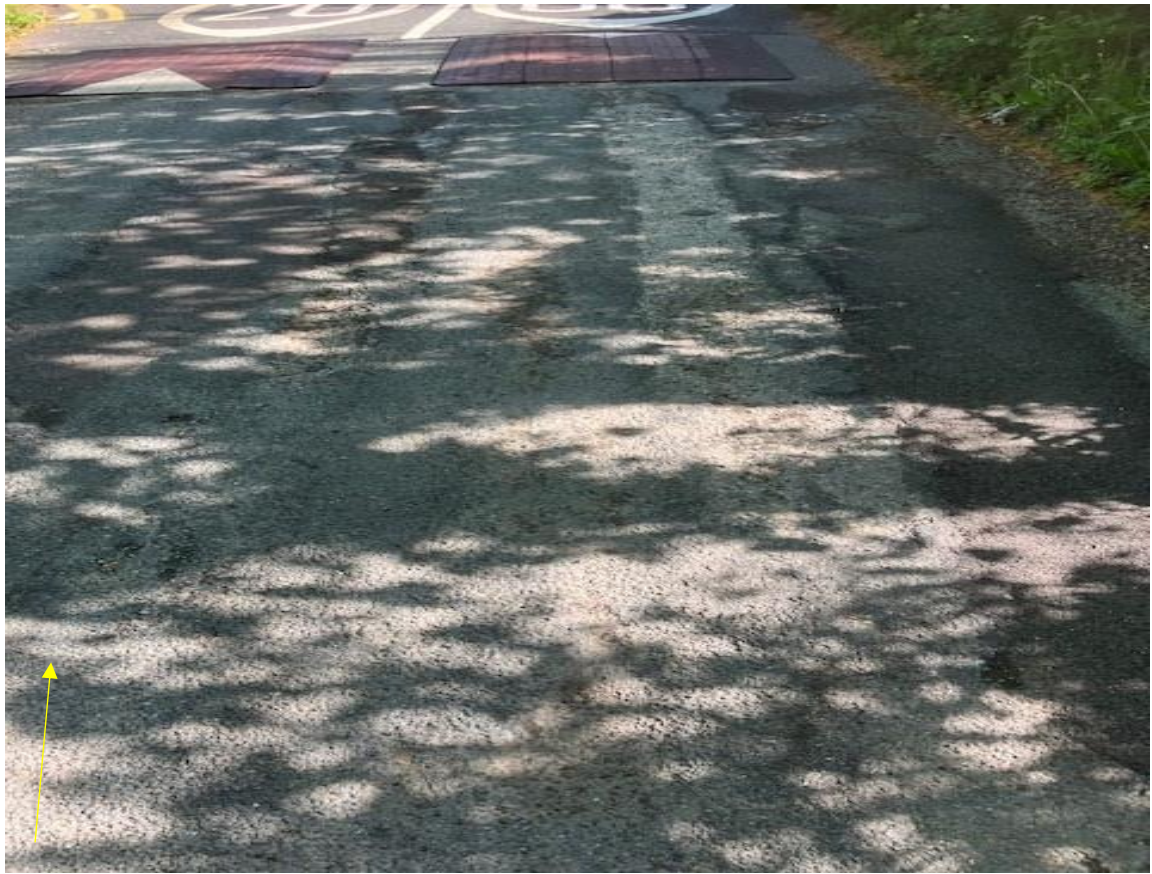
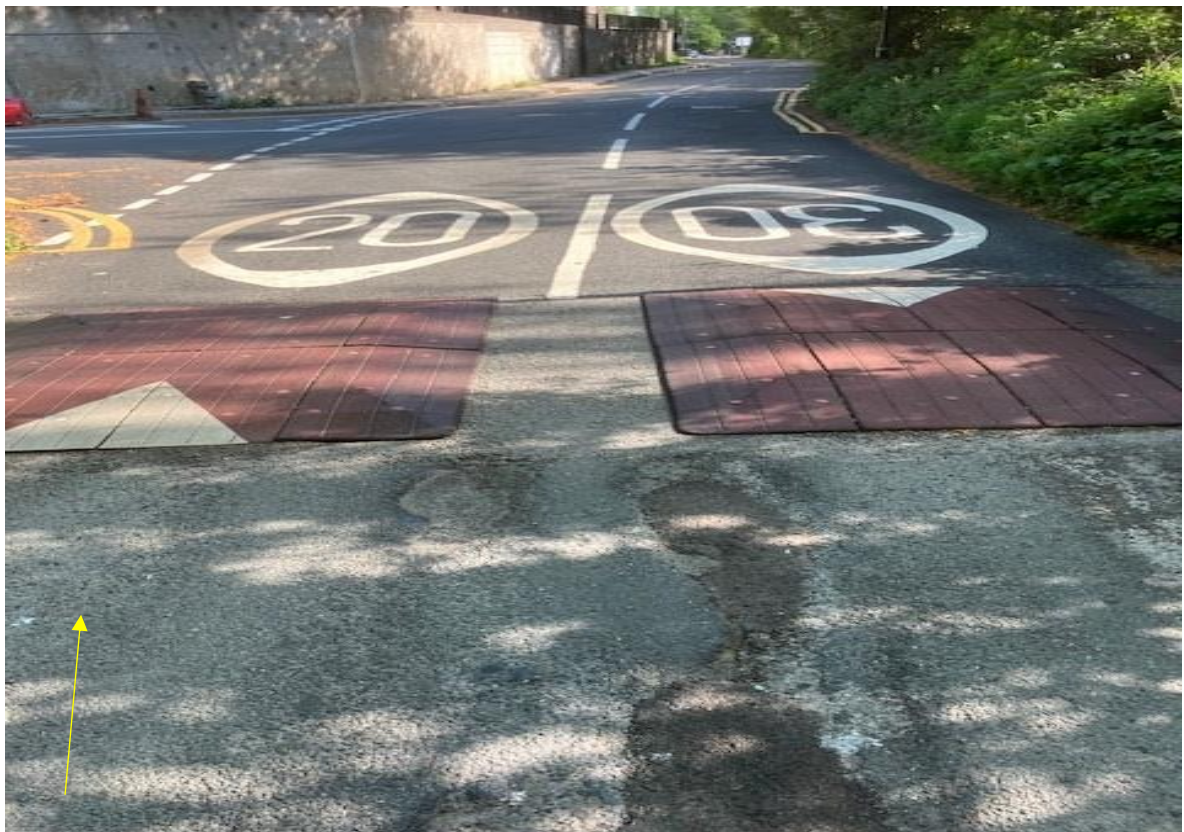
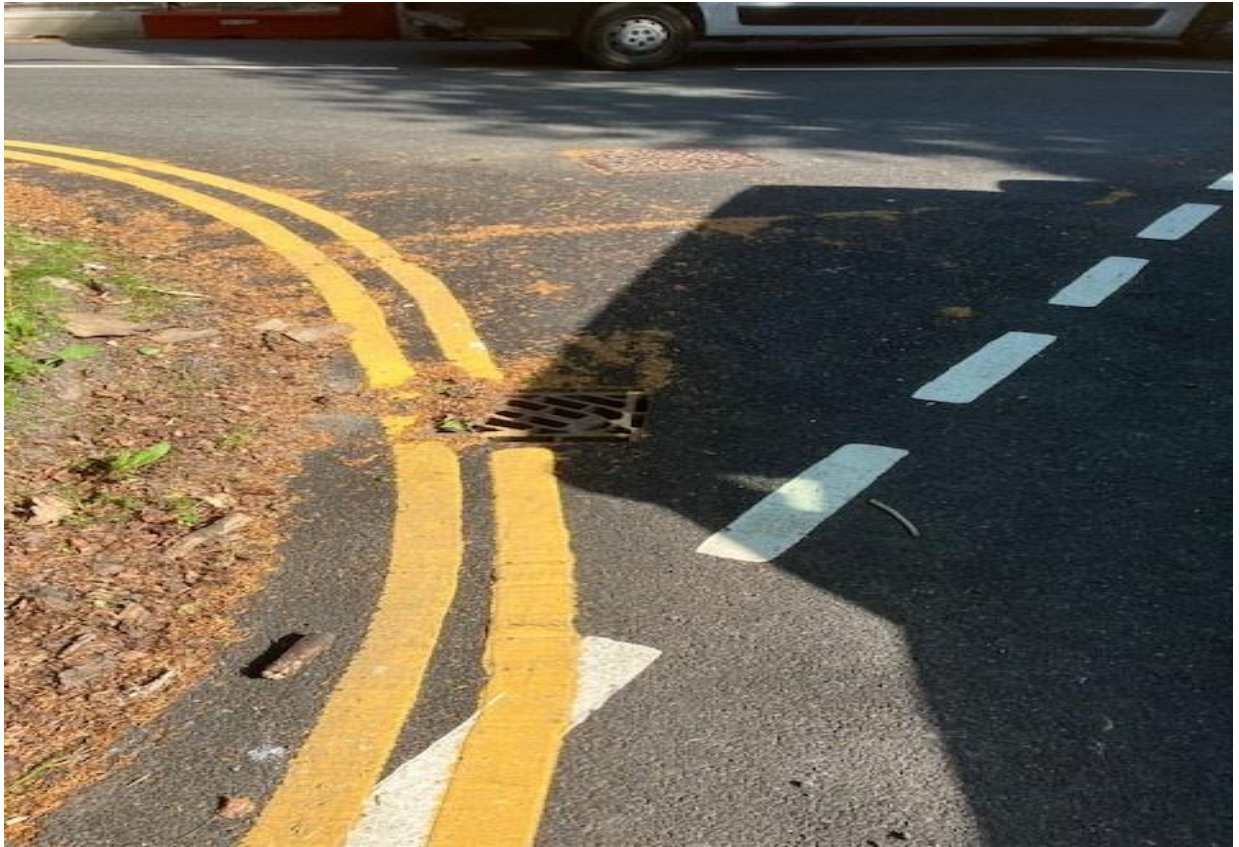
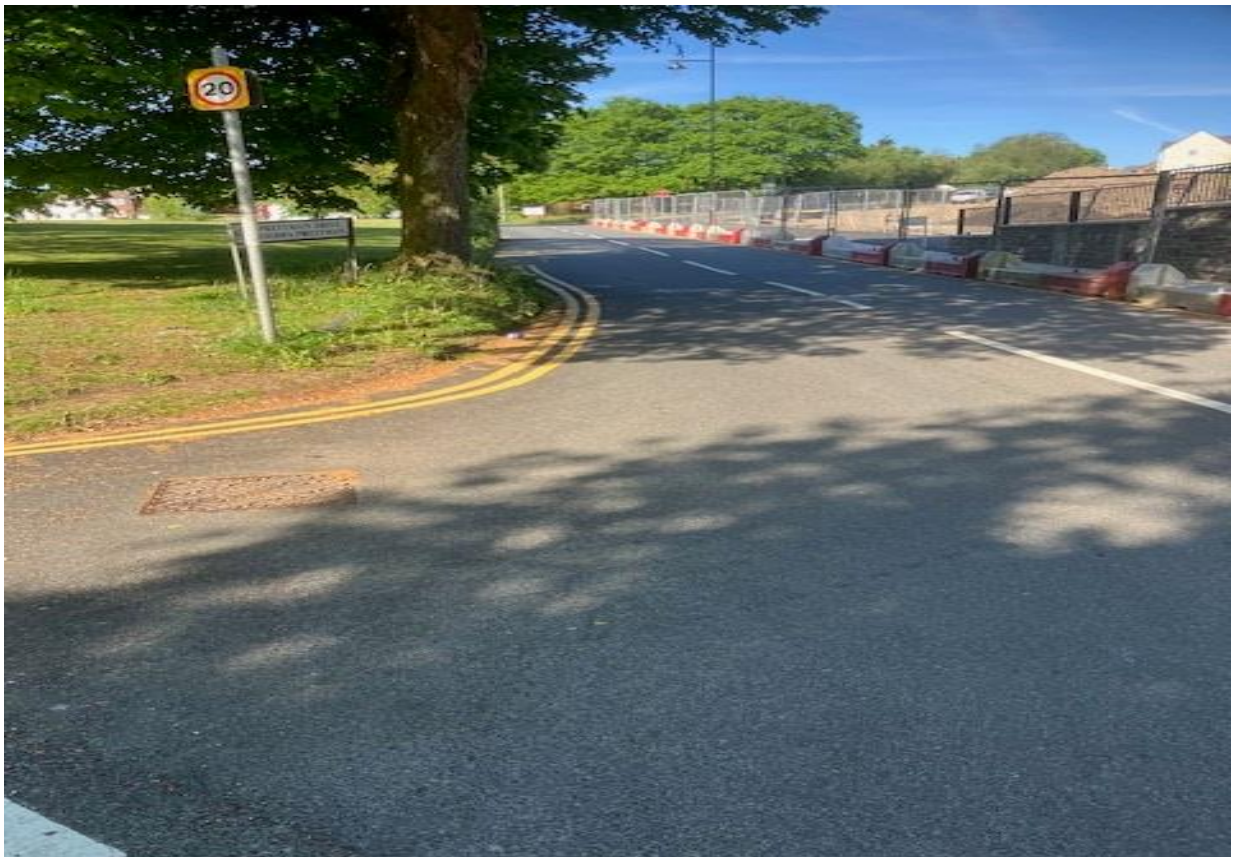
Various cracks noted above

There is minor cracking which has been viewed in several areas, this is due to there being no formal solid edge detail (kerbing) to the lane.
