# GeoShield Verification Report 01

GEO105283

Nant Y Cafn Business Park  
Seven Sisters,  
Neath,  
SA10 9EY

Ground Floor Slab of Proposed Industrial Building - Full Line Out

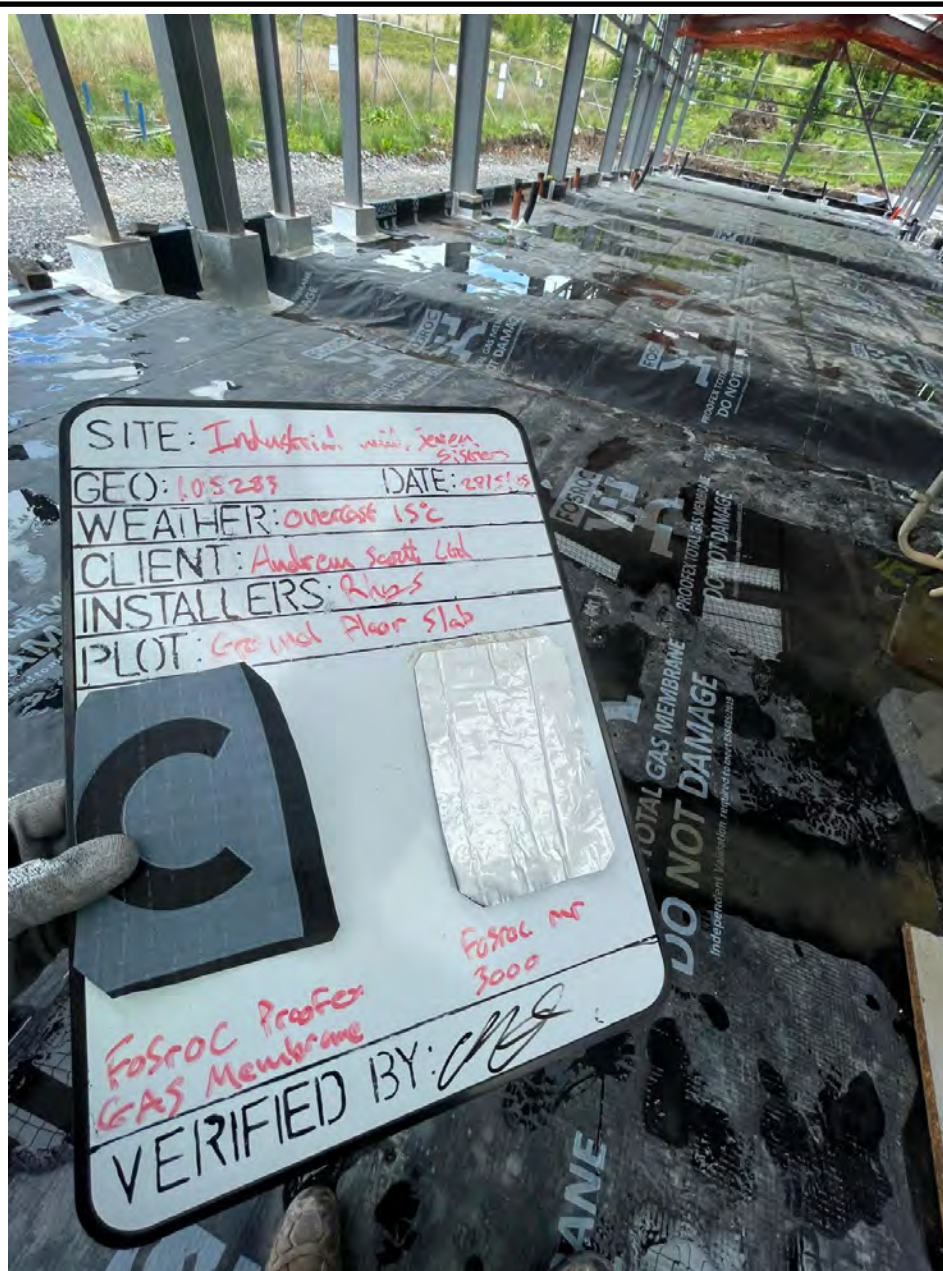
## Verification Inspection Information

The above photograph shows the details of the verification visit and the materials used.
