# **HERITAGE IMPACT STATEMENT**

**In Support of an Application for Listed Building Consent for: Opening the Gates at the Gnoll Gatehouse. Grid Reference: 275642, 197320**

Lloyd Killick, Outside Works Officer, NPTCBC  
July 2025.

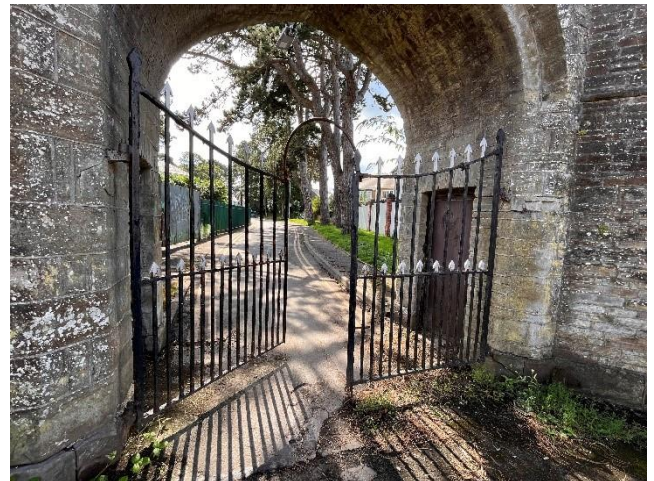
Figure 2, The Gates at Gnoll Gatehouse

The gate is located within a pointed stone arched gateway setback between stone octagonal lodges. The gatehouse was originally used as the entrance to the Gnoll Park. The gatehouse is currently used as a pedestrian thoroughfare between Gnoll Avenue and Gnoll Drive.

- 4.2 The metal gates are painted and there are areas of rust causing the paint to peel. The age of the gates is not known but exposed areas indicate welded carbon steel construction or areas of previous repair. The condition of welded junctions is hidden by paint.
- 4.3 There is a ground locating bolt to one of gates that is preclude from fixing in an open position due to the restricting hoop. The bolt receiver hole should be located in the ground but is filled in by debris.
- 4.4 Some masonry is stressed and partially dislocated with open mortar joints at the hinge locations.
- 4.5 There is wear and tear to the tarmac road surface making trip hazards for pedestrians and hazardous to bicycles. This is also creating standing water along the foot of the gatehouse.

- Remove constricting hoop and fix to the opened gate to store and be on view.
  - Report any unforeseen defects to the Contract Administrator and agree a method of repairs before proceeding.

- Strip away any peeling paint and clean back surface rust deposit.
  - Paint bared surfaces with an appropriate primer recommended by the topcoat manufacturer.

- Paint with Rust Oleum Combicolour Metal Paint, to match the existing.
- 5.2 New hinge eyes in masonry to be extended through the masonry walls with a threaded end and internal Pattress Plate: galvanised steel or painted to match gates, size to be agreed to overlap mortar joints.
