### Asbestos Survey Report

Tata Steel  
Redundant Morfa Coke Ovens  
HAA  
HAA Structure-Feed Hoppers & Conveyor 1290  
Port Talbot Steel Works  
SA13 2NG

| Survey No | Date of Survey | Survey Type | Prepared by | Authorised by |
|---|---|---|---|---|
| 5938 SC | 22/04/2025 | Demolition Survey | Derek Williams | Anthony Avery |

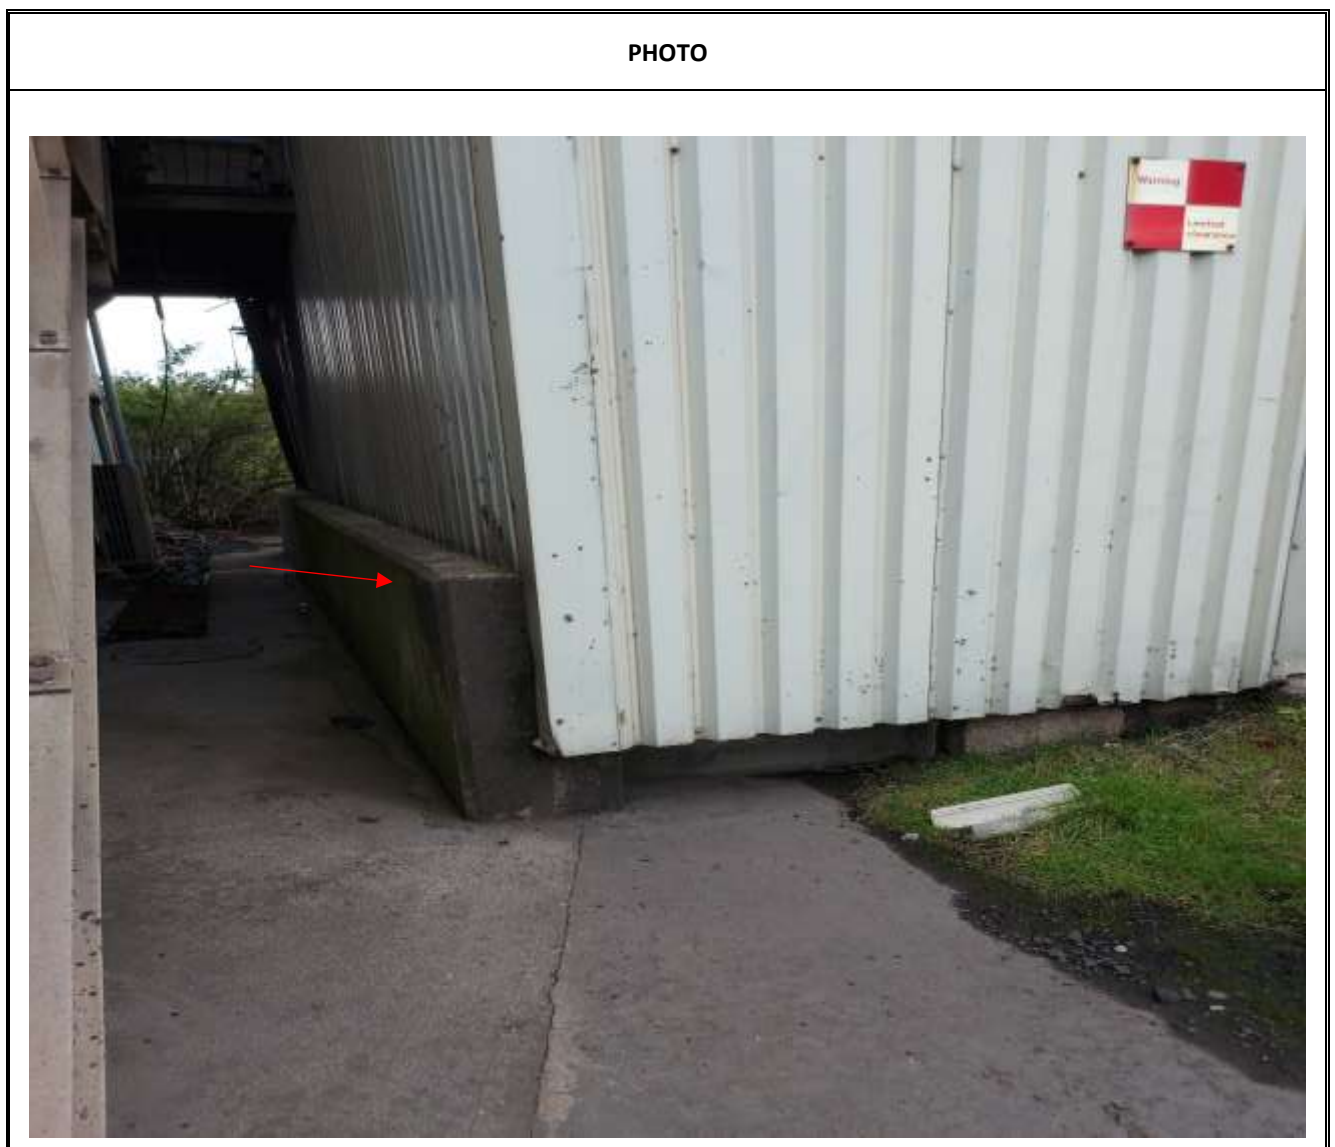
| <b>Site</b> | HAA Structure-Feed Hoppers & Conveyor 1290 | <b>Sample No.</b> | W176525-S05 |

| Comments | <b>No Asbestos Detected</b> |

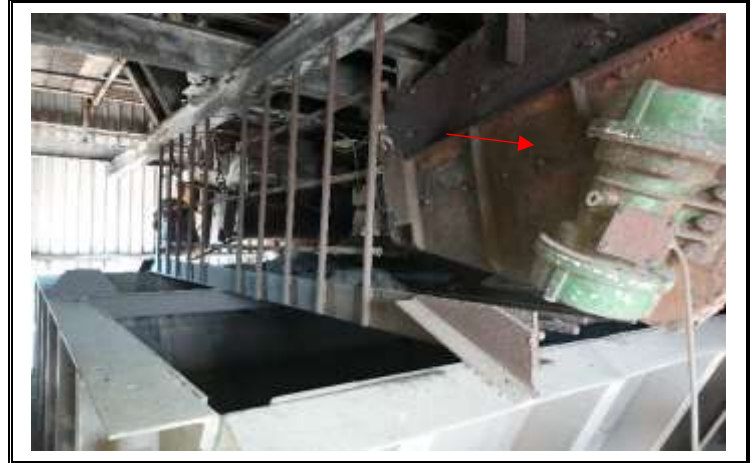
| <b>Inspection Ref</b> | <b>MESL-5938 SC Vi2</b> |

| <b>Location</b> | MCO-HAA Structure-1 <sup>st</sup> Floor-<br>Material Main Feeder Chute-<br>South |
| <b>Material</b> | Metals & Alloys. |
| <b>Comments</b> | Visually no Asbestos Suspected.<br>(VNAS) Reasoned argument. |

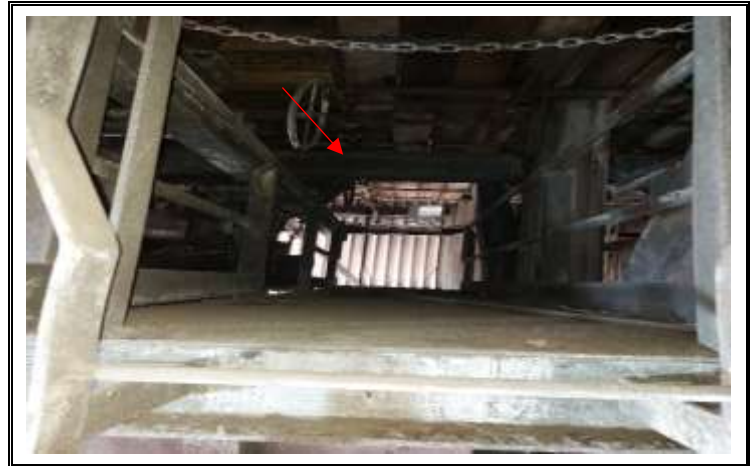
| <b>Inspection Ref</b> | <b>MESL-5938 SC<br/>Vi5</b> |

| <b>Location</b> | MCO-HAA Structure-1 <sup>st</sup> Floor-<br>Material Chute-Northeast |
| <b>Material</b> | Plastics, Metals & Alloys. |
| <b>Comments</b> | Visually no Asbestos Suspected.<br>(VNAS) Reasoned argument. |

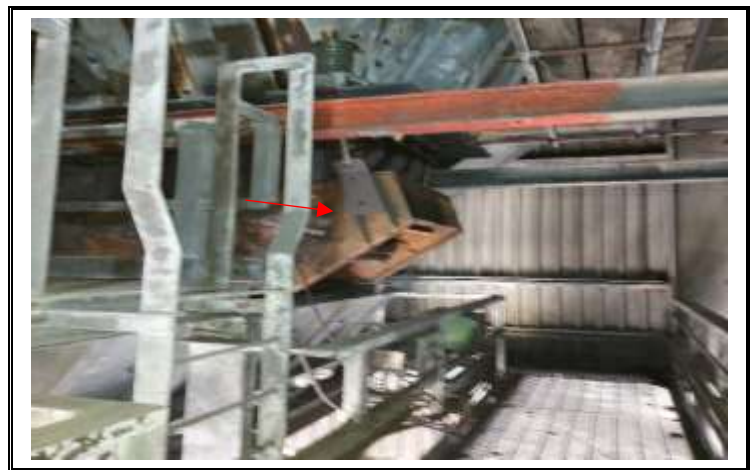
| <b>Inspection Ref</b> | <b>MESL-5938 SC<br/>Vi6</b> |

| <b>Location</b> | MCO-HAA Structure-1 <sup>st</sup> Floor-<br>Electrical Controls Boxes-<br>Northeast-3 Items |
| <b>Material</b> | Plastics, Metals & Alloys. |
| <b>Comments</b> | Visually no Asbestos Suspected.<br>(VNAS) Reasoned argument. |

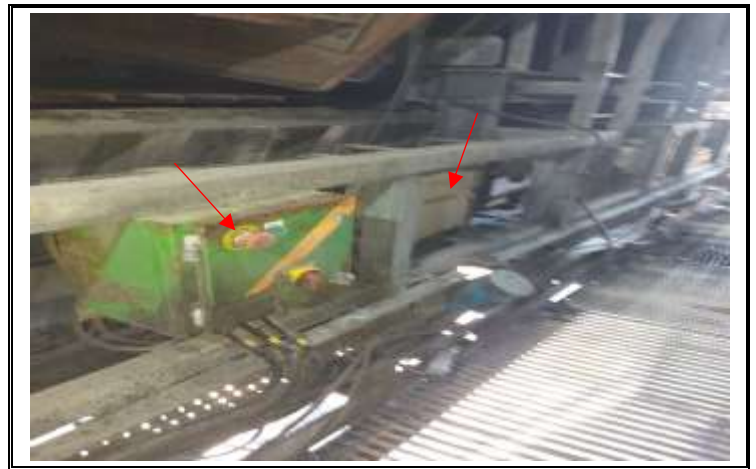
| <b>Inspection Ref</b> | <b>MESL-5938 SC<br/>Vi11</b> |

| <b>Location</b> | MCO-HAA Structure-1 <sup>st</sup> Floor-<br>Inspections Platform N0.2 |
| <b>Material</b> | Plastics, Metals & Alloys. |
| <b>Comments</b> | Visually no Asbestos Suspected.<br>(VNAS) Reasoned argument. |

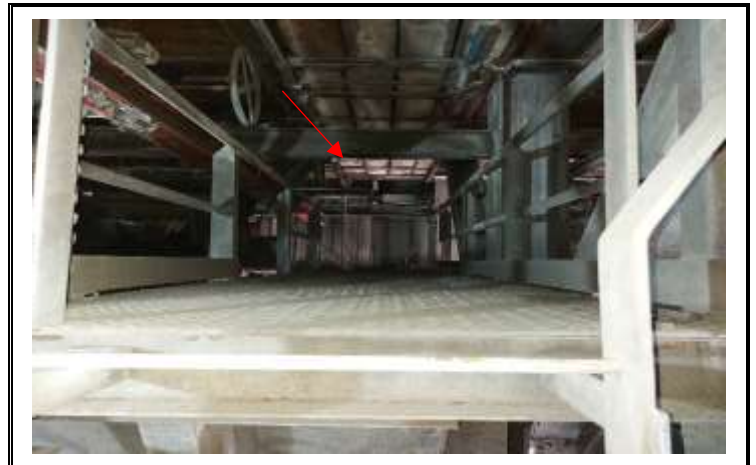
| <b>Inspection Ref</b> | <b>MESL-5938 SC<br/>Vi12</b> |

| <b>Location</b> | MCO-HAA Structure-1 <sup>st</sup> Floor-<br>Electrical Controls Boxes-West<br>Walkway-1 Item |
| <b>Material</b> | Plastics, Metals & Alloys. |
| <b>Comments</b> | Visually no Asbestos Suspected.<br>(VNAS) Reasoned argument. |

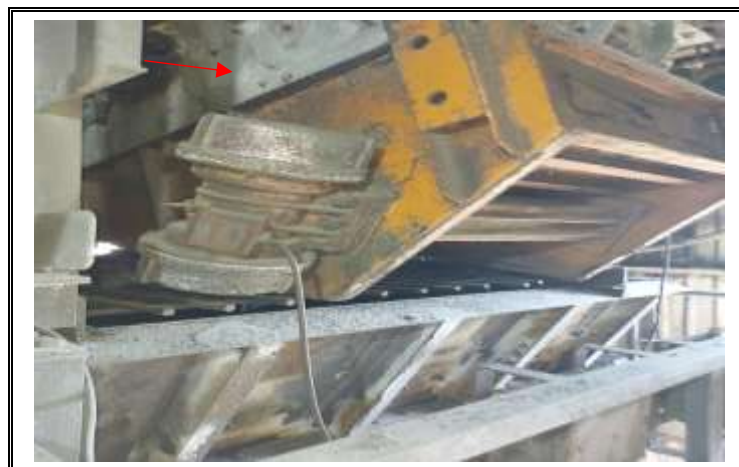
| <b>Inspection Ref</b> | <b>MESL-5938 SC Vi14</b> |

| <b>Location</b> | MCO-HAA Structure-1 <sup>st</sup> Floor-<br>Electrical Controls Boxes-<br>Southwest-2 Items |
| <b>Material</b> | Plastics, Metals & Alloys. |
| <b>Comments</b> | Visually no Asbestos Suspected.<br>(VNAS) Reasoned argument. |

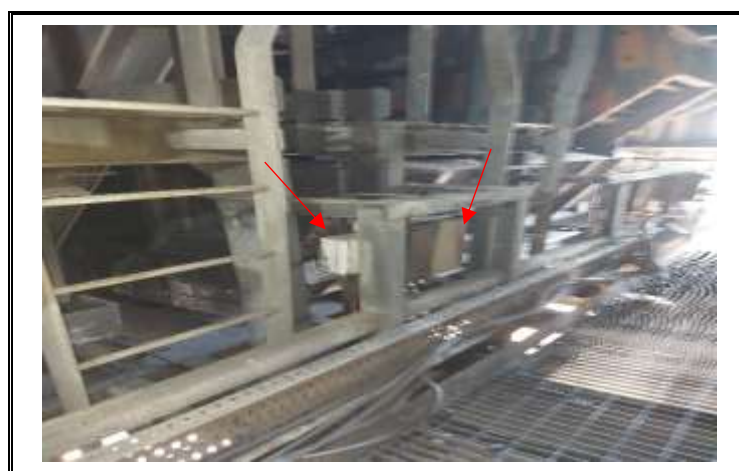
| <b>Inspection Ref</b> | <b>MESL-5938 SC Vi15</b> |

| <b>Location</b> | MCO-HAA Structure-1 <sup>st</sup> Floor-<br>Electrical Controls Boxes-<br>Southwest-2 Items |
| <b>Material</b> | Plastics, Metals & Alloys. |
| <b>Comments</b> | Visually no Asbestos Suspected.<br>(VNAS) Reasoned argument. |

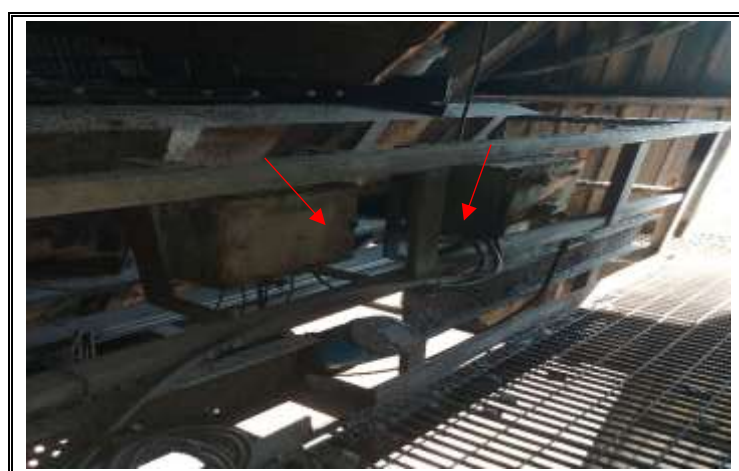
| <b>Inspection Ref</b> | <b>MESL-5938 SC Vi16</b> |

| <b>Location</b> | MCO-HAA Structure-1 <sup>st</sup> Floor-Electrical Lighting Control Box-1 Items |
| <b>Material</b> | Plastics, Metals & Alloys. |
| <b>Comments</b> | Visually no Asbestos Suspected. (VNAS) Reasoned argument. |

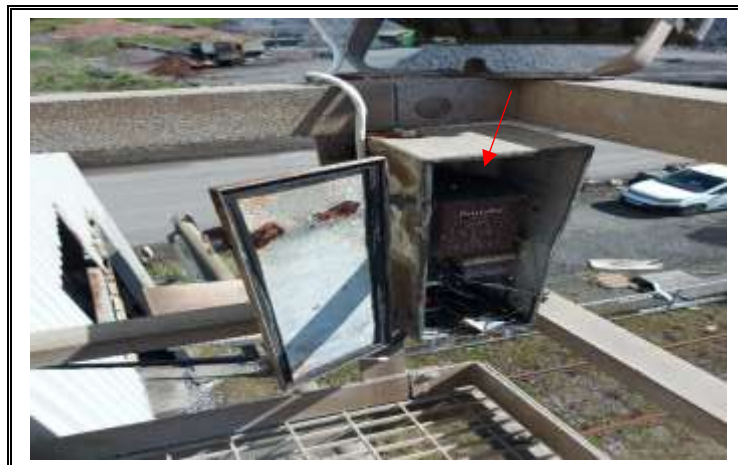
| <b>Inspection Ref</b> | <b>MESL-5938 SC Vi17</b> |

| <b>Location</b> | MCO-HAA Structure-1 <sup>st</sup> Floor-Electrical Lighting Control Box-1 Items |
| <b>Material</b> | Plastics, Metals & Alloys. |
| <b>Comments</b> | Visually no Asbestos Suspected. (VNAS) Reasoned argument. |

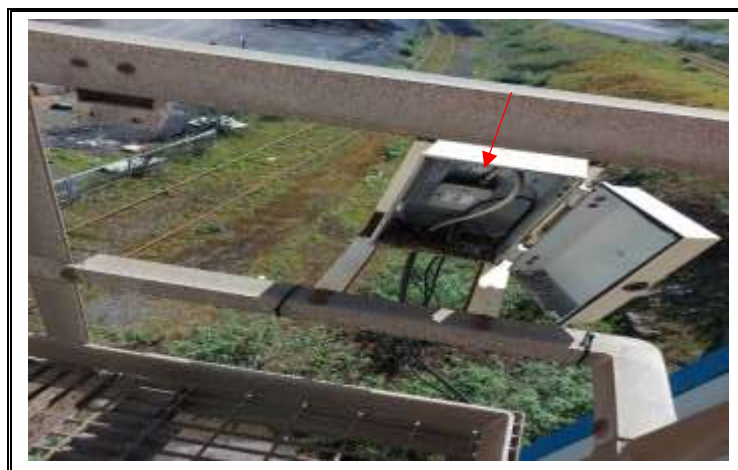
| <b>Inspection Ref</b> | <b>MESL-5938 SC Vi18</b> |

| <b>Location</b> | MCO-HAA Structure-1 <sup>st</sup> Floor-Material Main Feeder Chutes |
| <b>Material</b> | Metals & Alloys. |
| <b>Comments</b> | Visually no Asbestos Suspected. (VNAS) Reasoned argument. |

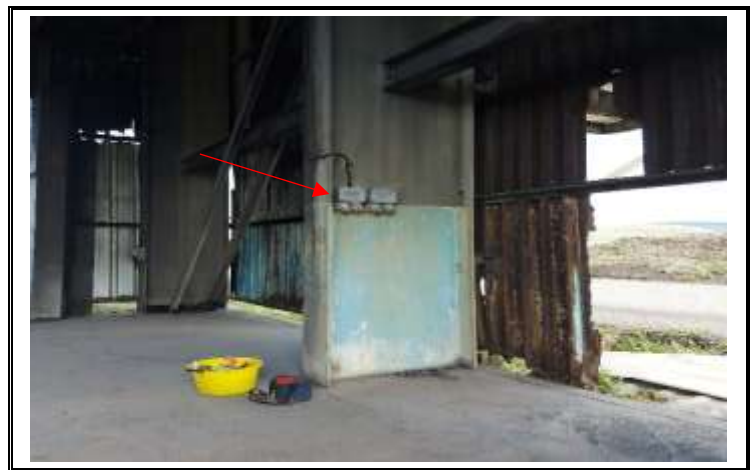
| <b>Inspection Ref</b> | <b>MESL-5938 SC Vi21</b> |

| <b>Location</b> | MCO-HAA Structure-GF- East-Electrical Control Box-1 Item |
| <b>Material</b> | Plastics, Metals & Alloys. |
| <b>Comments</b> | Visually no Asbestos Suspected. (VNAS) Reasoned argument. |

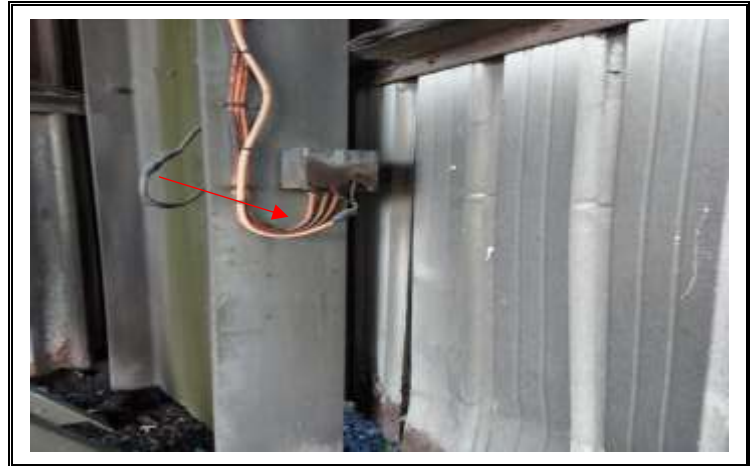
| <b>Inspection Ref</b> | <b>MESL-5938 SC<br/>Vi23</b> |

| <b>Location</b> | MCO-HAA Structure-GF- West-<br>Electrical Junction Box-1 Item |
| <b>Material</b> | Plastics, Metals & Alloys. |
| <b>Comments</b> | Visually no Asbestos Suspected.<br>(VNAS) Reasoned argument. |

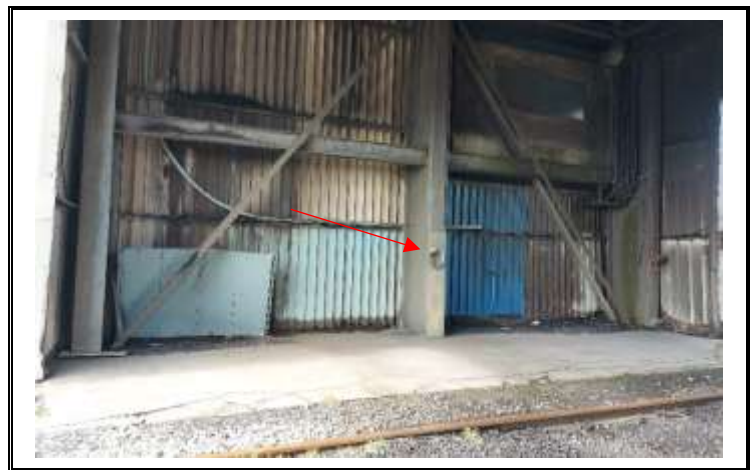
| <b>Inspection Ref</b> | <b>MESL-5938 SC<br/>Vi24</b> |

| <b>Location</b> | MCO-HAA Structure-GF- West-<br>Electrical Lighting-Throughout |
| <b>Material</b> | Plastics, Glass, Metals & Alloys. |
| <b>Comments</b> | Visually no Asbestos Suspected.<br>(VNAS) Reasoned argument. |

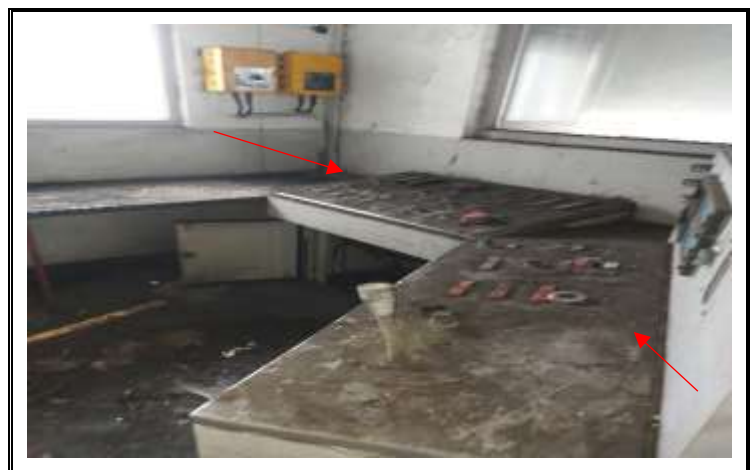
| <b>Inspection Ref</b> | <b>MESL-5938 SC Vi27</b> |

| <b>Location</b> | MCO-HAA Structure-1 <sup>st</sup> Floor Annex-Control Desk |
| <b>Material</b> | Plastics, Metals & Alloys. |
| <b>Comments</b> | Visually no Asbestos Suspected. (VNAS) Reasoned argument. |

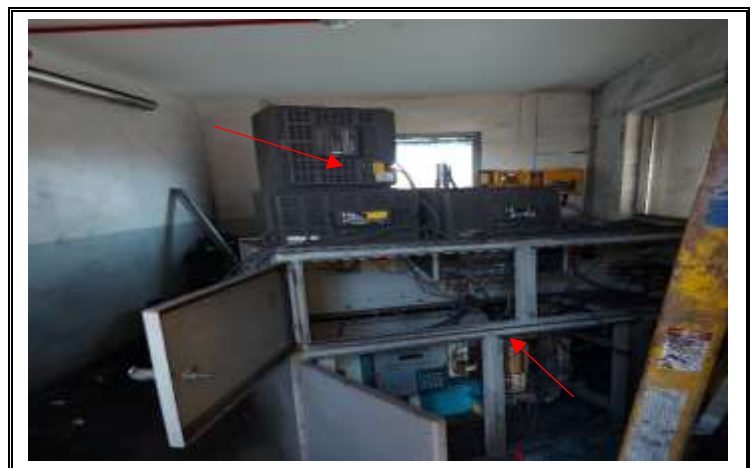
| <b>Inspection Ref</b> | <b>MESL-5938 SC Vi28</b> |

| <b>Location</b> | MCO-HAA Structure-1 <sup>st</sup> Floor<br>Annex-Fire Alarm Control<br>Panel-1 Item |
| <b>Material</b> | Plastics, Metals & Alloys. |
| <b>Comments</b> | Visually no Asbestos Suspected.<br>(VNAS) Reasoned argument. |

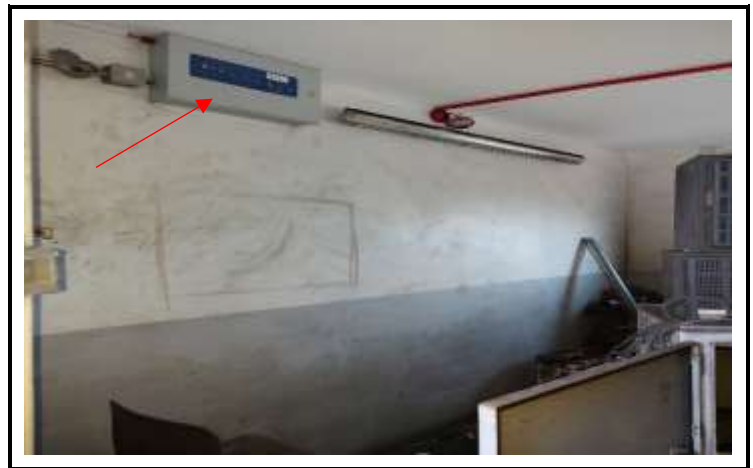
| <b>Inspection Ref</b> | <b>MESL-5938 SC Vi29</b> |

| <b>Location</b> | MCO-HAA Structure-1 <sup>st</sup> Floor<br>Annex-Electrical Control Panels-<br>2 Items |
| <b>Material</b> | Plastics, Metals & Alloys. |
| <b>Comments</b> | Visually no Asbestos Suspected.<br>(VNAS) Reasoned argument. |

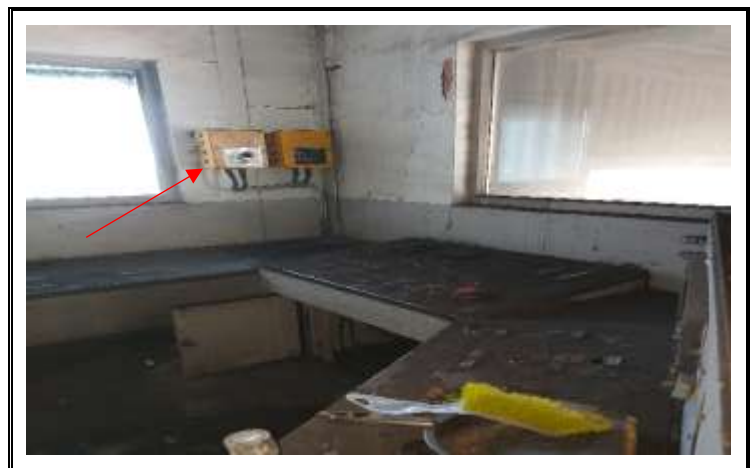
| <b>Inspection Ref</b> | <b>MESL-5938 SC Vi30</b> |

| <b>Location</b> | MCO-HAA Structure-1 <sup>st</sup> Floor<br>Annex-Electrical Control Panel-1<br>Item |
| <b>Material</b> | Plastics, Metals & Alloys. |
| <b>Comments</b> | Visually no Asbestos Suspected.<br>(VNAS) Reasoned argument. |

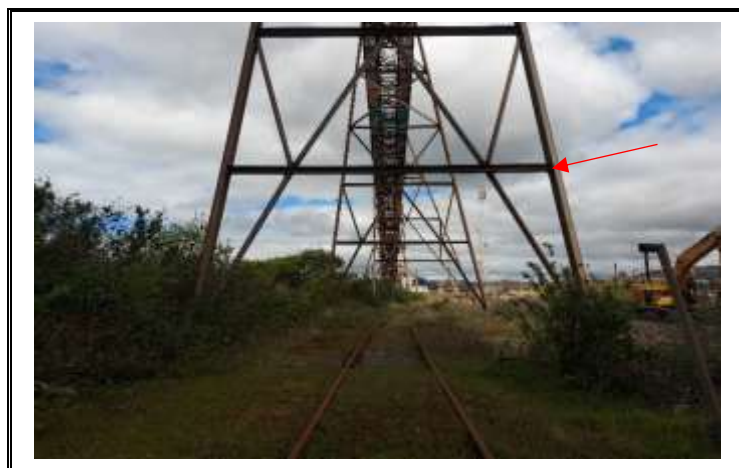
| <b>Inspection Ref</b> | <b>MESL-5938 SC Vi37</b> |

| <b>Location</b> | MCO-HAA-Redundant 1290 Conveyor System |
| <b>Material</b> | Metals, Alloys, Rubber & Plastics |
| <b>Comments</b> | Visually no Asbestos Suspected. (VNAS) Reasoned argument. |

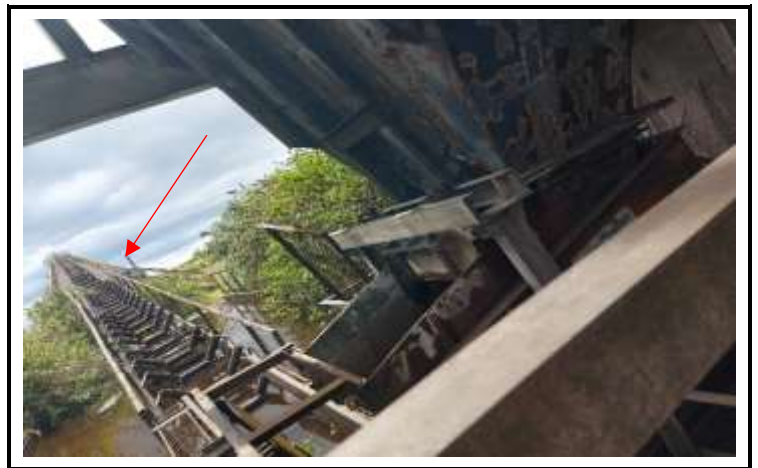
| <b>Inspection Ref</b> | <b>MESL-5938 SC Vi38</b> |

| <b>Location</b> | MCO-HAA-Redundant 1290 Conveyor-Feed Hoppers Chutes |

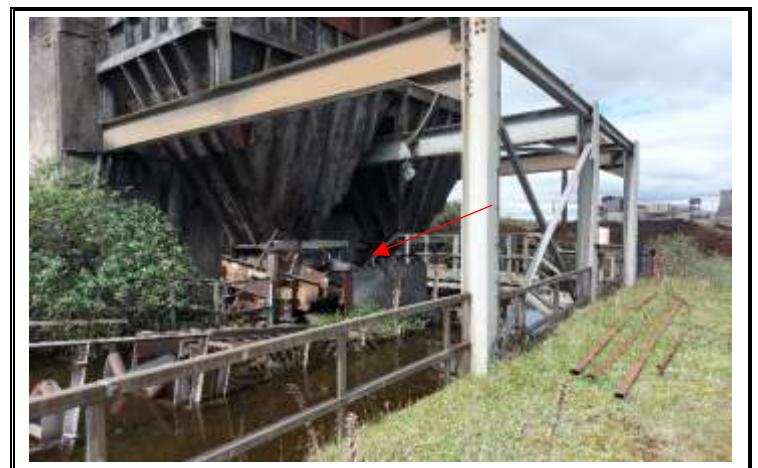
| <b>Comments</b> | Visually no Asbestos Suspected. (VNAS) Reasoned argument. |

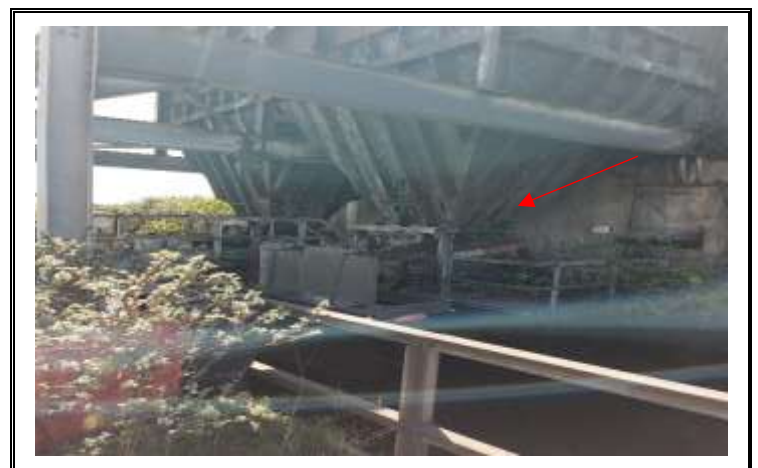
| <b>Inspection Ref</b> | <b>MESL-5938 SC Vi39</b> |

| <b>Location</b> | MCO-HAA-Redundant 1290 Conveyor-Feed Hoppers Chutes |
| <b>Comments</b> | Visually no Asbestos Suspected. (VNAS) Reasoned argument. |

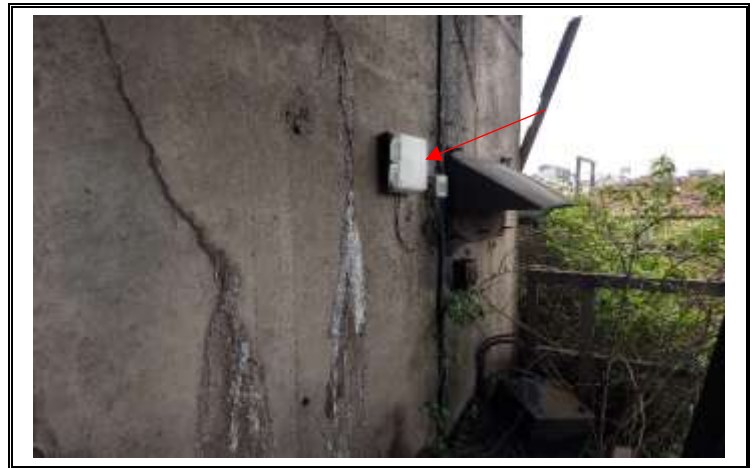
| <b>Inspection Ref</b> | <b>MESL-5938 SC<br/>Vi40</b> |

| <b>Location</b> | MCO-HAA-Redundant 1290<br>Conveyor-Feed Hoppers-<br>Electrical Lighting |
| <b>Comments</b> | Visually no Asbestos Suspected.<br>(VNAS) Reasoned argument. |

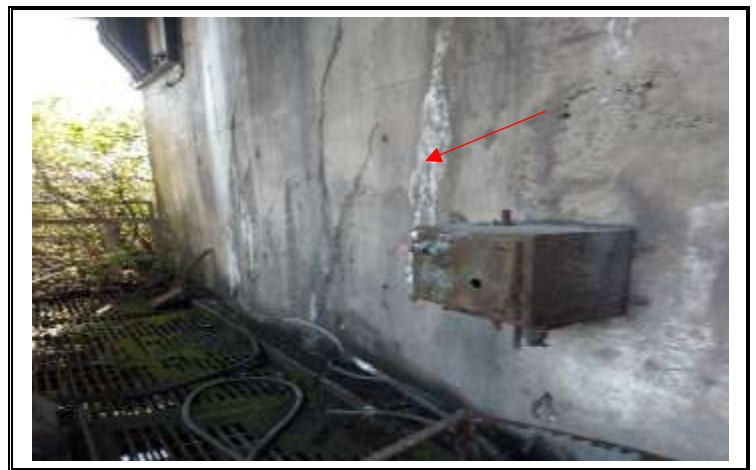
| <b>Inspection Ref</b> | <b>MESL-5938 SC<br/>Vi41</b> |

| <b>Location</b> | MCO-HAA-Redundant 1290<br>Conveyor-Feed Hoppers-<br>Electrical Control Panel-1 Item |
| <b>Comments</b> | Visually no Asbestos Suspected.<br>(VNAS) Reasoned argument. |

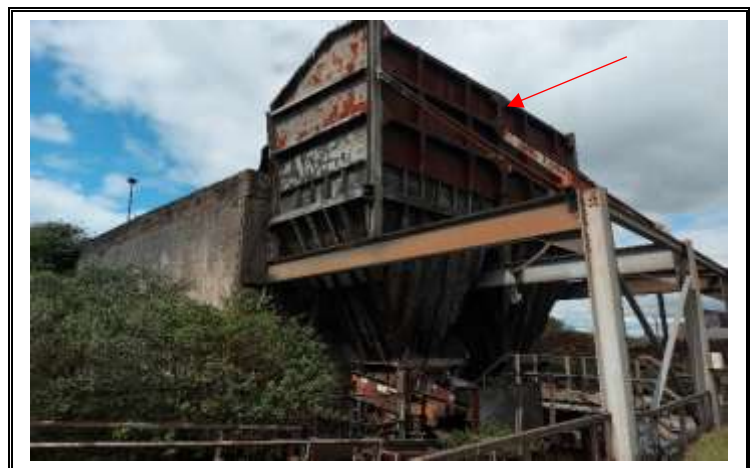
| <b>Inspection Ref</b> | <b>MESL-5938 SC<br/>Vi42</b> |

| <b>Location</b> | MCO-HAA-Redundant 1290<br>Conveyor-Feed Hoppers-<br>Construction Materials |
| <b>Comments</b> | Visually no Asbestos Suspected.<br>(VNAS) Reasoned argument. |

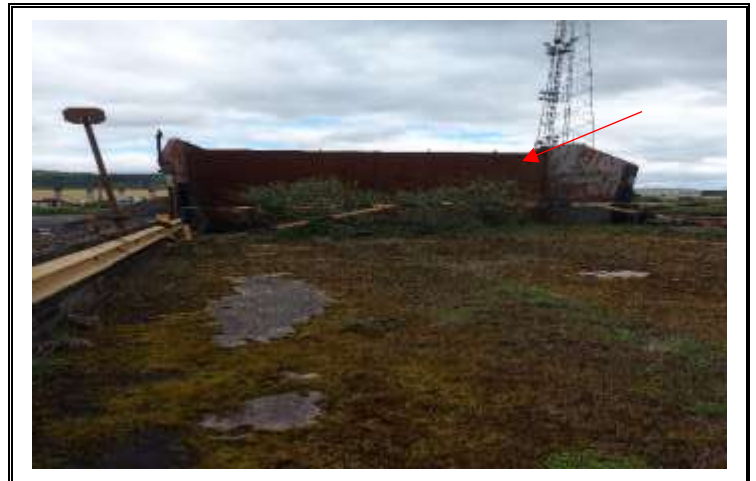
| <b>Inspection Ref</b> | <b>MESL-5938 SC<br/>Vi43</b> |

| <b>Location</b> | MCO-HAA-Redundant 1290<br>Conveyor-Feed Hoppers-Vehicle<br>Loading Area-Construction<br>Materials |
| <b>Comments</b> | Visually no Asbestos Suspected.<br>(VNAS) Reasoned argument. |

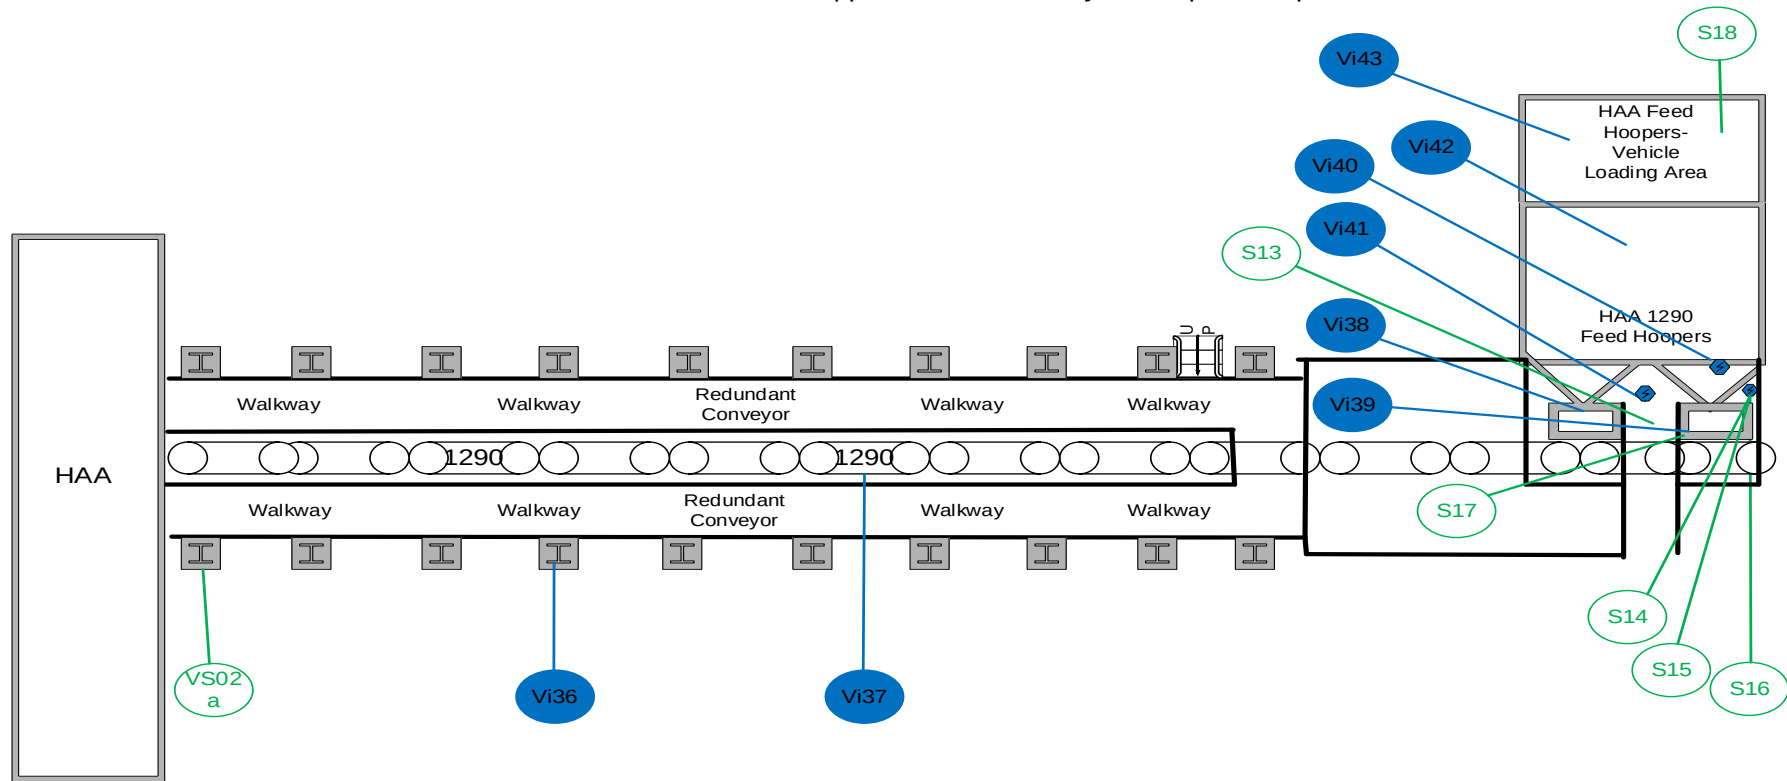
5938 SC-Redundant Morfa Coke Ovens-HAA-Feed Hoppers & 1290 Conveyor-Sample & Inspection Locations

Please note; The upper floor levels of the structure, its plant & equipment could not be inspected. There was no safe access- Walkways unsafe-All items within this area must be presumed to contain asbestos until proven otherwise-Further inspections required.

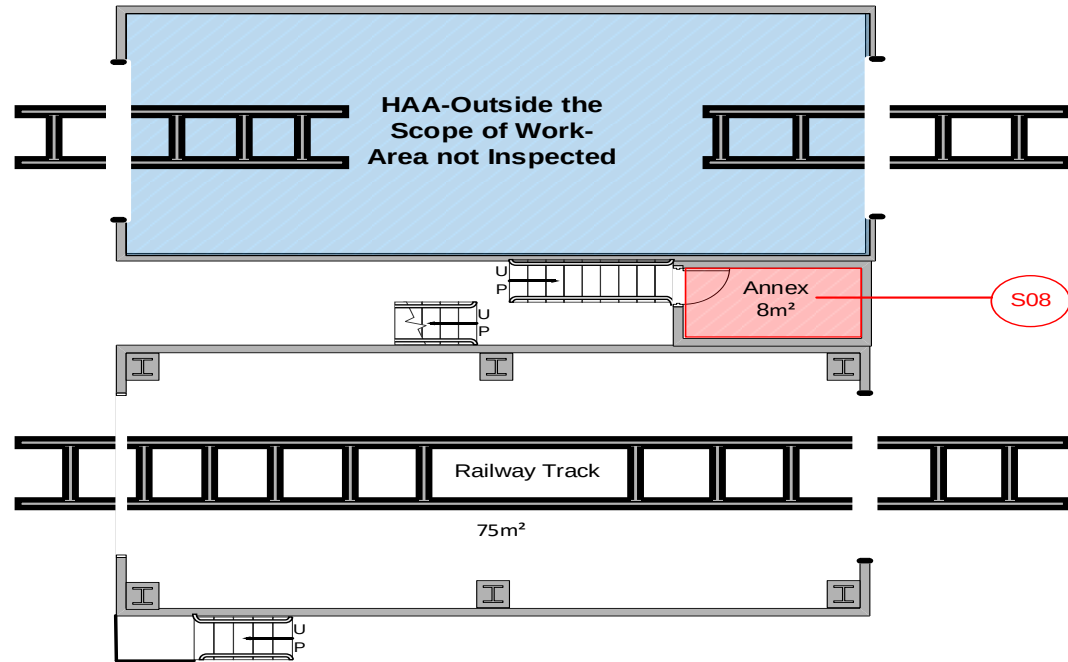
5938 SC-Redundant Morfa Coke Ovens-HAA-Ground Floor & Annex-Asbestos Locations

Please note; The upper floor levels of the structure, its plant & equipment could not be inspected. There was no safe access- Walkways unsafe-All items within this area must be presumed to contain asbestos until proven otherwise-Further inspections required.
