**Re:** Results of tree/bat survey completed on areas A-D within the Grandison Brook area.

This letter is an account of the and bat roosting survey undertaken on the 2<sup>nd</sup> of October 2025

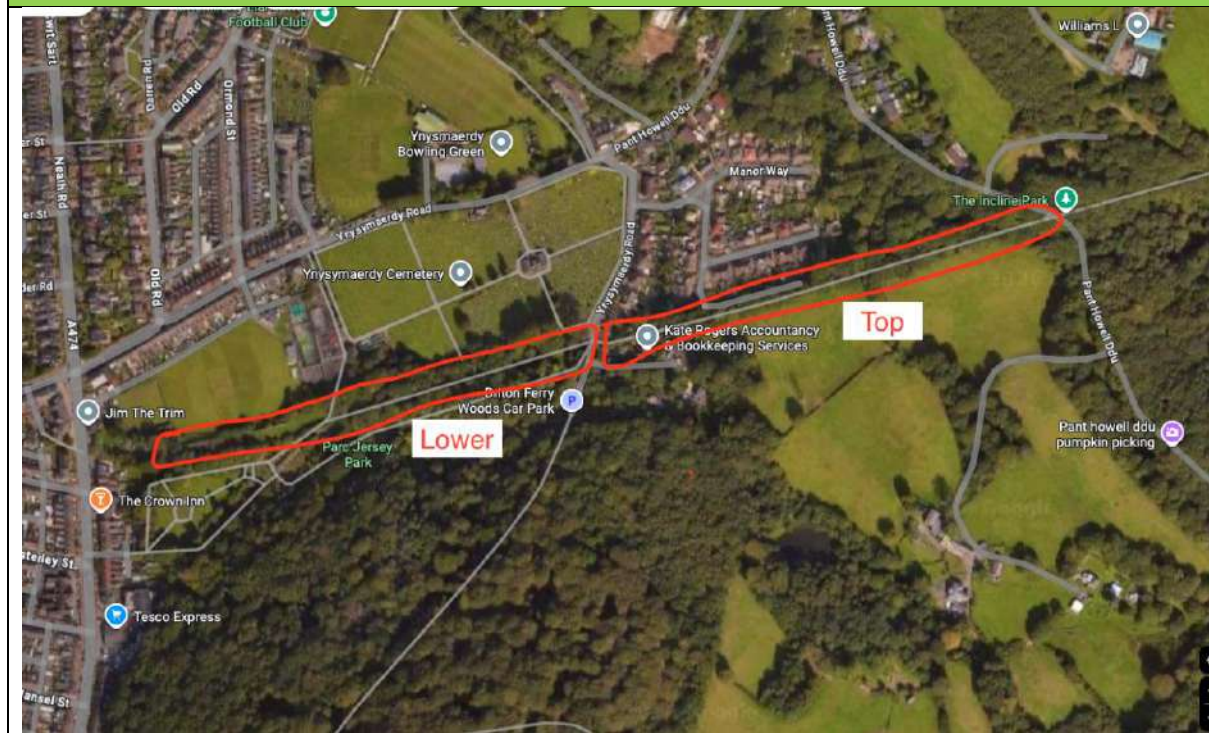
Area A is labelled below TOP and LOWER for ease of reference

Location and trees with the noted features are below:

All except one of the trees noted with features seem to be on the southern side of the pathway known as the incline, it is currently understood that this part will remain unaffected by the works. If the trees on this side are also to be removed, then any trees with potential features should be inspected again immediately prior to felling. Any trees heavily covered in ivy should also have the ivy removed to allow for a full and clear visual inspection prior to felling.

Recommendations are to proceed with caution when removing the trees that are covered in ivy. Removing the ivy prior to felling would allow for a full and thorough inspection of the trees making any PRF's present visible. If trees with the noted PRF's are to be removed then advice should be sought and/or an inspection by a competent person should be made before proceeding with any tree works.

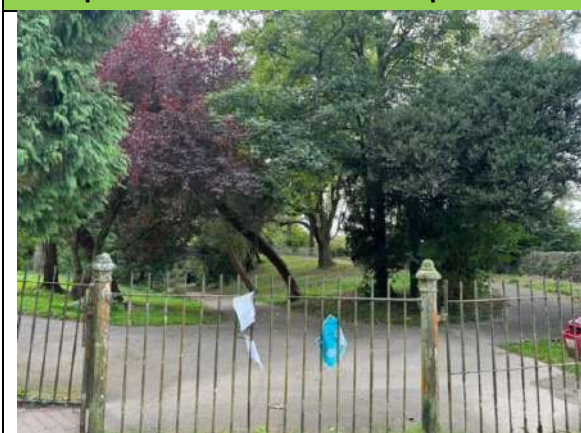
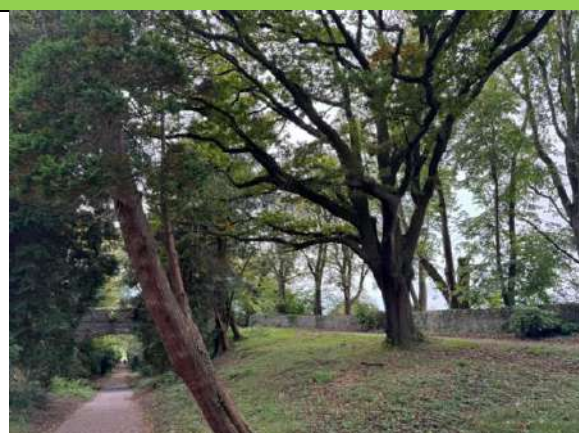
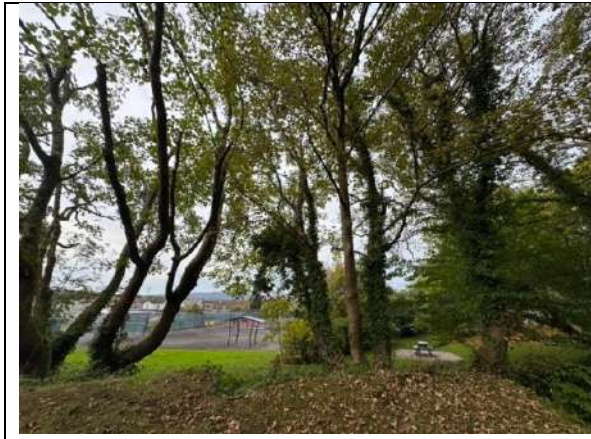
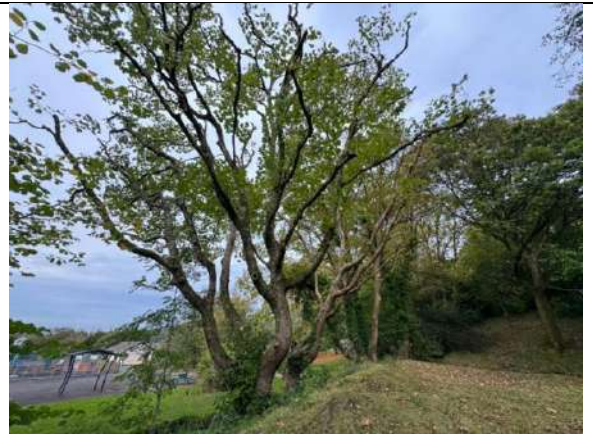
#### Example of the trees in the lower part of area A

The lower portion of area A has some notable tree species; there were NO noted trees or features within the lower part of area A.

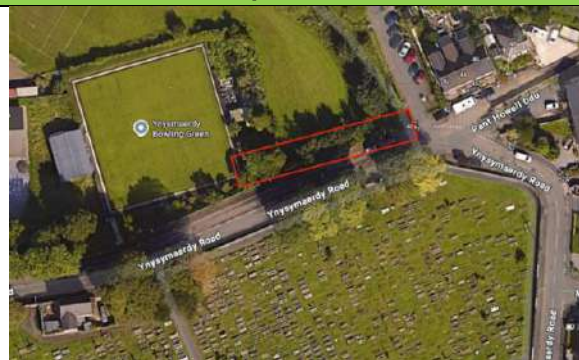
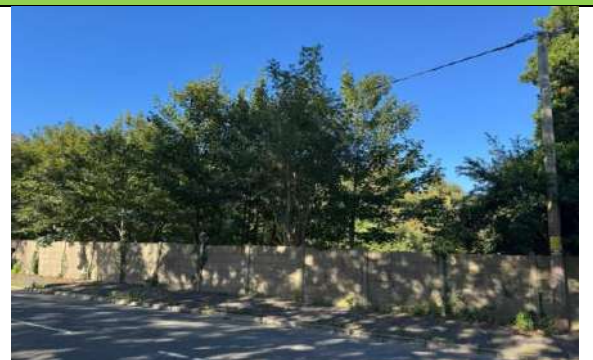
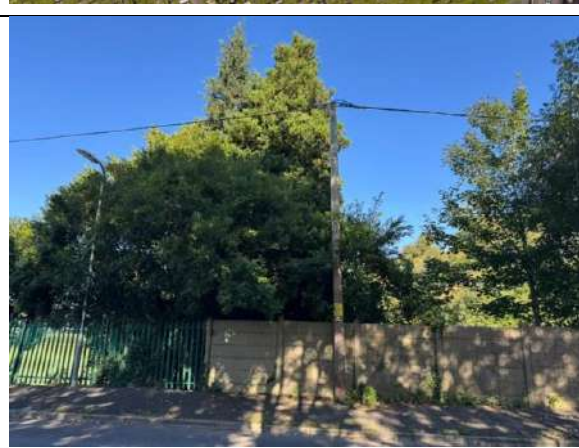
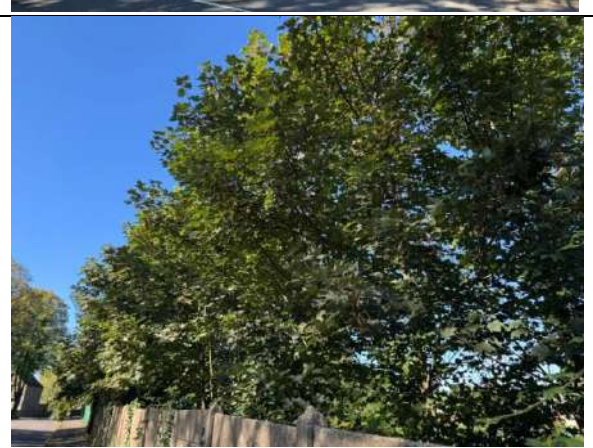
### Area B – Grid Reference – SS 747951

The trees at this location were prominently Sycamore with 1 Ash tree a fir tree and some privet – There were NO suitable features noted on any of these trees.  
Location and example of trees below:

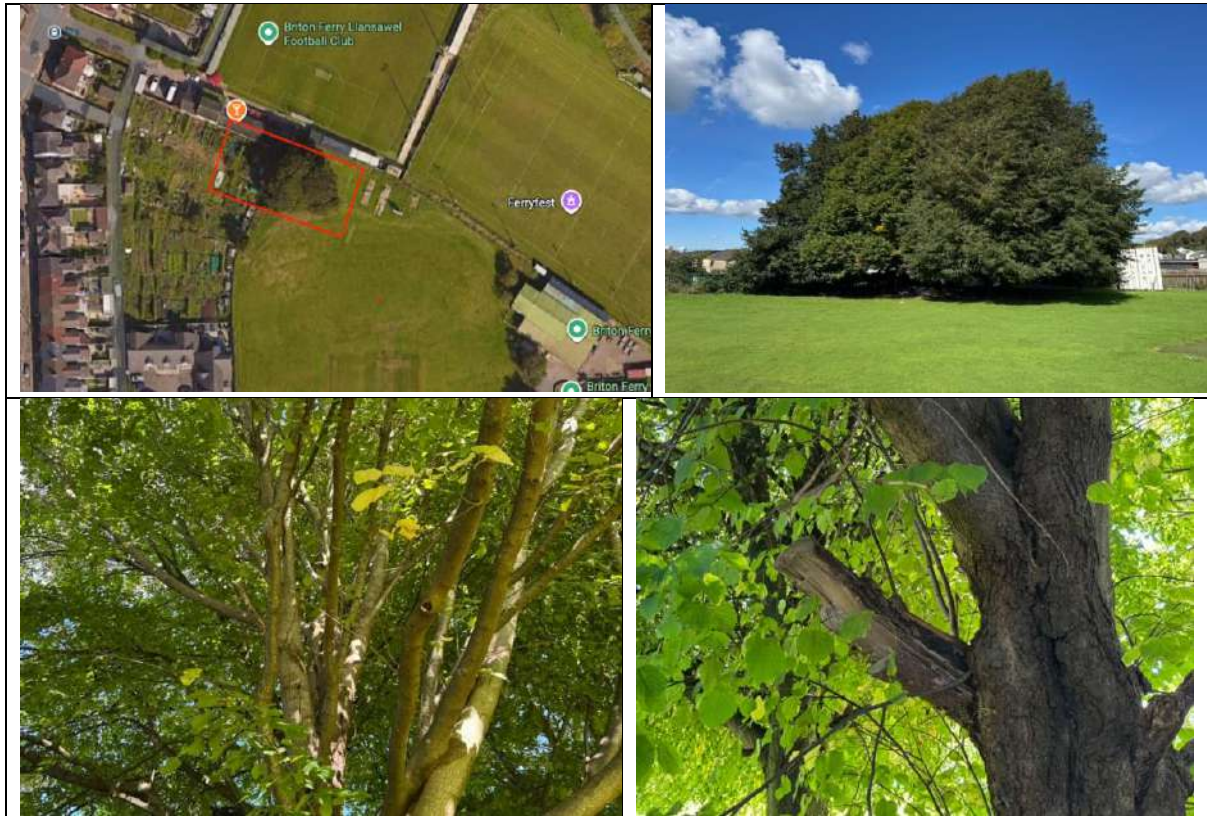
### Area C – Grid Reference – SS 74576 59192

Trees in this location are all Lime trees, with NO suitable features noted other than superficial wounds.

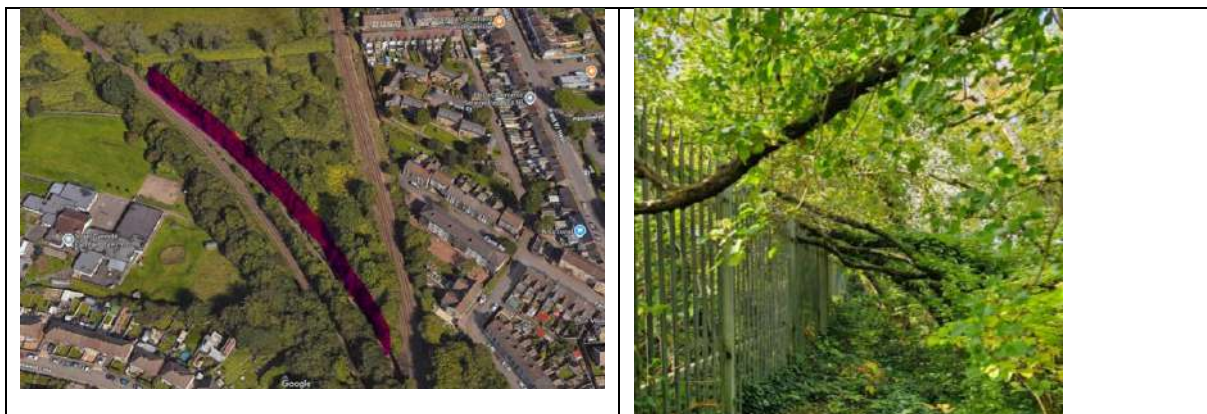
### Area D – Grid Reference – SS741955

Trees in this location were of mixed species with NO suitable features noted.
