# PROPOSED DEVELOPMENT AT THE PLAZA CINEMA, PORT TALBOT

## REMEDIATION STRATEGY REPORT

Report No. Q0045/RS

May 2020

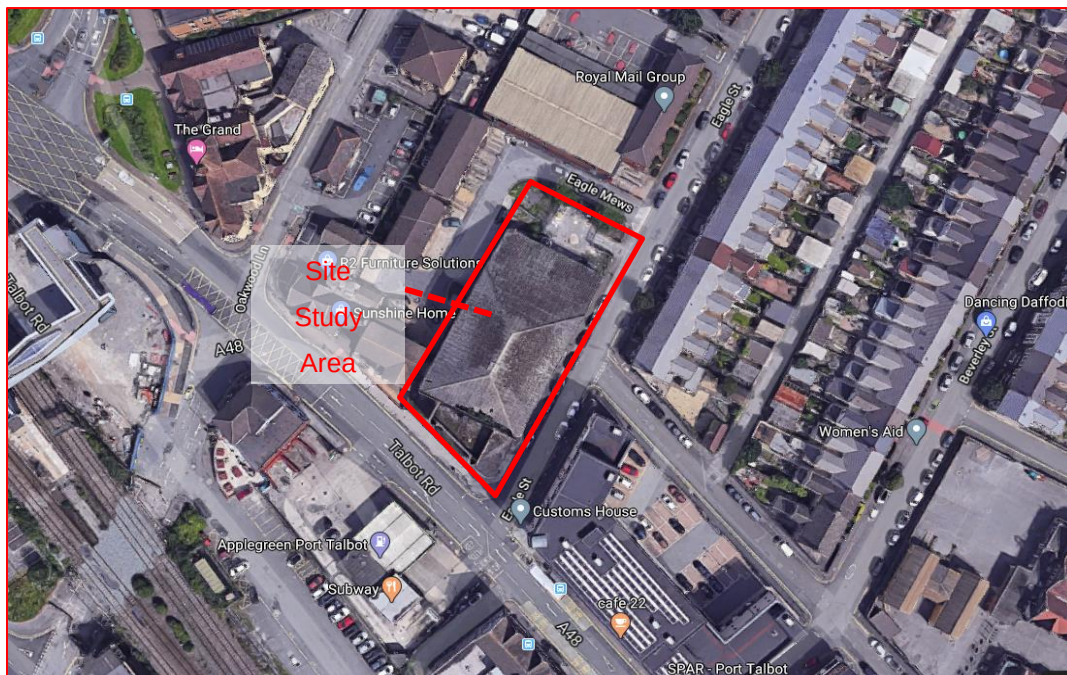
**Figure 2:** Aerial Ordnance Survey photograph of existing premises. *Not to Scale*

The site is centred on National Grid Reference 276855,189602 and covers an area approximately 1800m<sup>2</sup>. The proposed development site is approximately rectangular in plan shape with the south western and central areas of the site is occupied by the remaining Plaza Cinema brick building. The north eastern area of the site is rough vegetation and hardstanding. The area to which this Remediation Strategy relates is outlined for ease of reference in Figure 1 over page with an aerial photograph of the site (dated 2020) as Figure 2.
