*Report No. BC/MB/11.20.02.*

# **Coal Mining Risk Report: Land at Wellfield Road, Baglan, Port Talbot.**

# **Coal Mining Risk Assessment: Land at Wellfield Road, Baglan, Port Talbot.**

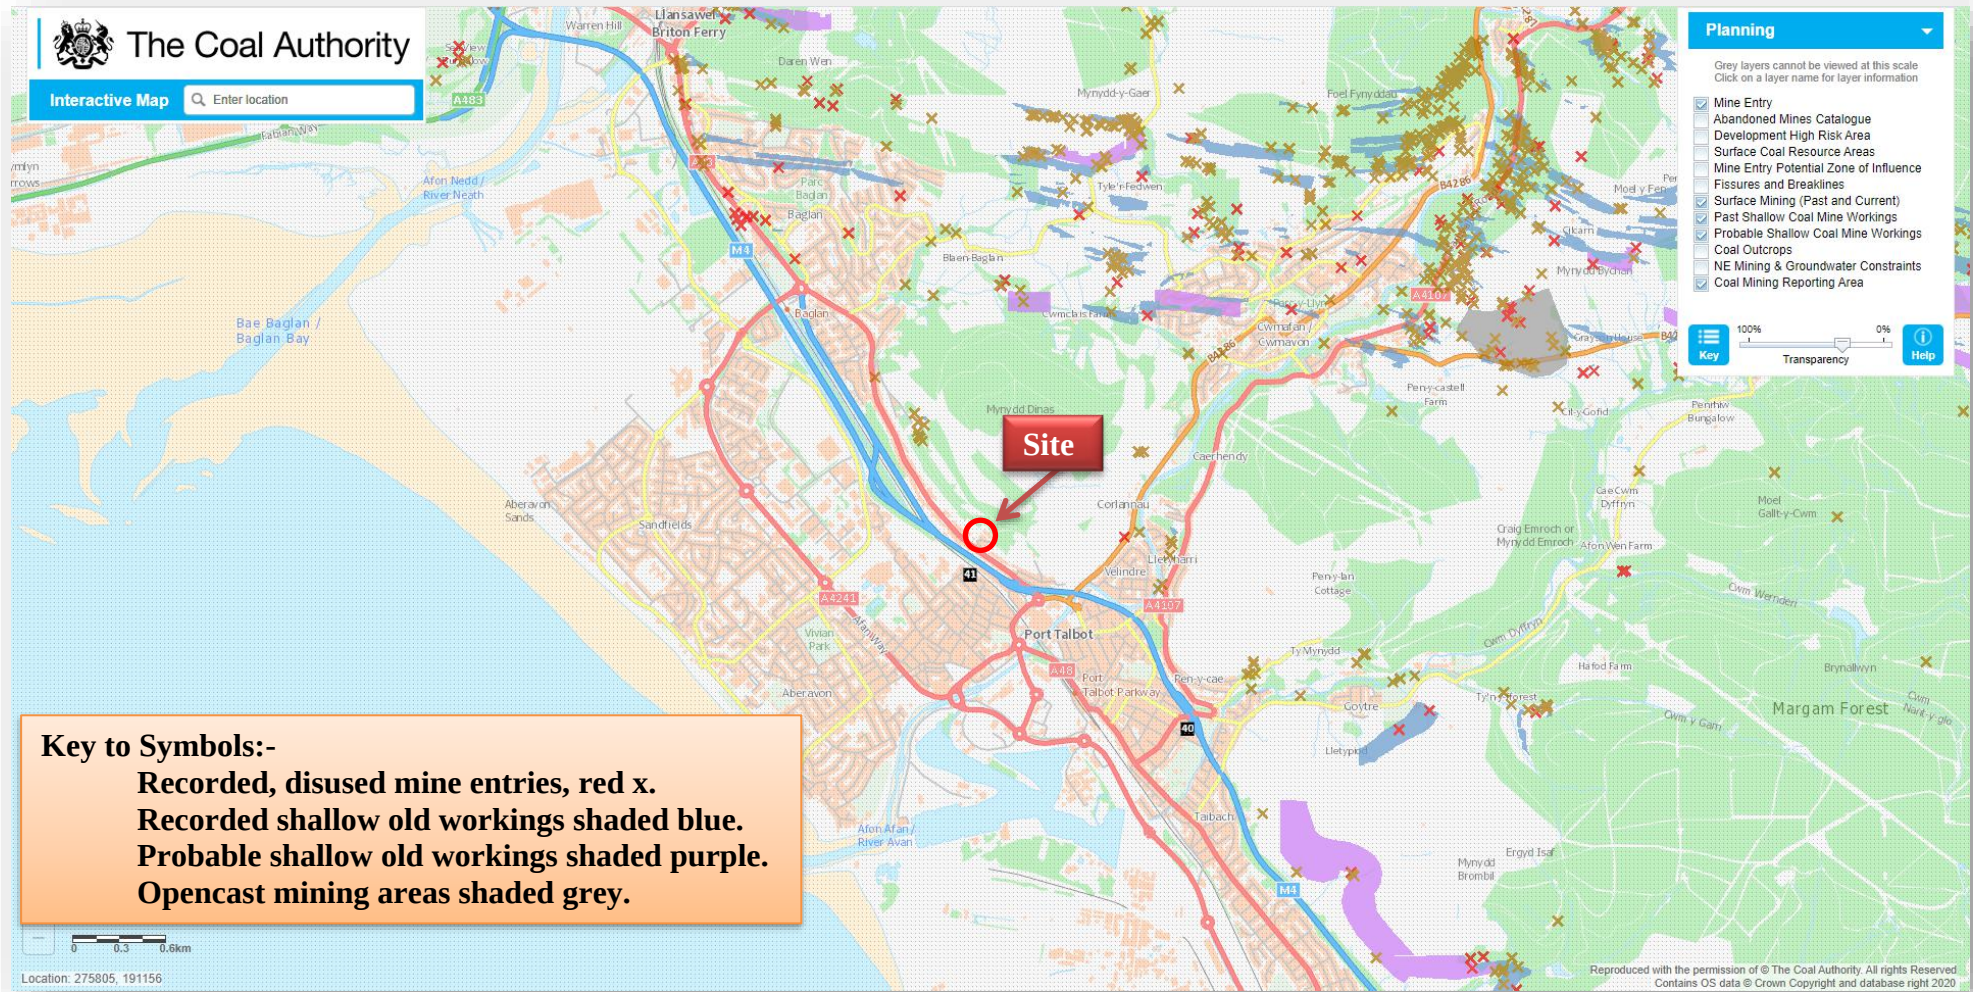
**Figure 3**  
**Print-out of The Coal Authority's Interactive Map**  
 (Accessed 3<sup>rd</sup> November 2020)

The general area has been subject to coal mining operations dating back to the nineteenth century. Coal seams were accessed by adits driven into the mining horizons near their outcrops supplemented by air shafts; larger shafts gave access to deeper lying coal seams. However, The Coal Authority's interactive map shows that there are no recorded workings underlying the Site, shallow or otherwise, and no 'probable' shallow mine workings in the vicinity of the Site (see Figure 3). In fact, there are no recorded shallow mine workings or 'probable' workings anywhere within 3km of the Site. There are no recorded mine entries within the confines of the Site or within 20m of it, and no records of any nearby disused adits that might have provided access to underground workings that could extend beneath the Site.

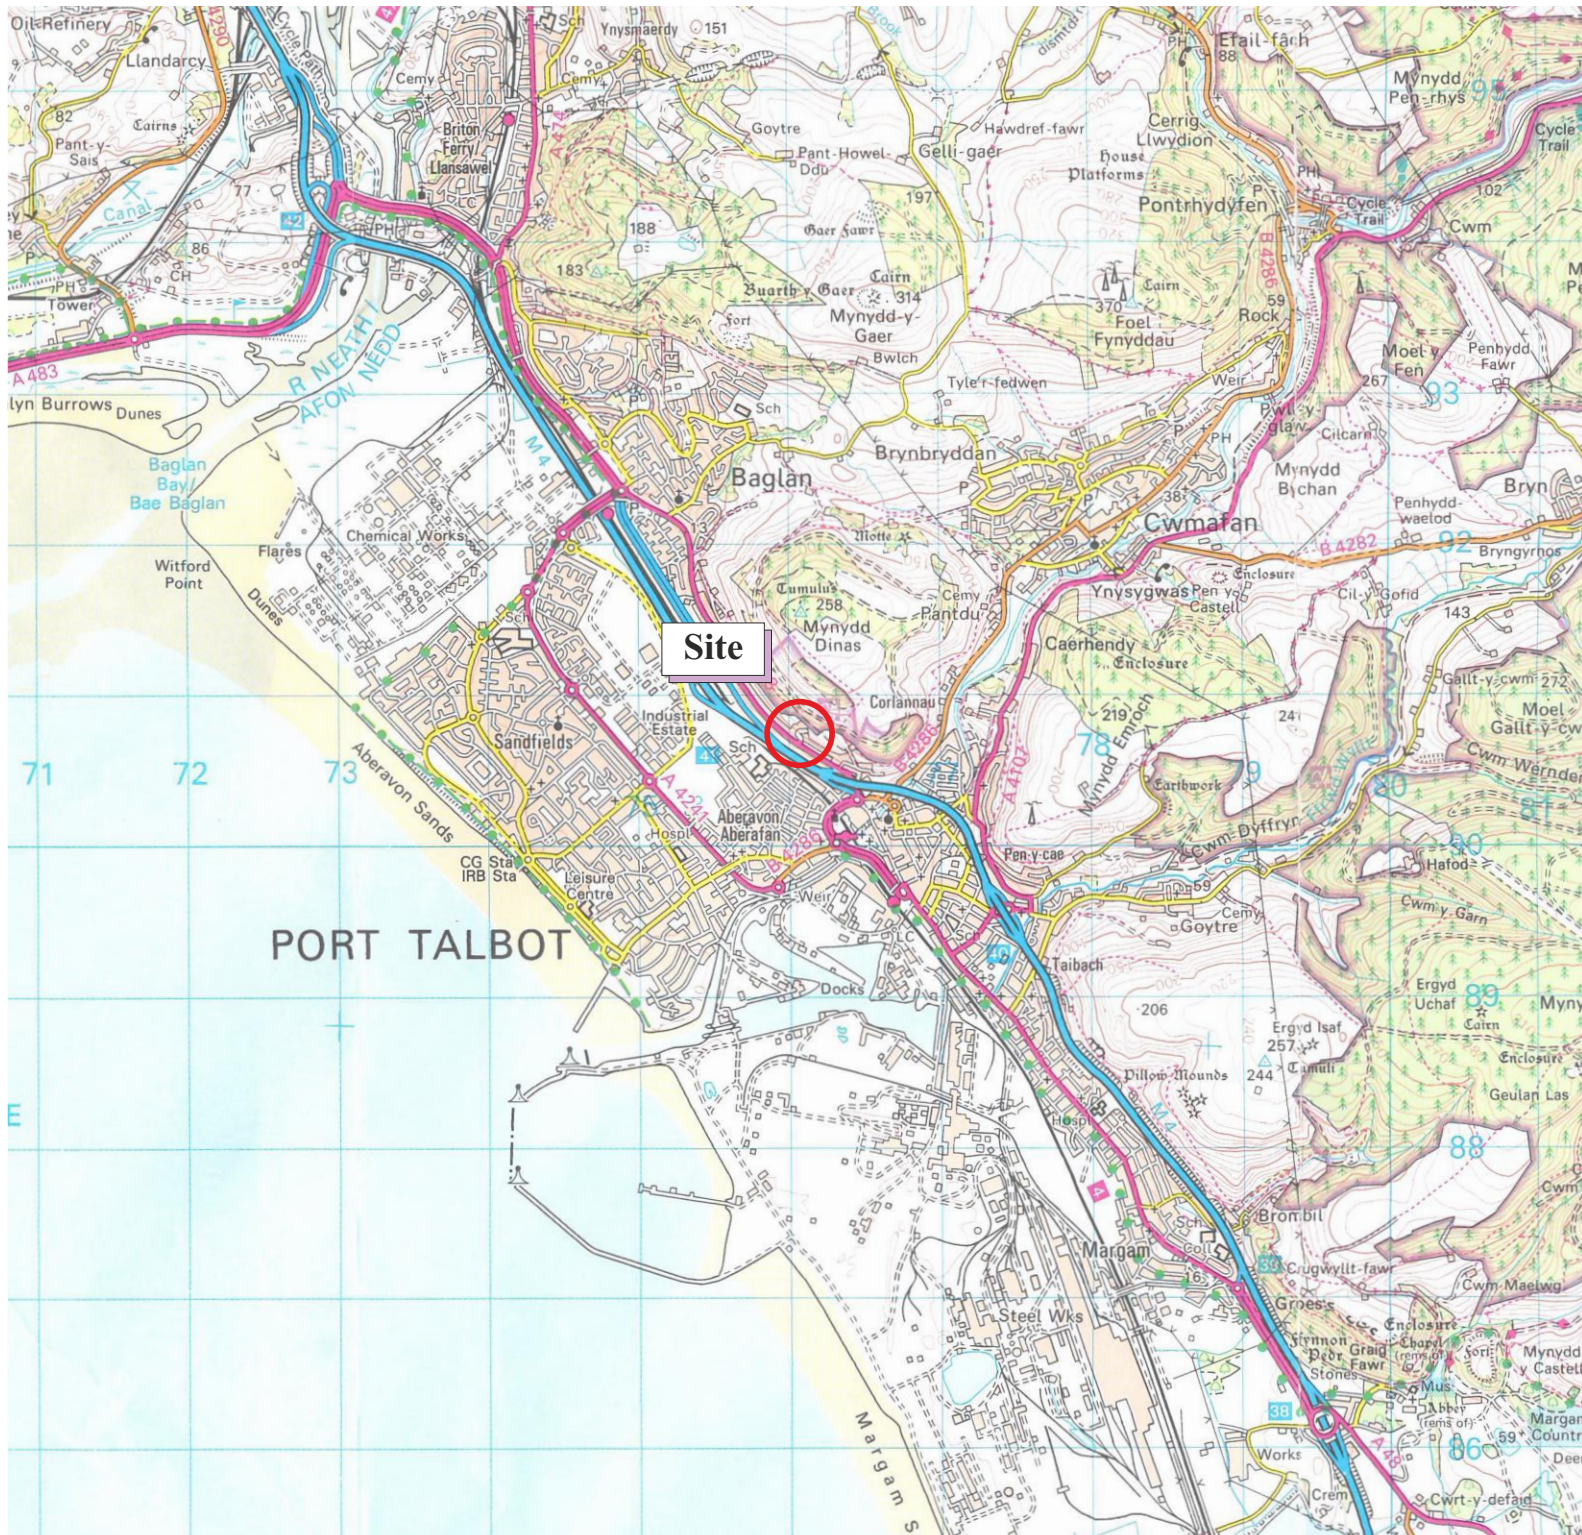
General Location Plan.

Plan Scale: 1:50,000.

| <b>Drawing No:</b> | | <b>Scale:</b> |
|---|---|---|
| <i>BC/MB/11.20.02.01.</i> | <i>General Location Plan.</i> | <i>1:50,000.</i> |
