*Report No. BC/MB/04.20.07.*

# **Coal Mining Risk Assessment: Land at Abergarwed Farm.**

***Absolute Scaffolding Ltd***

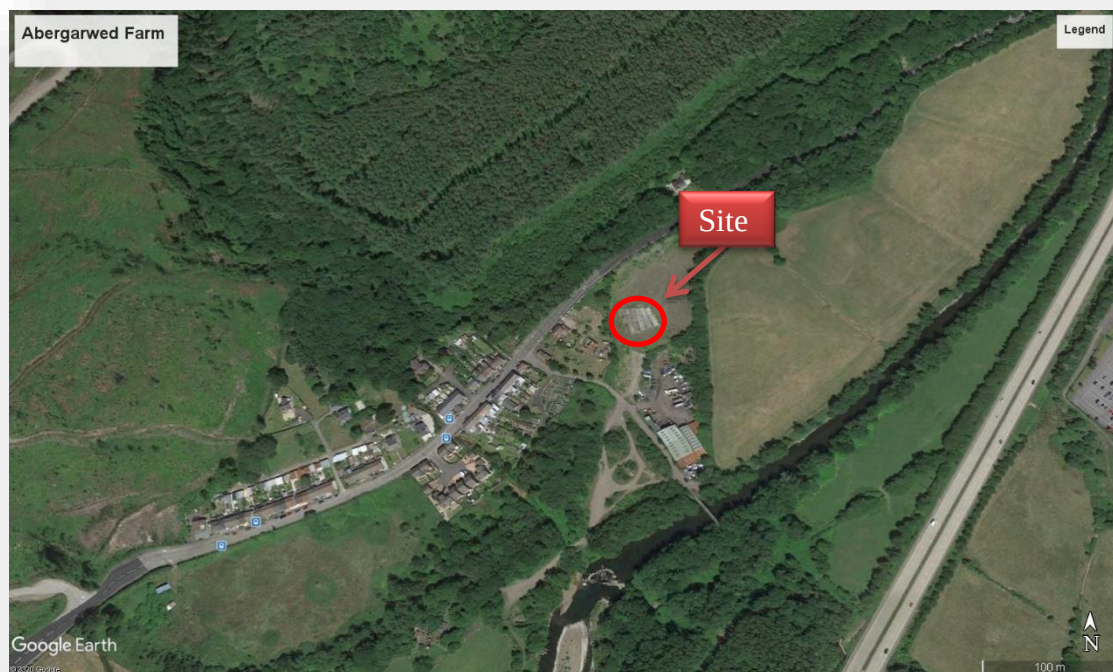
**Figure 1**  
**Aerial View of Site**

The plot of land where it is proposed to construct the storage facility, 'the Site' is located in a rural area and is situated on the floor of the Neath Valley, approximately 11km east of the commercial centre of Neath and 7.5m south-west of the centre of Glyn Neath (see Figure 1 and *General Location Plan, drawing no. BC/MB/04.20.07.01*). The Site is located at the eastern fringes of Abergarwed and close to the River Neath and is largely surrounded by a mixture of woodland and agricultural enclosures. The Site is irregular in outline and the proposed storage building has dimensions of approximately 30m by 20m; its location is at an elevation of approximately 22m aod (see Figure 1 and *Detailed Location Plan, drawing no. BC/MB/04.20.07.03*).

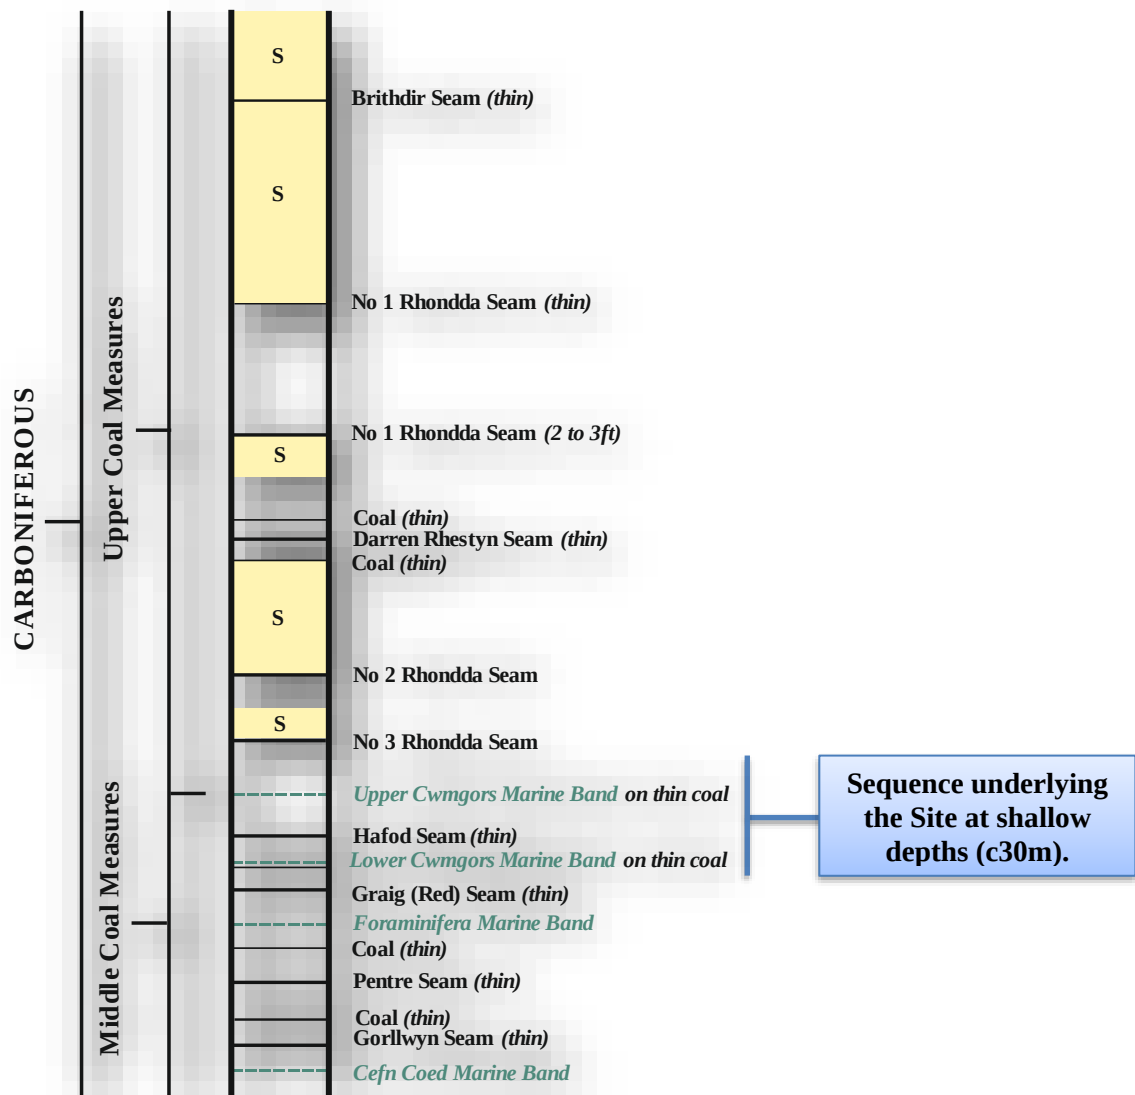
**Figure 2**  
**Indicative Stratigraphic Column.**

The Site is situated towards the northern margins of the former South Wales Coalfield. The inferred position of the Upper Cwm Gors Marine Band is shown on the published geological sheet (Sheet ST 18 NE) to pass through or in the immediate vicinity of the Site. The Marine Band marks the division between the Upper and Middle Coal Measures. The geological sheet shows the inferred position of the outcrop of the No 3 Rhondda Seam to be present immediately to the east of the Site, such that the seam does not underlie the Site (see *Geology Plan, drawing no. BC/MB/04.20.07.02*). There are no coal seams underlying the Site at shallow depths that are thick enough to have supported underground mining operations.

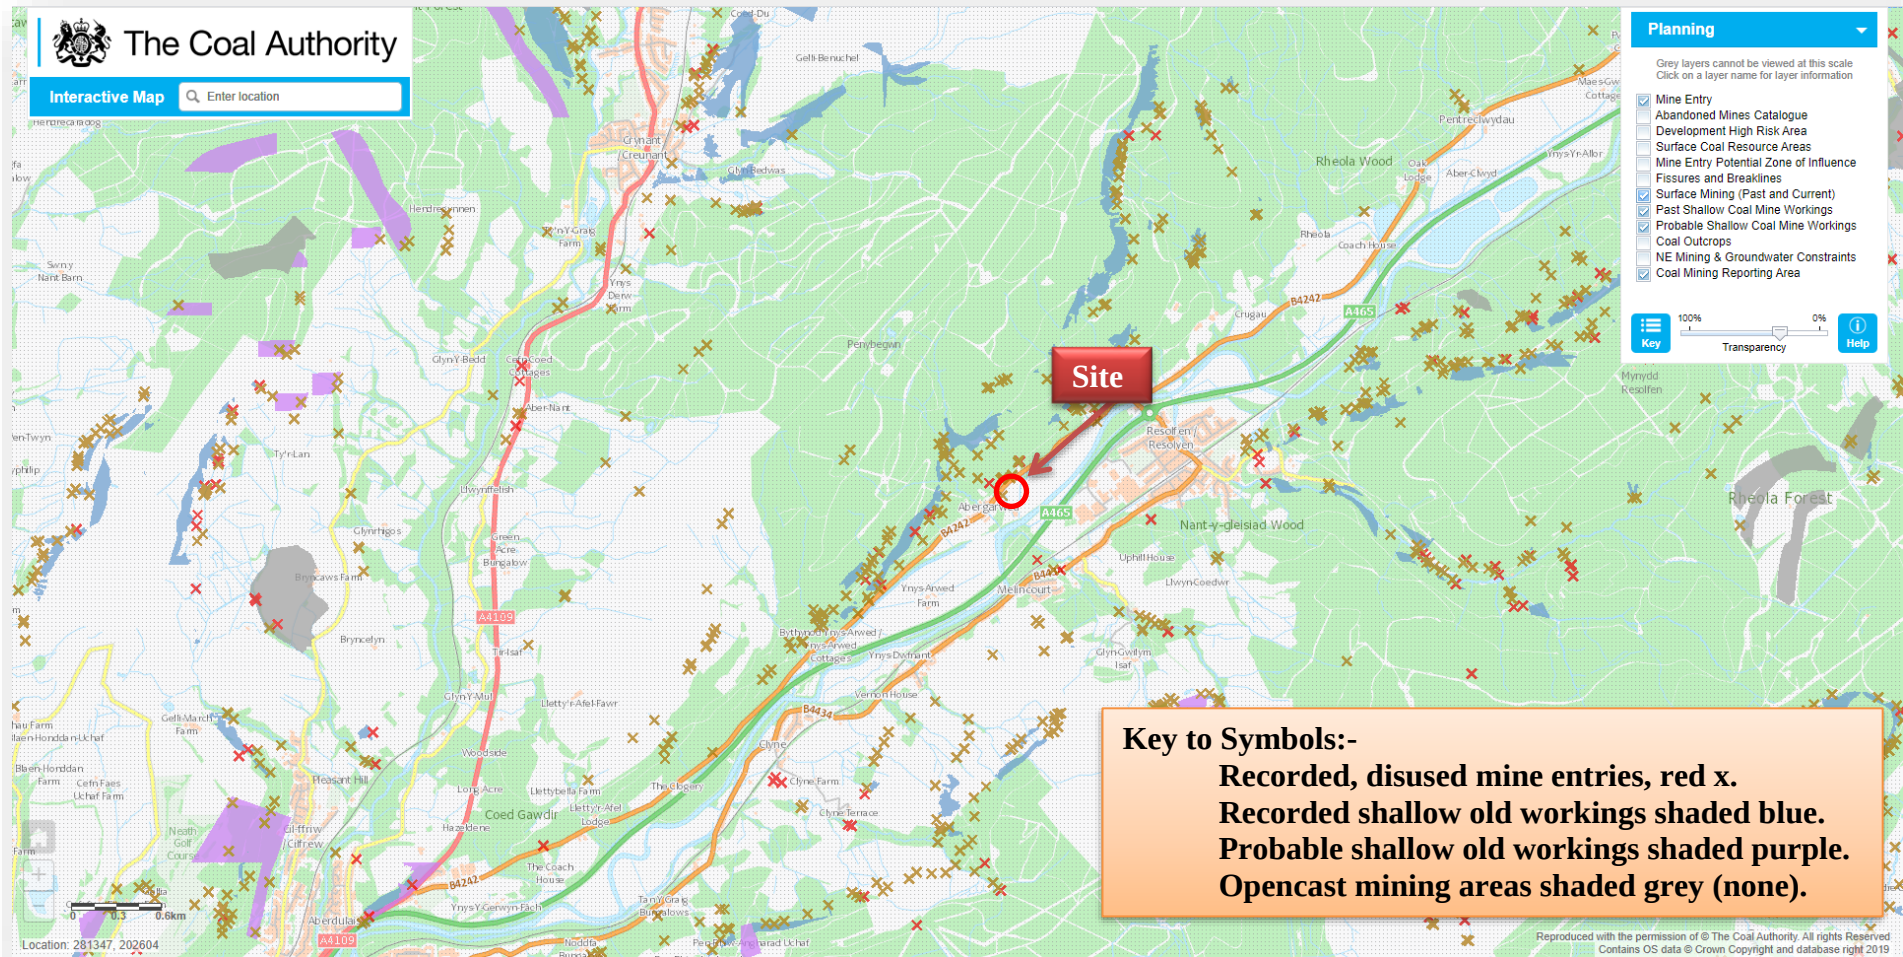
**Figure 3**  
**Print-out of The Coal Authority's Interactive Map**  
 (Accessed 11<sup>th</sup> May 2020)

The area has been subject to fairly extensive coal mining operations dating back to the nineteenth century. Coal seams were accessed by adits driven into the mining horizons near their outcrops supplemented by air shafts; larger shafts gave access to deeper lying coal seams. Our searches identified that the Site is not within an area that could be affected by past coal mining; The Coal Authority's interactive map also shows that there are no recorded old workings underlying the Site, shallow or otherwise (see Figure 3).

There are no recorded old workings underlying the Site, shallow or otherwise and there is no coal seam at shallow depths beneath the Site that is thick enough to have supported an underground mining operation. There are no active coal mines in the area that could affect the structural integrity of the proposed development and the Site has not been part of an opencast coal site. In so far as the mining heritage of the area is concerned, no particular measures are needed in the design and construction of the foundations of the proposed storage building.
