# **Barclays Bank, 9 The Parade, Neath, West Glamorgan, SA11 1RE**

**Heritage Impact Assessment**

**Firstplan Ref:** 21268TW

**Date:** June 2021

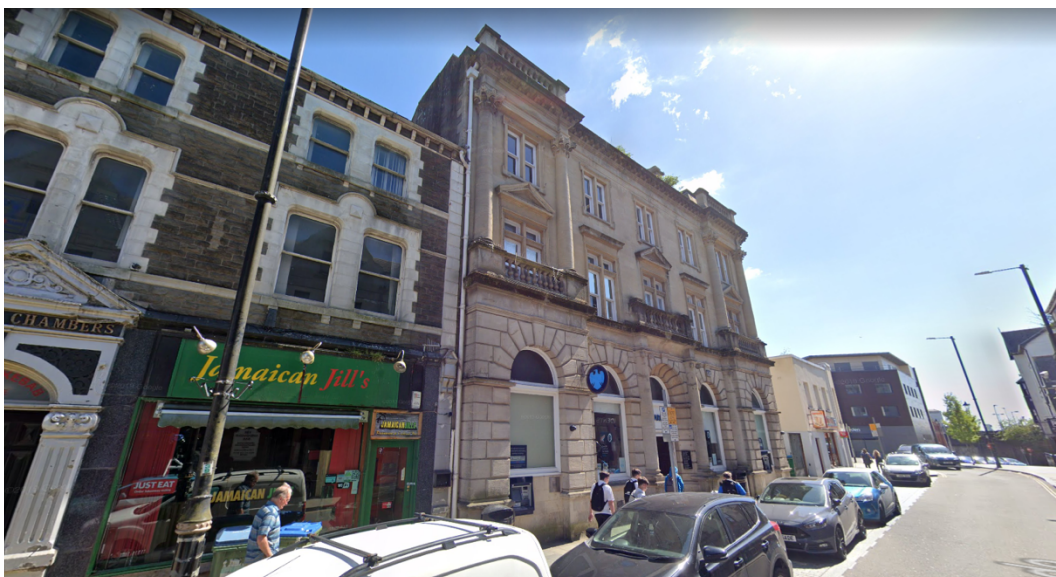
3.4      For ease of reference, Figure 1 below shows the building along with the context of the surrounding streetscene:

**Figure 1.** Photograph of listed building surrounding streetscene

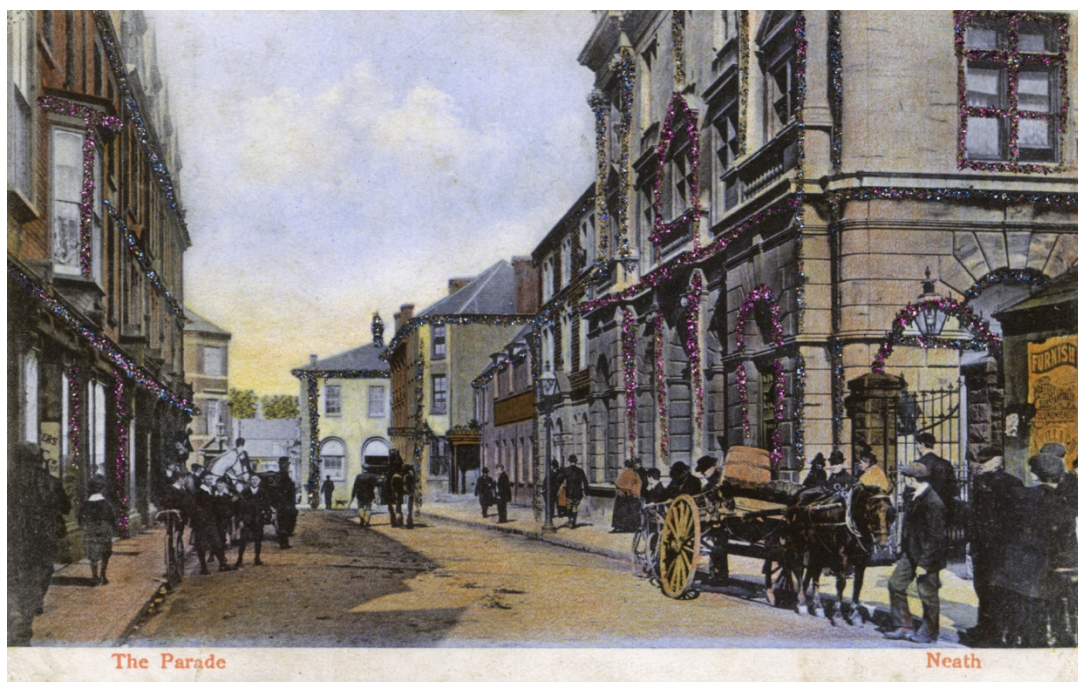
**Figure 4.** No. 9 The Parade sketch in circa 1904.

- 5.8 As it is shown, the drawing provides a useful depiction of The Parade in circa 1904. No. 9 The Parade is very much similar to the building that stands today. The building is considered to offer a positive contribution to the streetscene and wider Neath Town Centre Conservation Area offering a medium historical value.

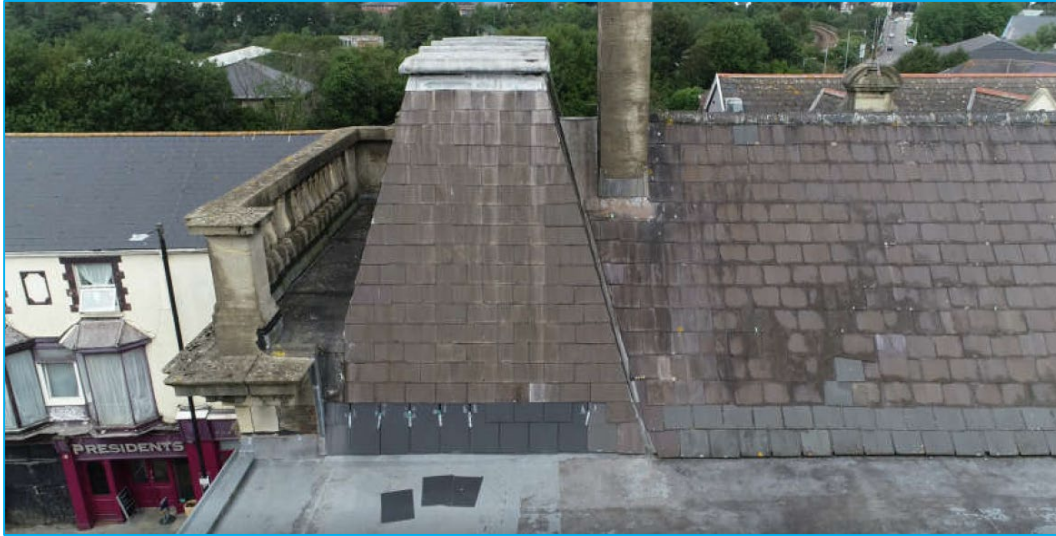
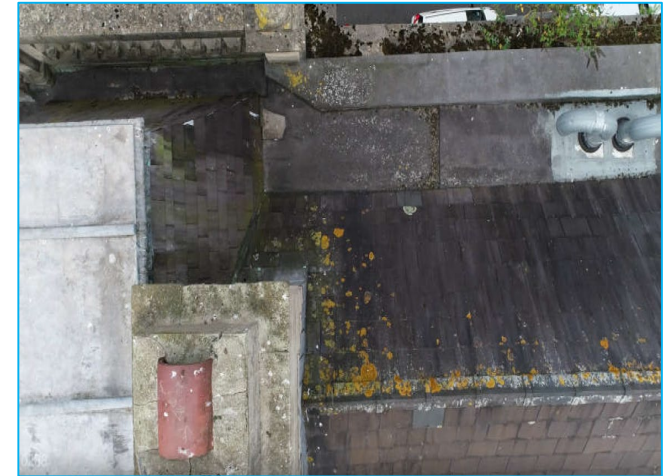
## Roof Area 1 – Pitched Roof inc Turrets, above 2nd Floor(Staff Room, Lift Motor Room & Store Rooms)

1. Replace damaged & slipped slate tiles
2. Overhaul coverings to flat “gulley” areas
3. Overhaul “crown” roof area to Turrets – remedial lead works required
4. Replace existing guttering(limited) to rear
5. Address valley areas
6. Make good, prepare & decorate fascia’s(to rear)
7. Undertake remedial works to chimney stack inc re-pointing brickwork & flaunching’s
8. Address Stonework balustrade, cornice & parapets

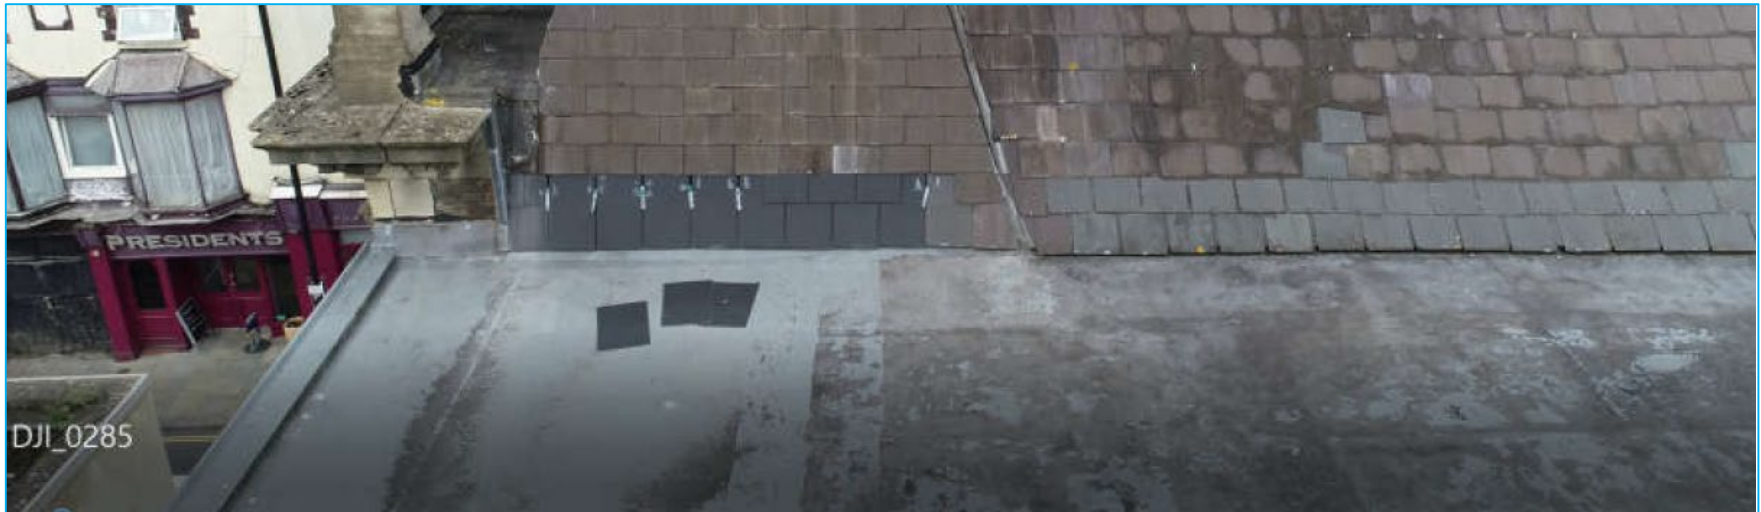
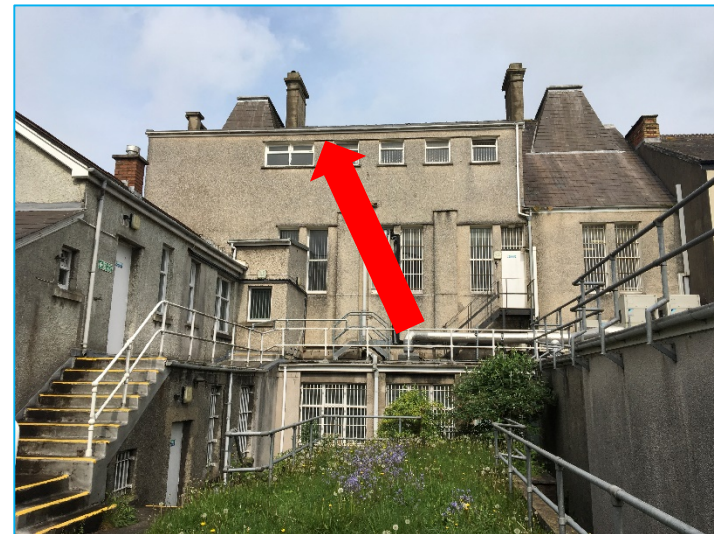
## Roof Area 2 – Flat Roof above 2nd Floor(Toilet areas)

1. Overlay existing covering with liquid coating
2. Make good, prepare & decorate fascia's
3. Replace guttering & RWP's

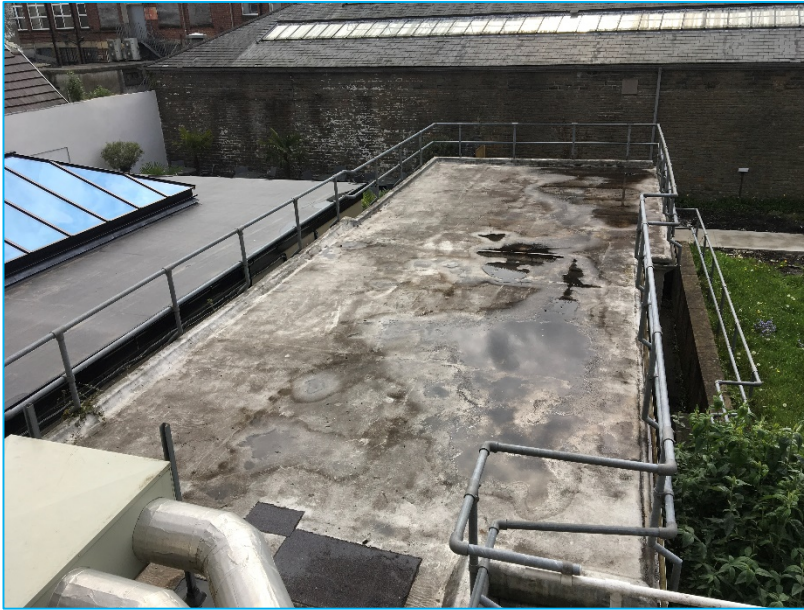
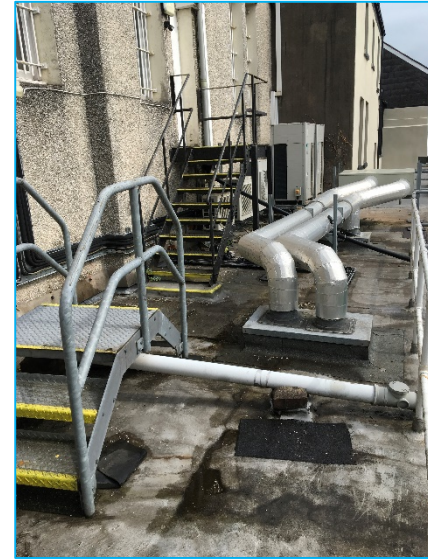
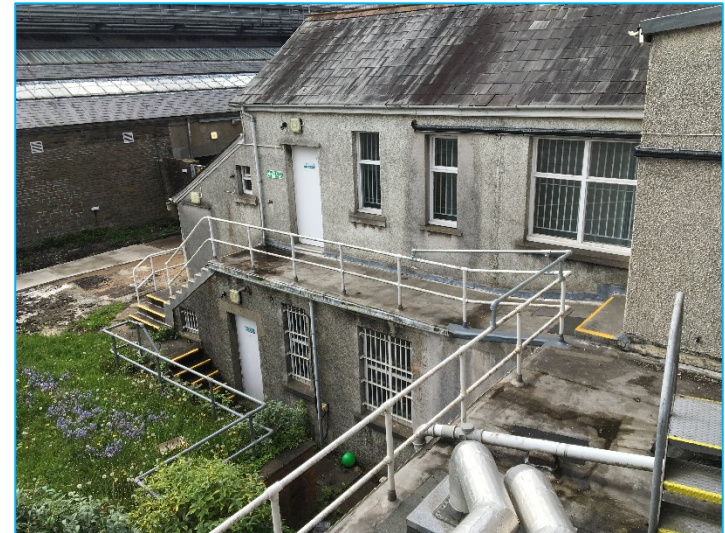
**Roof Area 3 – Flat Roof above Ground Floor(Strong Room, Cash Office, Counters, Banking Hall(part) & BoH Corridor)**

1. Replace existing covering inc insulation
2. Replace fascia & guttering
3. Remove existing edge protection & replace for new H&S compliant system
4. Address steps for H&S compliancy
5. Remove & re-instate HVAC Plant – re-commission systems
6. Remove & re-instate “step over” bridge
7. Install Anti Slip walkway
8. Address FE emergency lighting

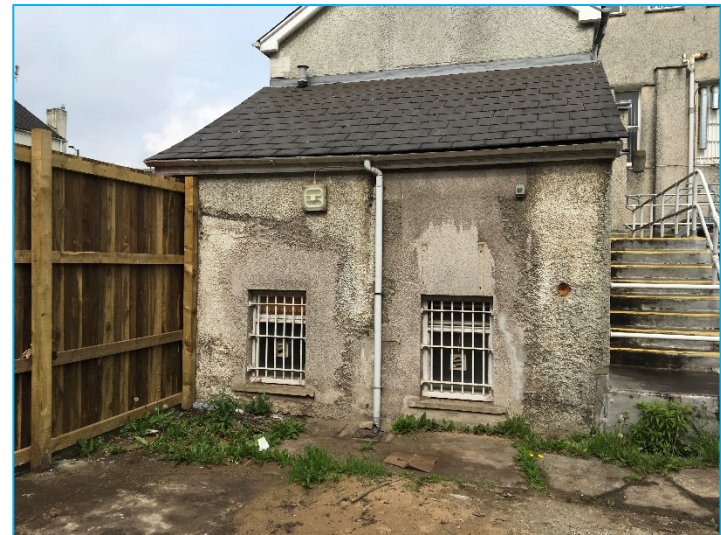
**Roof Area 4 – Pitched Roof above 1st Floor(1-2-1, Confi Waste)  
inc section above Grd Floor (Toilets)**

1. Replace damaged & slipped tiles
2. Make good, prepare & decorate fascia
3. Replace guttering & RWP's

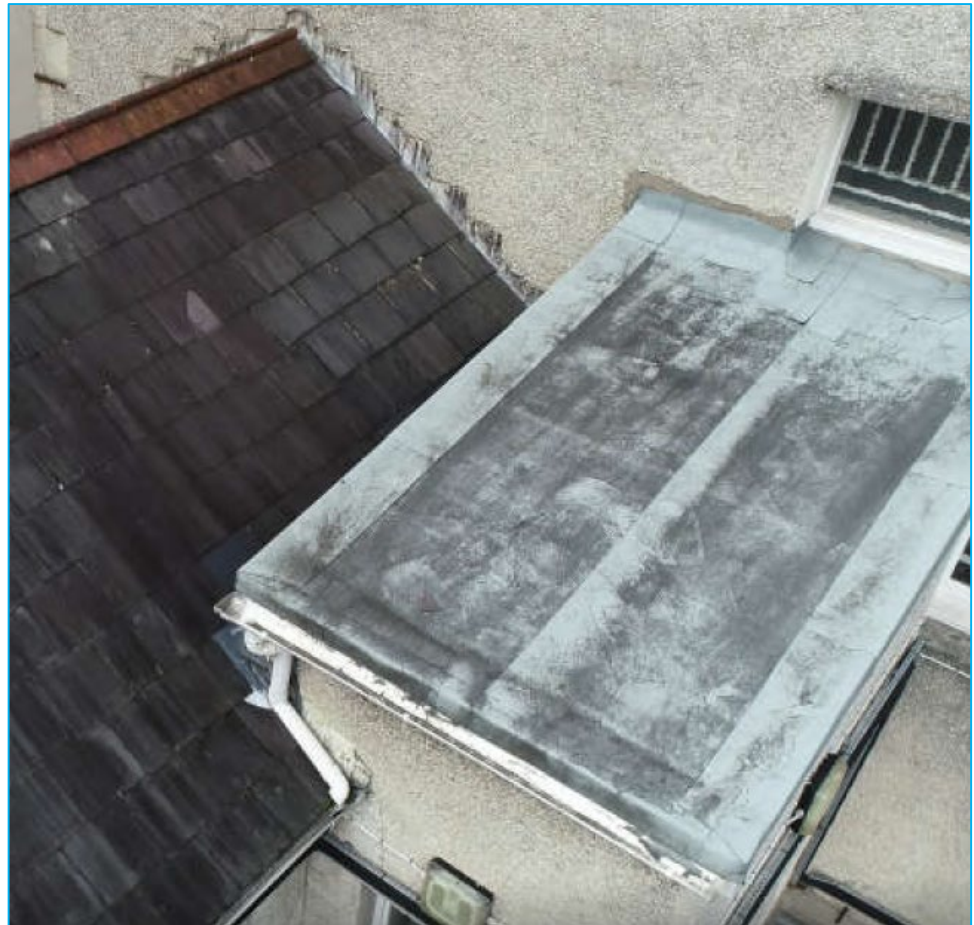
## Roof Area 5 – Flat Roof above 2nd Floor(Toilet areas)

1. Overlay existing covering with liquid coating
2. Make good, prepare & decorate fascia's
3. Replace guttering & RWP's
