## **Remediation Strategy**

Proposed Residential Development at  
the Former Afan Lido, The Princess  
Margaret Way, Port Talbot

Persimmon Homes West Wales

**Job No: 14647/RS**

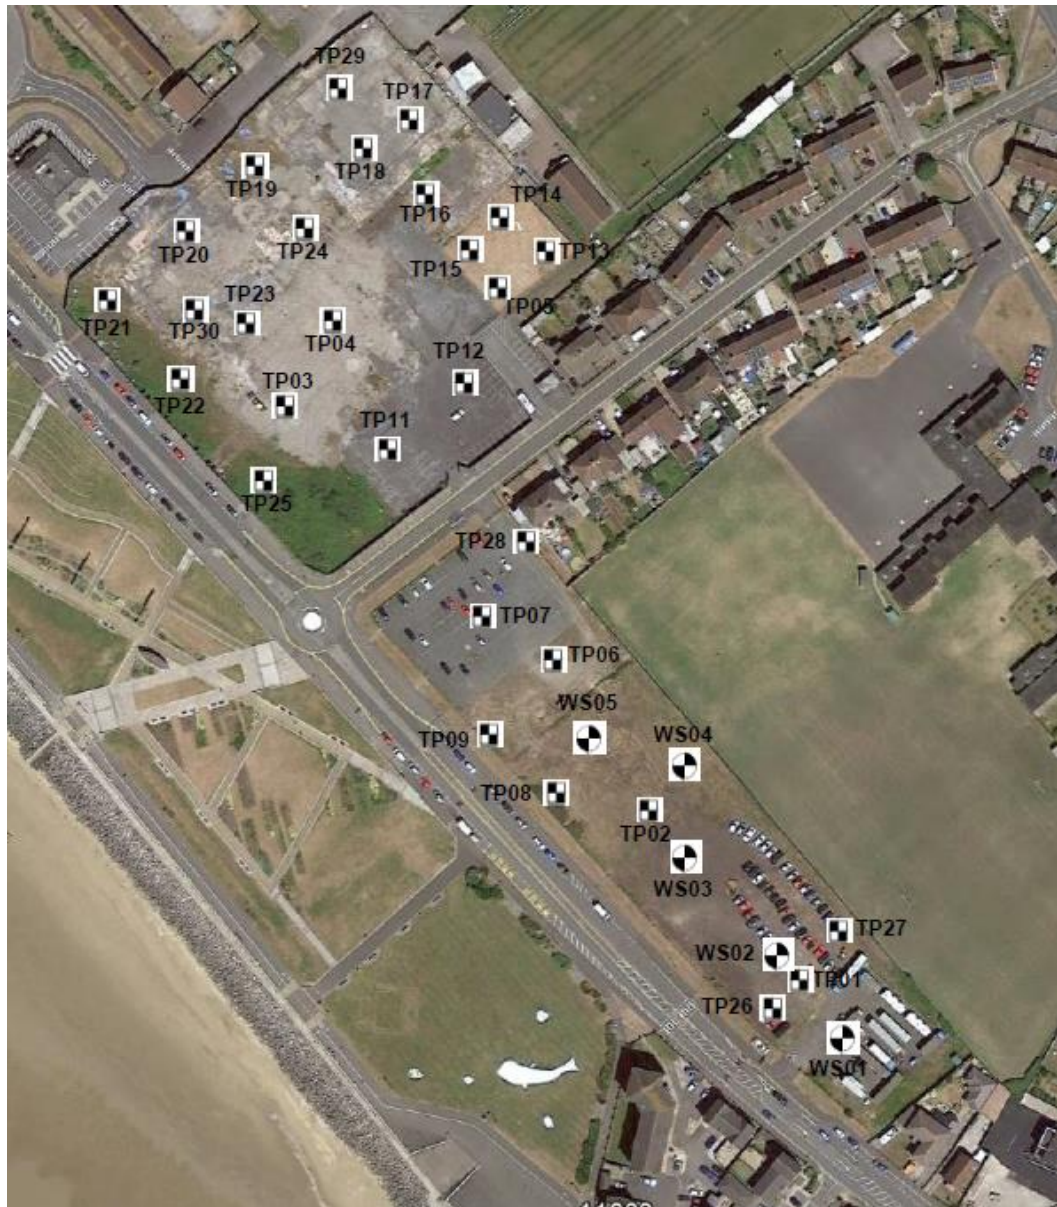
**Figure 2.1: Terra Firma Exploratory Hole Layout**

Pit locations are illustrated on **Figures 2.1** and **2.2** below.

Figure 2.1      Terra Firma Exploratory Hole Layout

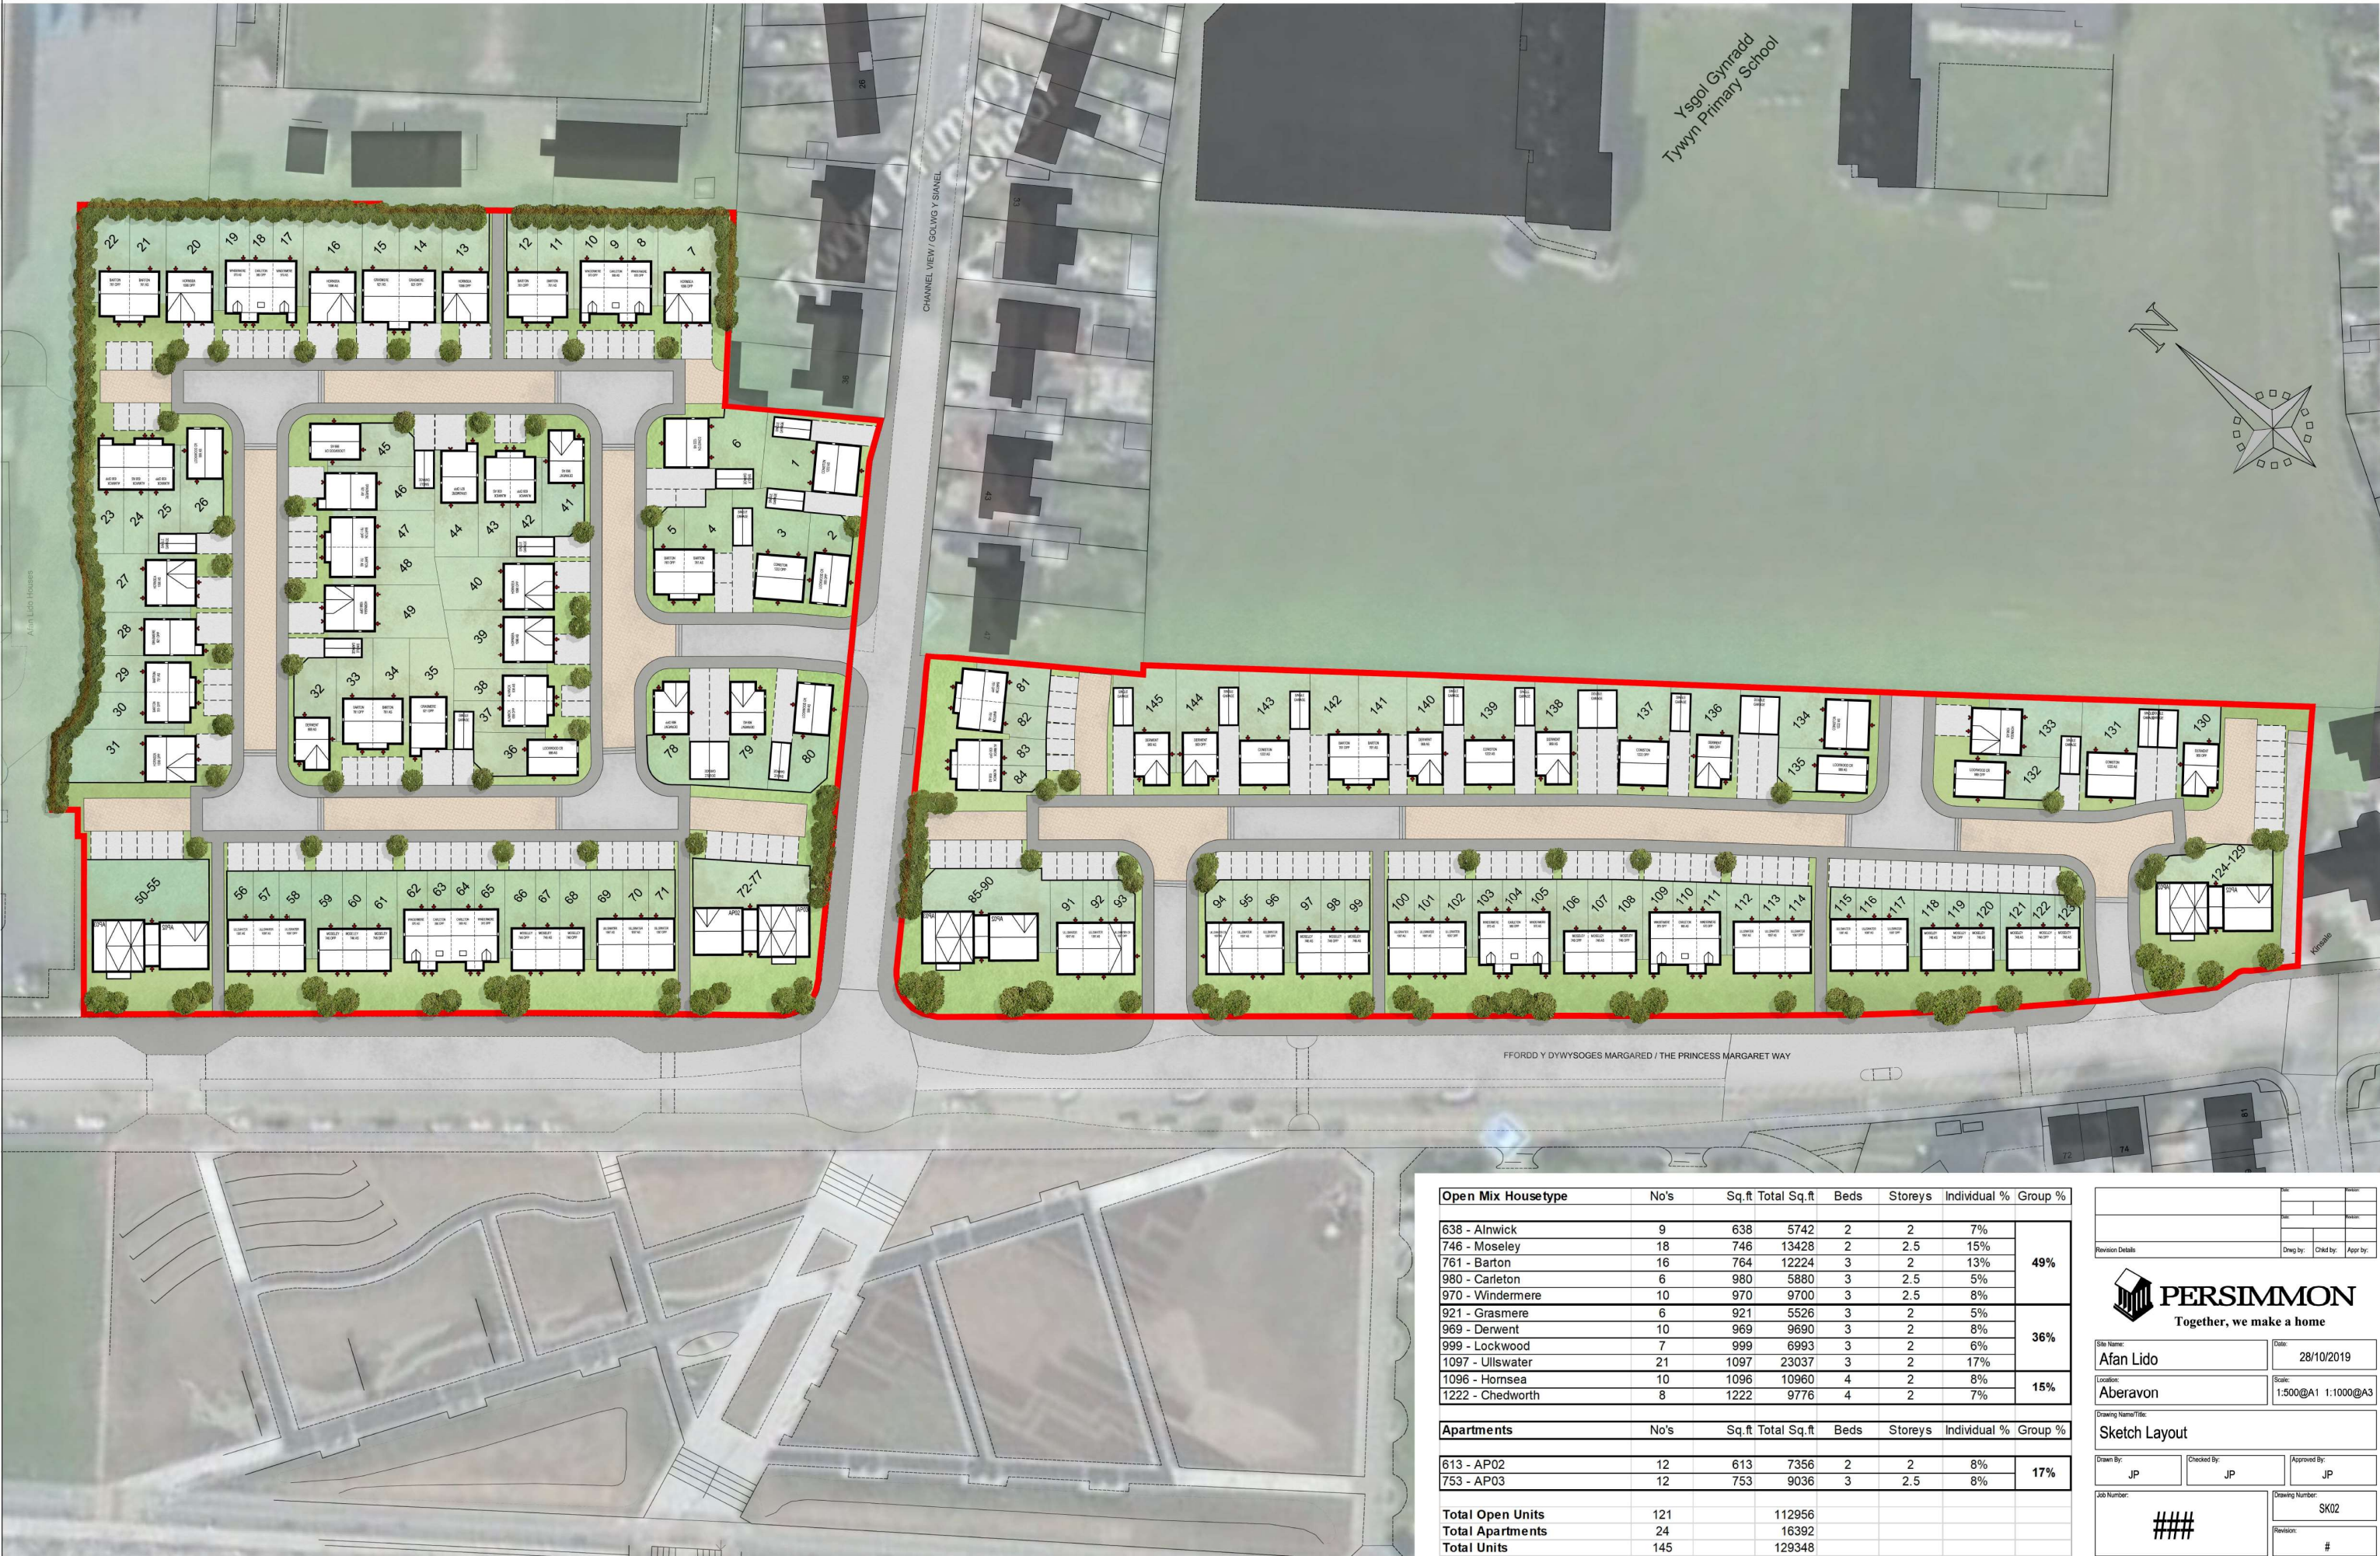
AFAN LIDO - SKETCH LAYOUT

**ANNEX A**  
Proposed Layout
