**Llandarcy Academy, Neath**

**SUBADRA**

## REVISED COAL MINING RISK ASSESSMENT REPORT

| Report | IN21655 CL 002a |

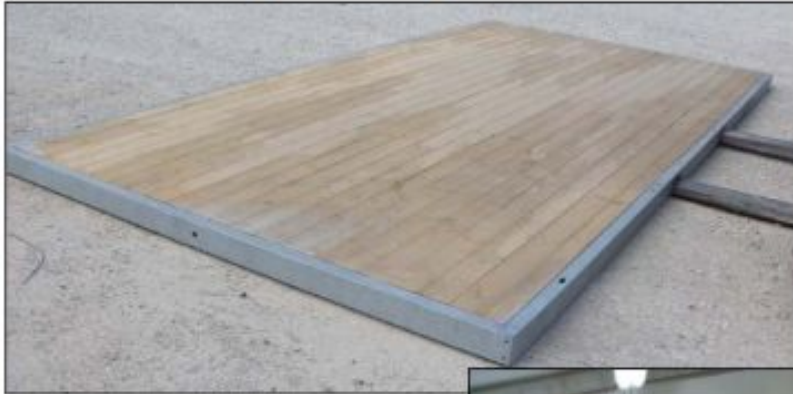
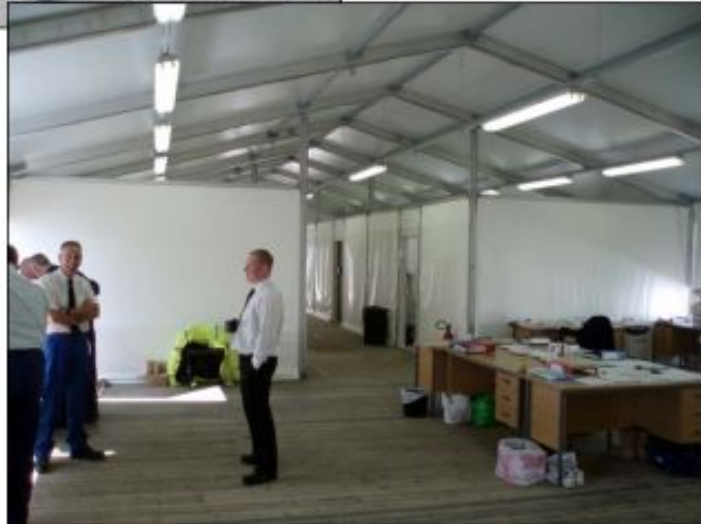
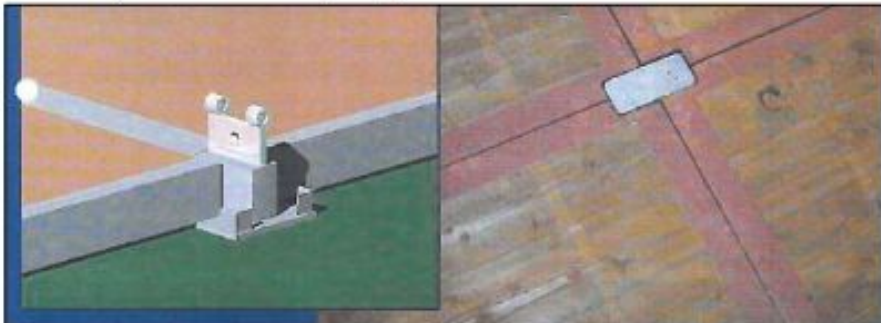
## Heavy Duty Flooring System

- 24mm Thickness
- Made with steel profiles U-100 and U65 cross bearers.
- Live Load: 500kg/m<sup>2</sup>
- Steel edging is galvanised
- Boiler pressure impregnated boards

| Proposed Developments | We understand the site/pitch is to be redeveloped by erecting a portal framed structure to house the current sports pitch area. The structure is to bear directly onto a new heavy duty floor system, with a gas proof membrane installed beneath. The heavy duty flooring and gas proof membrane are to be placed on-top of the current sports pitch. No below ground foundations are required. There is also an attenuation tank located directly beneath the current sports pitch, including an impermeable geomembrane. The building details are as follows: 15m x 30m x 5.2m side height (external), with a 7.678m roof height comprising twin layer insulated PVC, 40mm composite wall panels and two pedestrian doors. |
