**Remediation Strategy**

Proposed Residential Development at  
the Former Afan Lido, The Princess  
Margaret Way, Port Talbot

Persimmon Homes West Wales

**Job No: 14647/RS**

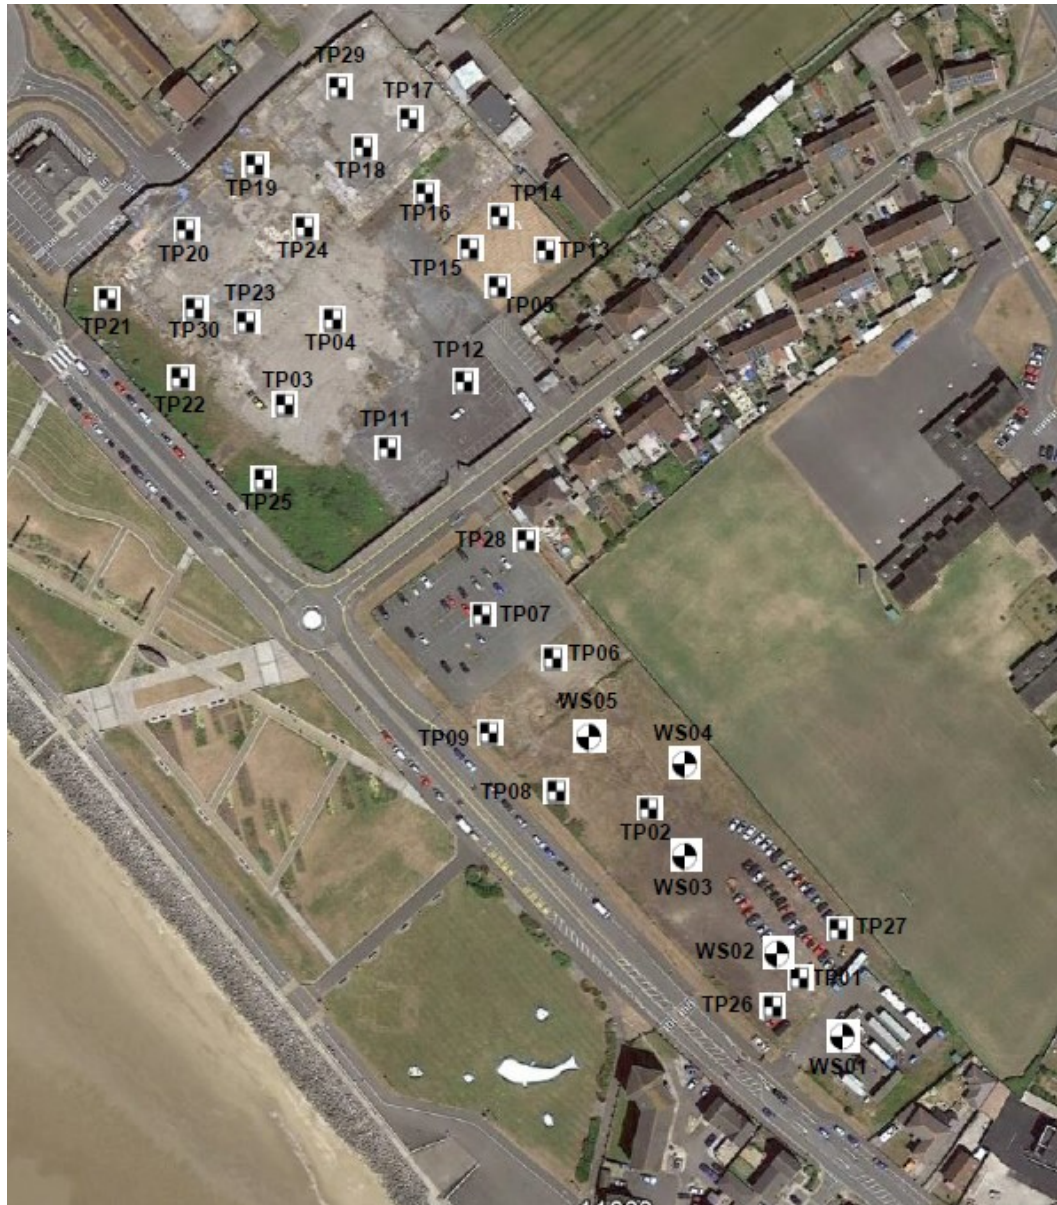
**Figure 2.1: Terra Firma Exploratory Hole Layout**

Pit locations are illustrated on **Figures 2.1** and **2.2** below.

Figure 2.1 Terra Firma Exploratory Hole Layout
