# Intrusive Coal Mining Risk Assessment Report

Site: Plot 26 and 27, Close Dewi Sant,  
Bryn

Prepared For: Ian Solomon Construction

Job No: 16483

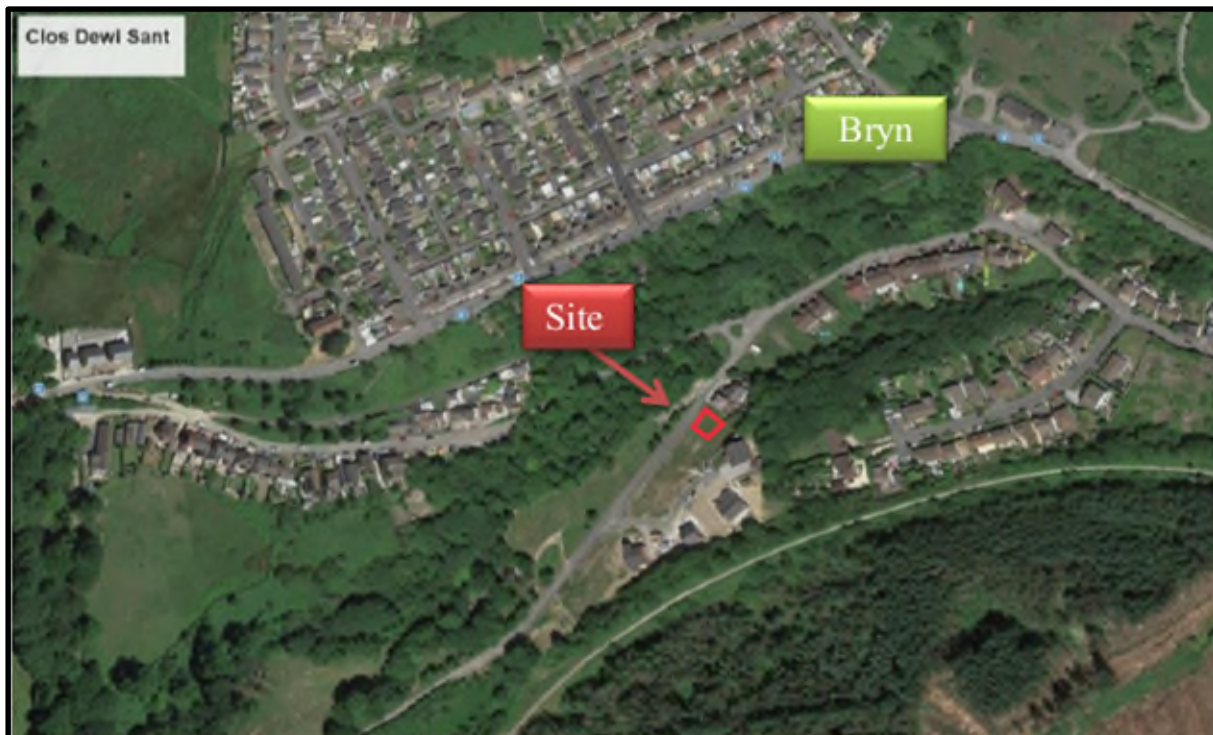
**Figure 2.1 Site Location**

The site location can be seen on

**Figure 2.1** along with the proposed site layout on **Drawing 01**.

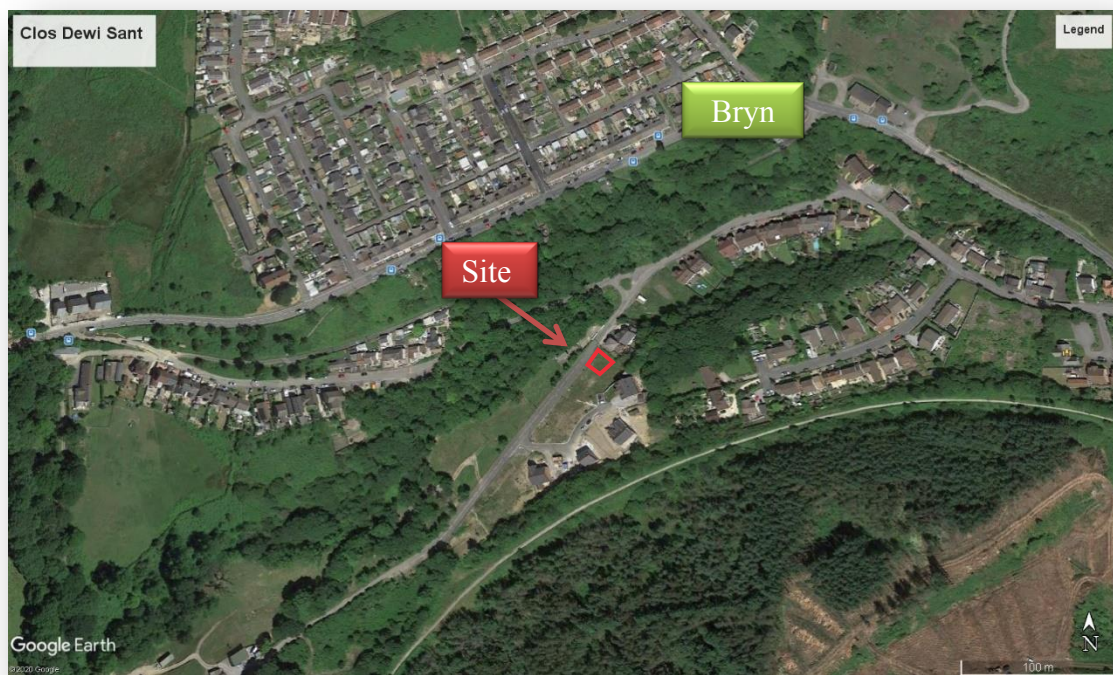
**Figure 1**  
**Aerial View of Site**

The Site is located at the south-western extremity of Bryn, approximately 5km north-east of the centre of Port Talbot and 4km north-west of the centre of Maesteg; it is on the southern side of the FFrwd Wyllt. The Site is on the southern side of Clos Dewi Sant, between the development's internal road and a disused railway; it is immediately outside the north-western edge of Margam Forest (see *General Location Plan, drawing no. BC/MB/07.20.06.01*) in Cwm Farteg. The Site is presently unoccupied, it slopes gently northwards, and the centre is at an approximate elevation of 118m aod. The Site is roughly irregular in outline and has maximum dimensions of approximately 17m by 27m.
