**Proposed Training Facility (Commercial) Development  
Mid & West Wales Fire Service, Earlswood Depot, Neath  
Geotechnical & Geo-Environmental Desk Study**

Report Reference: ESP.8178.3720

## Proposed Training Facility (Commercial) Development Mid & West Wales Fire Service, Earlswood Depot, Neath Geotechnical & Geo-Environmental Desk Study

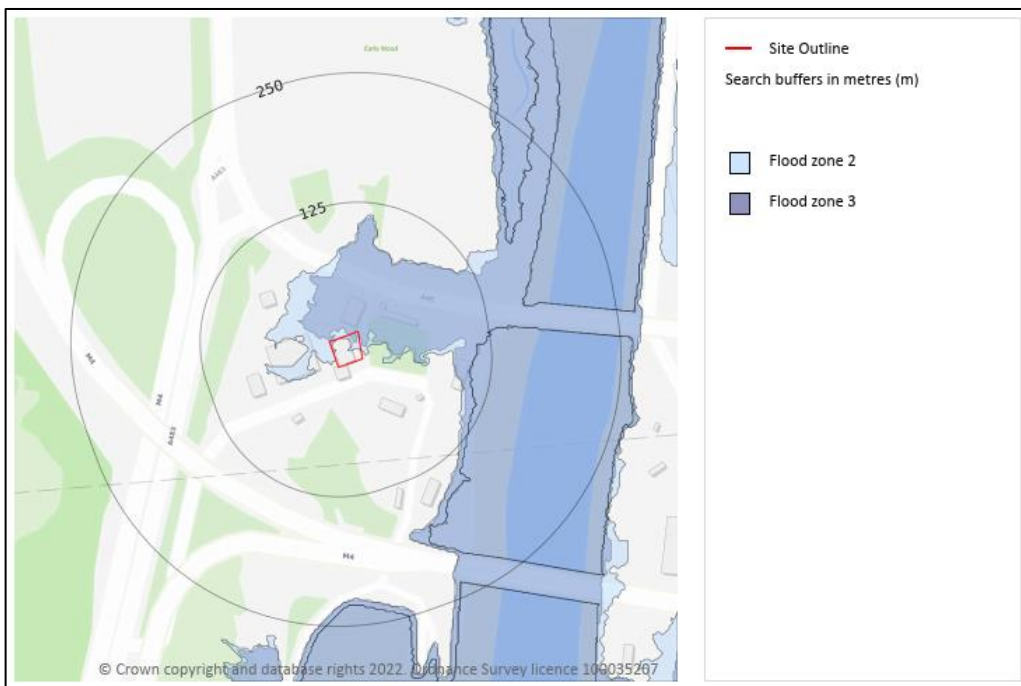
Insert 6 – Extract from Appendix C, indicating the site within a Flood Zone 2 and 3.
