# Remediation Strategy Report

Site: Eagle House, Port Talbot

**REPORT TITLE** : **Remediation Strategy Report: Residential and Commercial Development at Eagle House, Oakwood Lane, Port Talbot**

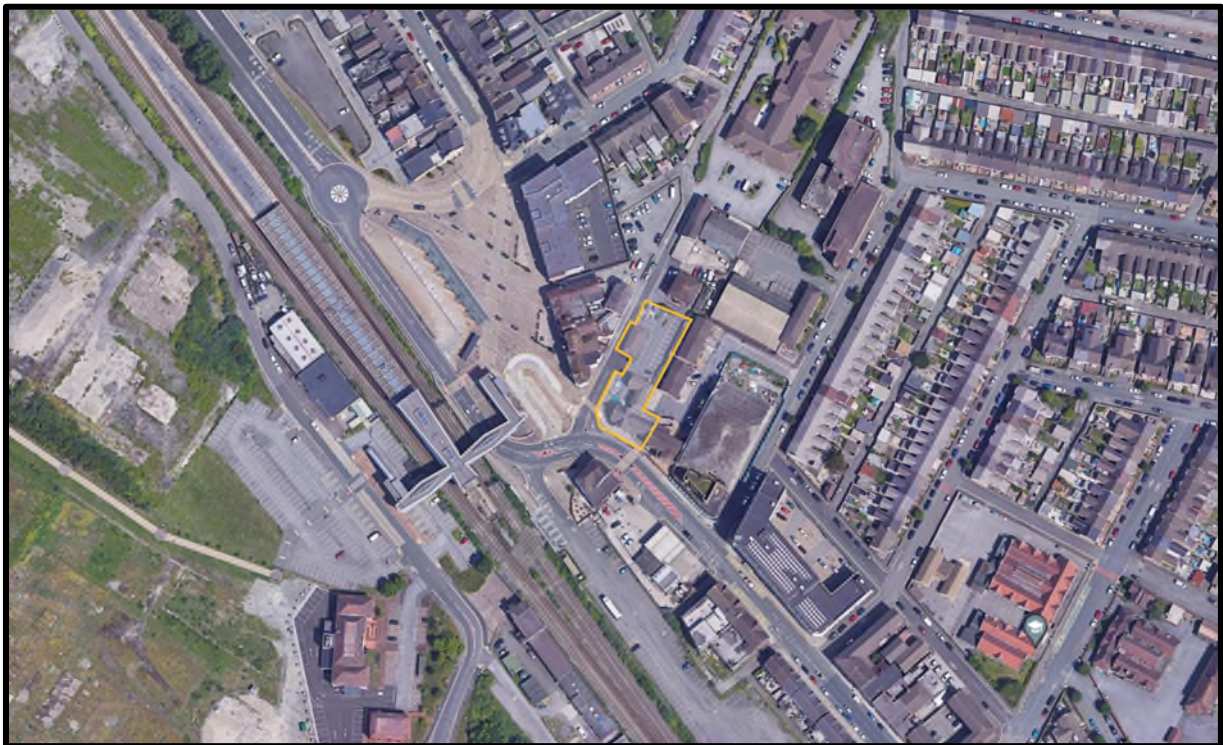
**Figure 2.1 Site Location**

The site location can be seen on **Figure 2.1** along with the proposed site layout on **Figure 2.1**.
