*Report No. BC/MB/02.23.04.*

# **Coal Mining Risk Assessment: Land at Lonlas and Mooretown Youth Club, Lonlas, Neath Port Talbot**

# **Coal Mining Risk Assessment: Land at Lonlas and Mooretown Youth Club, Lonlas, Neath Port Talbot.**

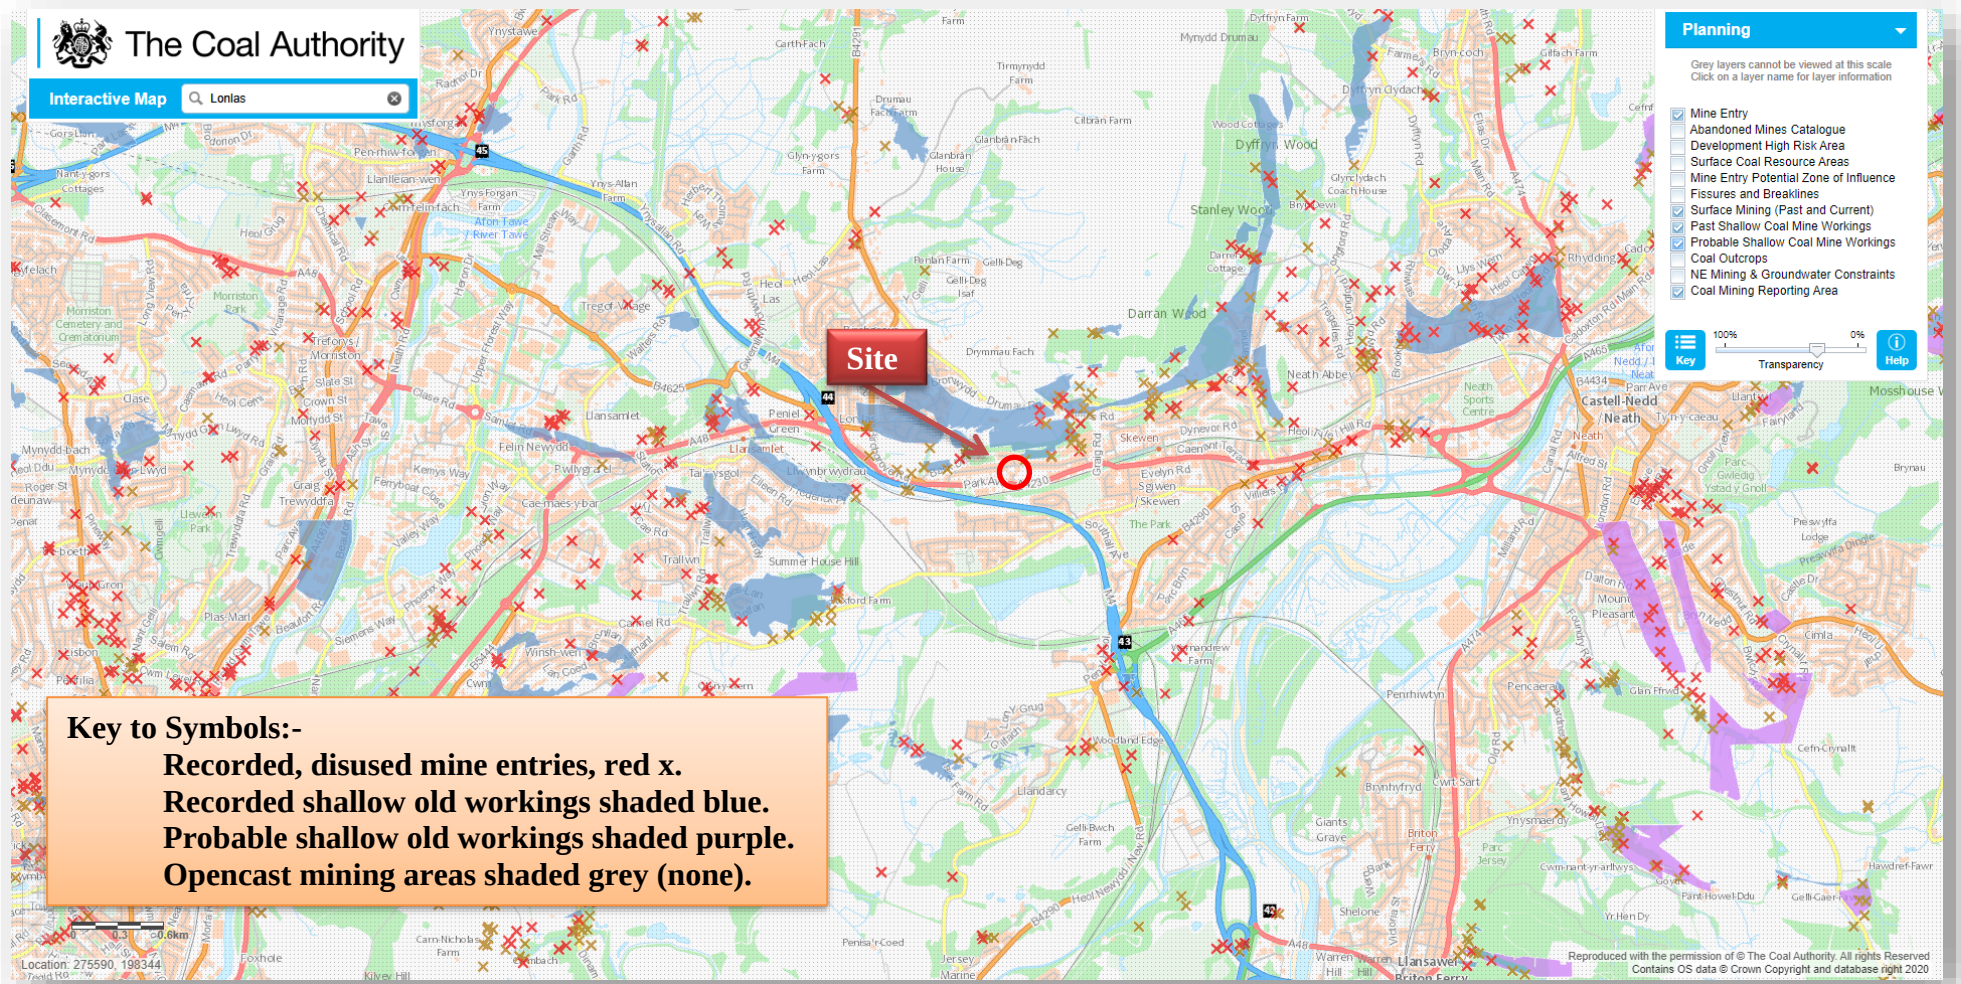
**Figure 3**  
**Print-out of The Coal Authority's Interactive Map**  
 (Accessed 16<sup>th</sup> February 2023)

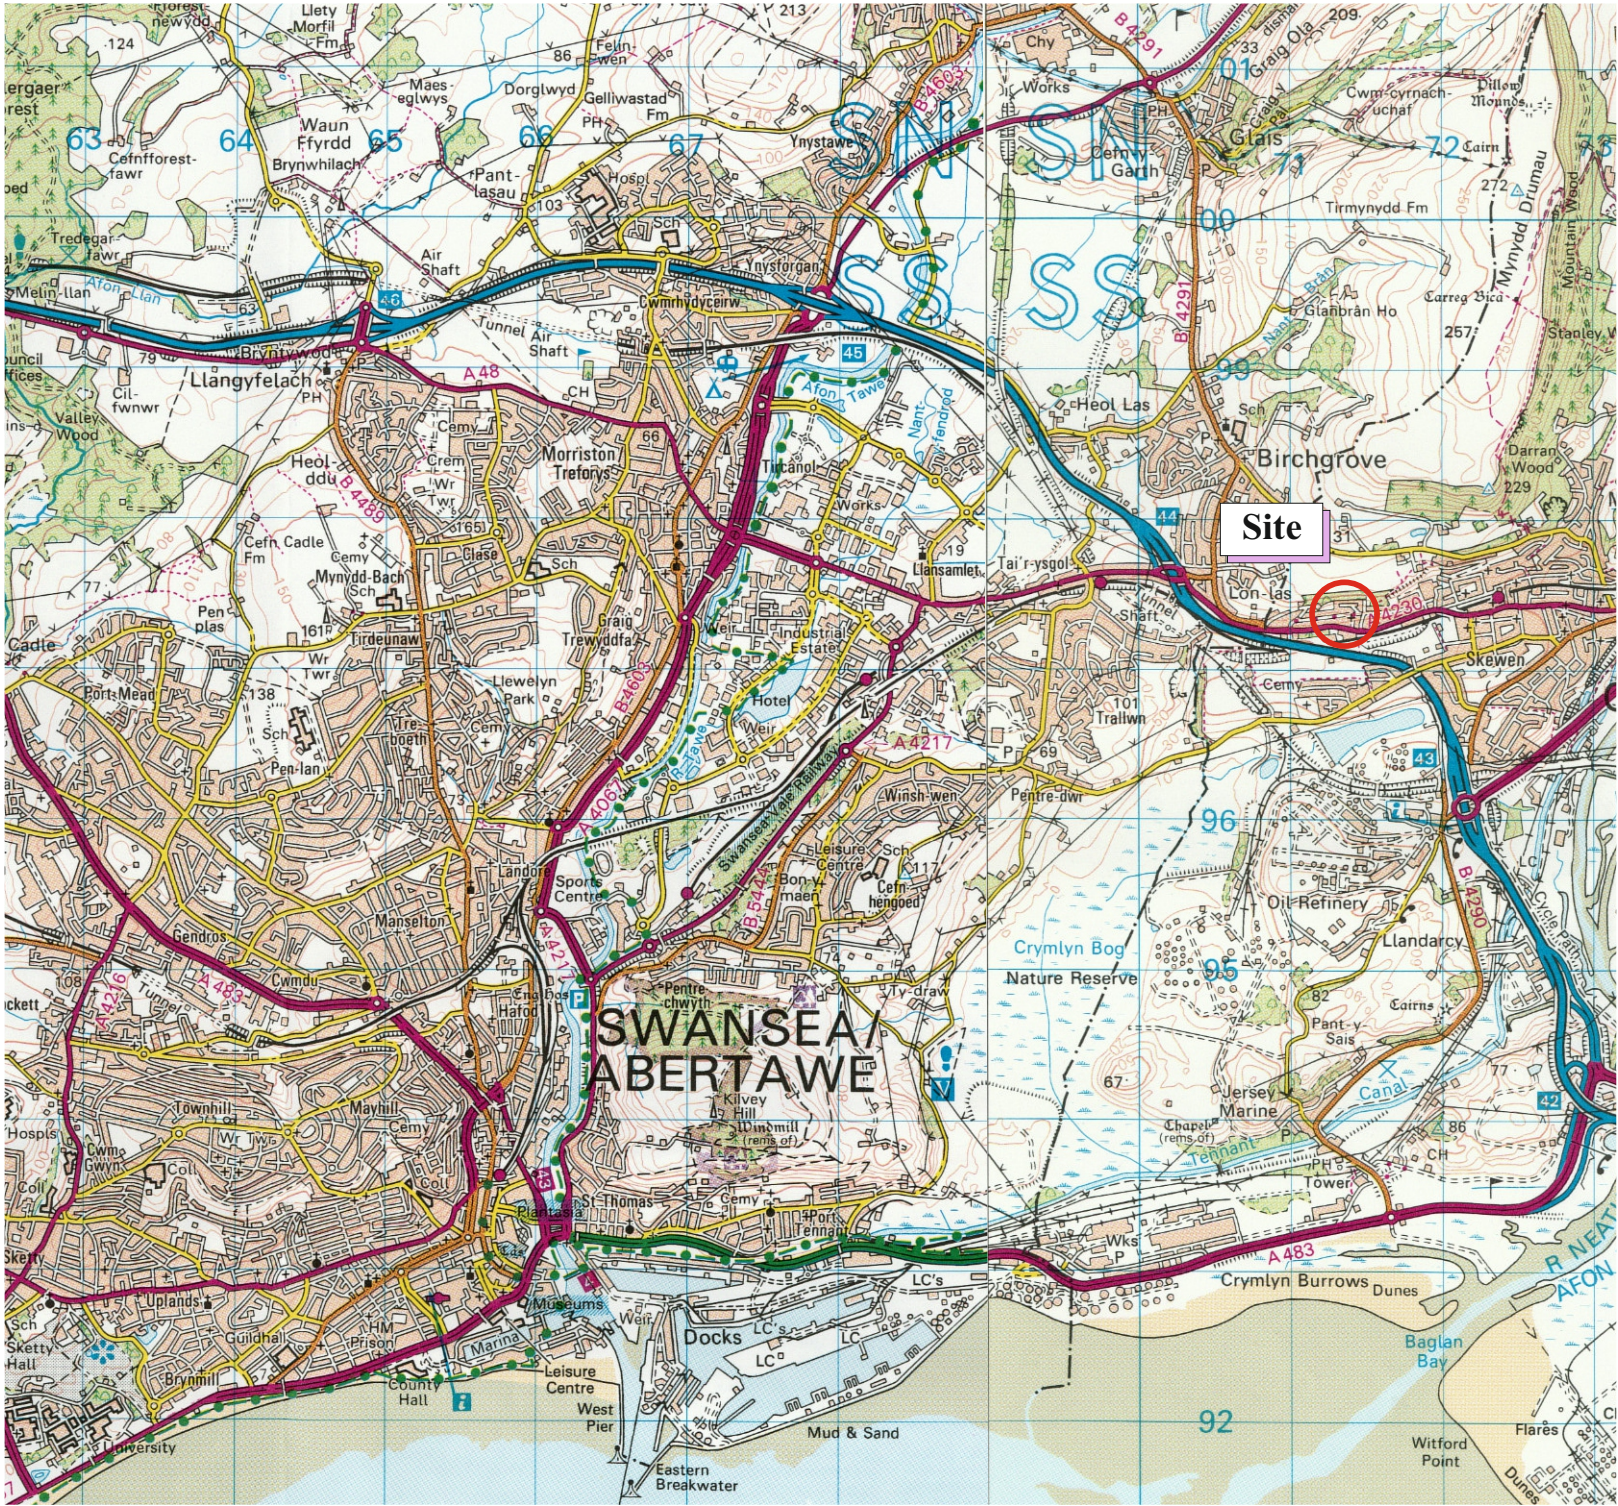
Plan Scale: 1:50,000.

General Location Plan.

The proposed Development Site is situated towards the south-eastern fringes of Lonlas; it is situated on the south facing slopes of Mynydd Drumau (see *General Location Plan*, drawing no. BC/MB/02.23.04.01). The parcel of land is irregular in outline and occupies an area of approximately 1,875m<sup>2</sup>, it is presently occupied by the Youth Club. The Site is situated within a mixed residential area comprised of detached, semi-detached and terraced dwellings. The Site slopes southwards from an approximate elevation of 64m aod to an approximate elevation of 55m aod.
