| Project: | Internal & External Alterations to Moose Hall, Neath | | | | | | |
| Drawing Title: | Demolitions & Removals: First Floor | Scale: | 1:100 at A3 | | | | |
| Project No: | 21/1011 | Drawing No: | 113 | Revision: | A | Status: | Planning |

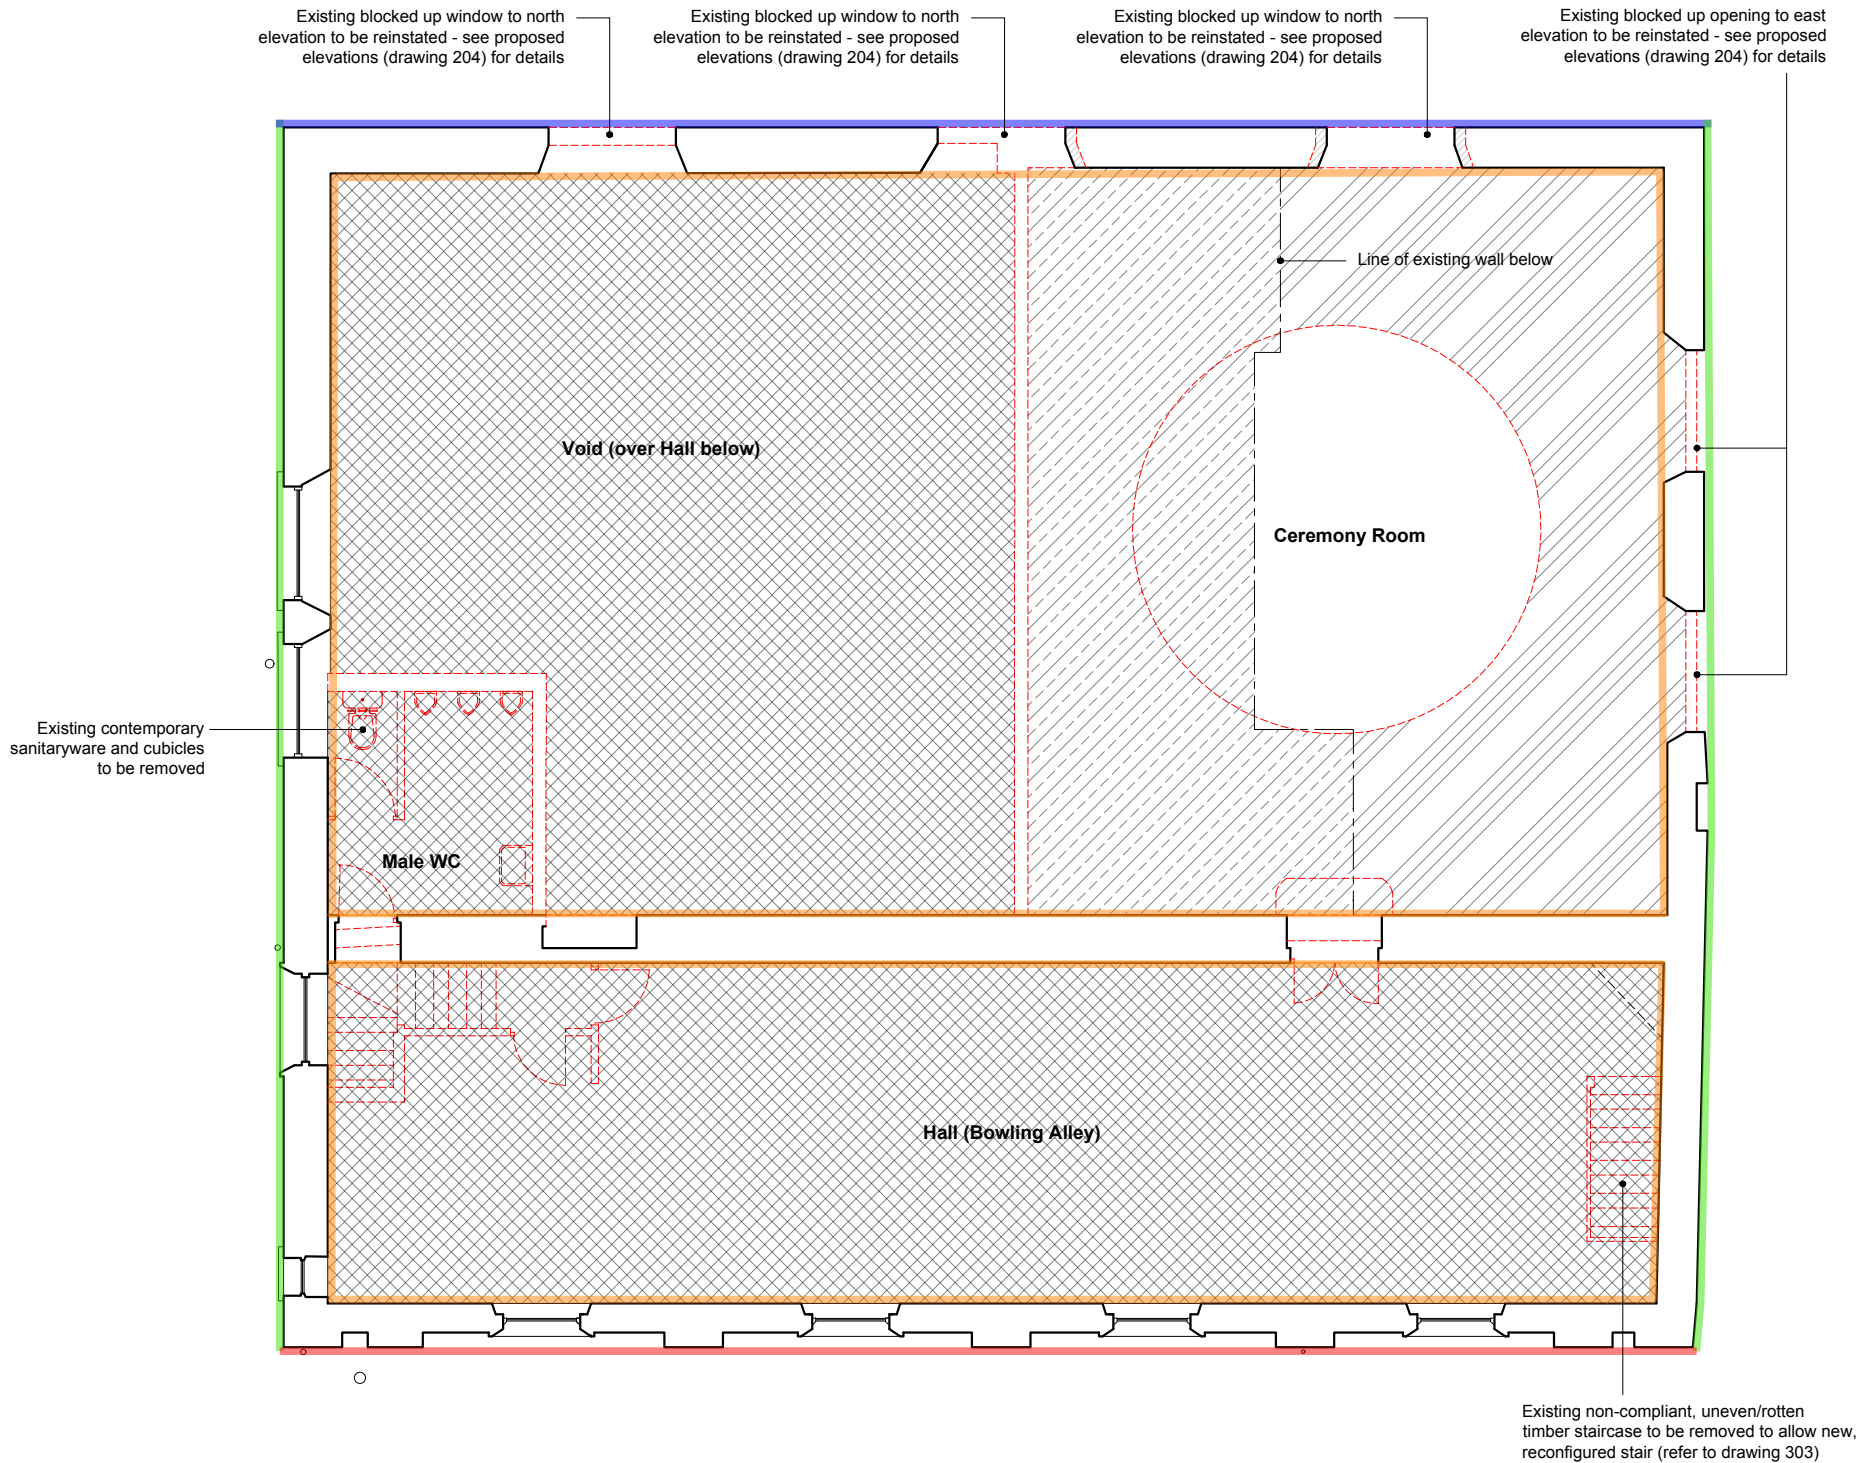
- Existing structures & fittings to be completely removed from site.
- To area indicated, remove existing contemporary false ceiling including any ceiling tiles, grid and framework back to original fabric, making good as required on a purely like-for-like basis to match existing.

- To area indicated, remove existing timber floor including all finishes, structure and ceilings to underside back to line of existing walls below, making good as required on a purely like-for-like basis to match existing.

- To area indicated, remove existing raised timber platform from perimeter of room to reveal existing level timber floor below.
- To area indicated, the **Structural Survey (Inspections)** report identifies cracking and weathering to the existing stonework. All cracked, defective and/or cement mortar to be raked out and all loose/deleterious material blown out to receive new lime based mortar pointing to ensure the solid stone wall can 'breathe' in its repaired state.

- As indicated on drawings 103 and 104, existing rendered surfaces to the areas indicated comprise a combination of contemporary fined down and rough-cast cementitious renders (added circa 1967) which is identified within the accompanying **Structural Survey (Inspections)** report to incorporate substantial cracking, crazing and detachment from the substrate across all elevations resulting in extensive penetrating damp to the interior of the building. It is therefore proposed to remove existing render in its entirety and the surfaces re-rendered in lime render to ensure the existing solid walls are able to 'breathe' in its repaired state. In accordance with the recommendations of the **Structural Survey (Inspections)** report, once the existing render has been removed the existing walls are to be inspected for structural defects, with any repairs undertaken in accordance with the recommendations of the structural report including any cracked, defective and/or cement mortar to be raked out and all loose/deleterious material blown out to receive new lime based mortar pointing to ensure the solid stone wall can 'breathe' in its repaired state.

- As indicated on drawings 103/104, the elevations indicated comprise cementitious render (added since 1967) and is believed to be in a generally sound condition (having not been identified within the accompanying **Structural Surveys (Inspection)** report as having substantial cracking/crazing or detachment from the substrate. It is therefore proposed that, to areas highlighted, that the existing render be repaired as required on a purely like-for-like basis to match existing, including decoration. Whilst undertaking remedial works, should the existing render be found to have substantially detached from the substrate the render is to be removed and replaced with lime render (to match the proposed East and West elevations).

- The internal face of external walls comprise a combination of contemporary plastered/plasterboard finishes which are identified within the accompanying **Structural Survey (Inspections)** report to be affected by penetrating damp resulting in cracking, crazing and detachment from the substrate. In accordance with the recommendations of the **Structural Survey (Inspections)** report, the existing finishes are to be removed and the existing walls to be inspected for structural defects, with any repairs undertaken in accordance with the recommendations of the structural report including any cracked, defective and/or cement mortar to be raked out and all loose/deleterious material blown out to receive new lime mortar pointing. Once repaired, the existing stone surface is to be retained exposed wherever possible with any areas not constructed from stone or subject to previously undertaken and poorly executed repairs to be rendered in lime plaster to enable to the wall structure to 'breathe' in its rendered state.
