Project: Internal & External Alterations to Moose Hall, Neath

Address: Moose Hall, Castle Street, Neath, Neath Port Talbot, SA11 3LU

Drawing Title: Elevations as Proposed (1 of 2)

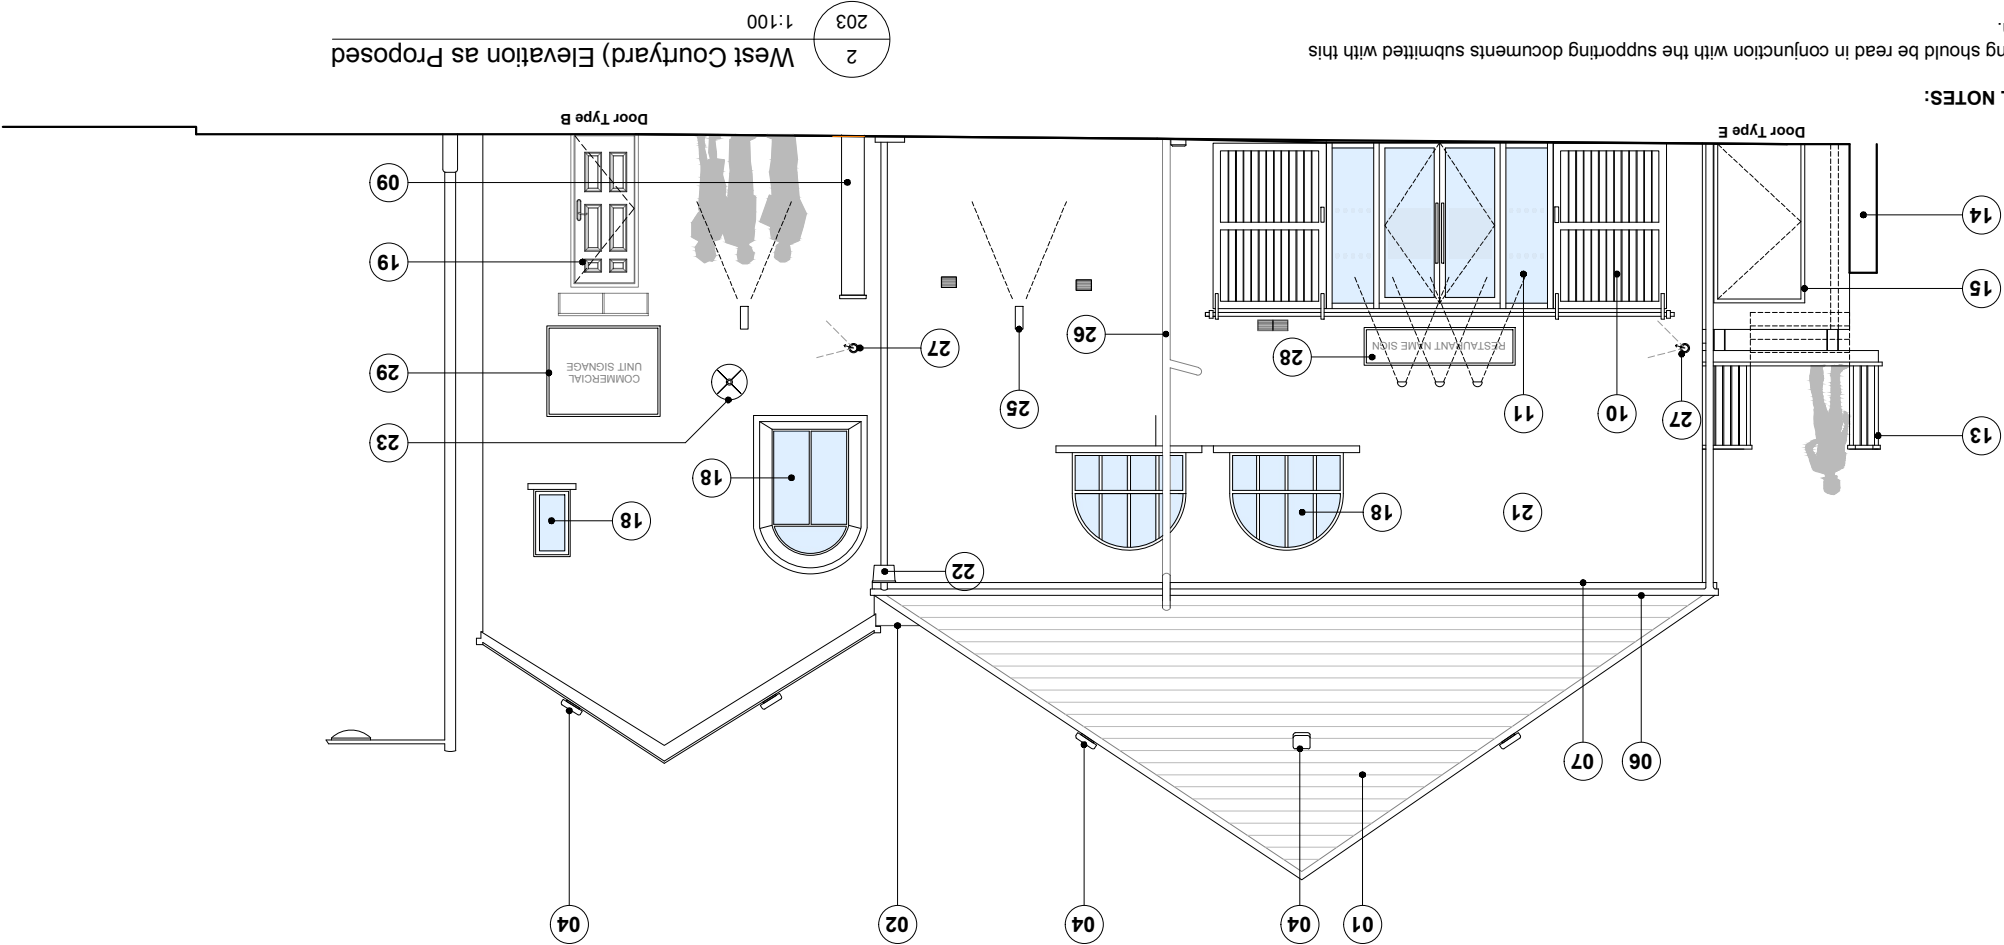
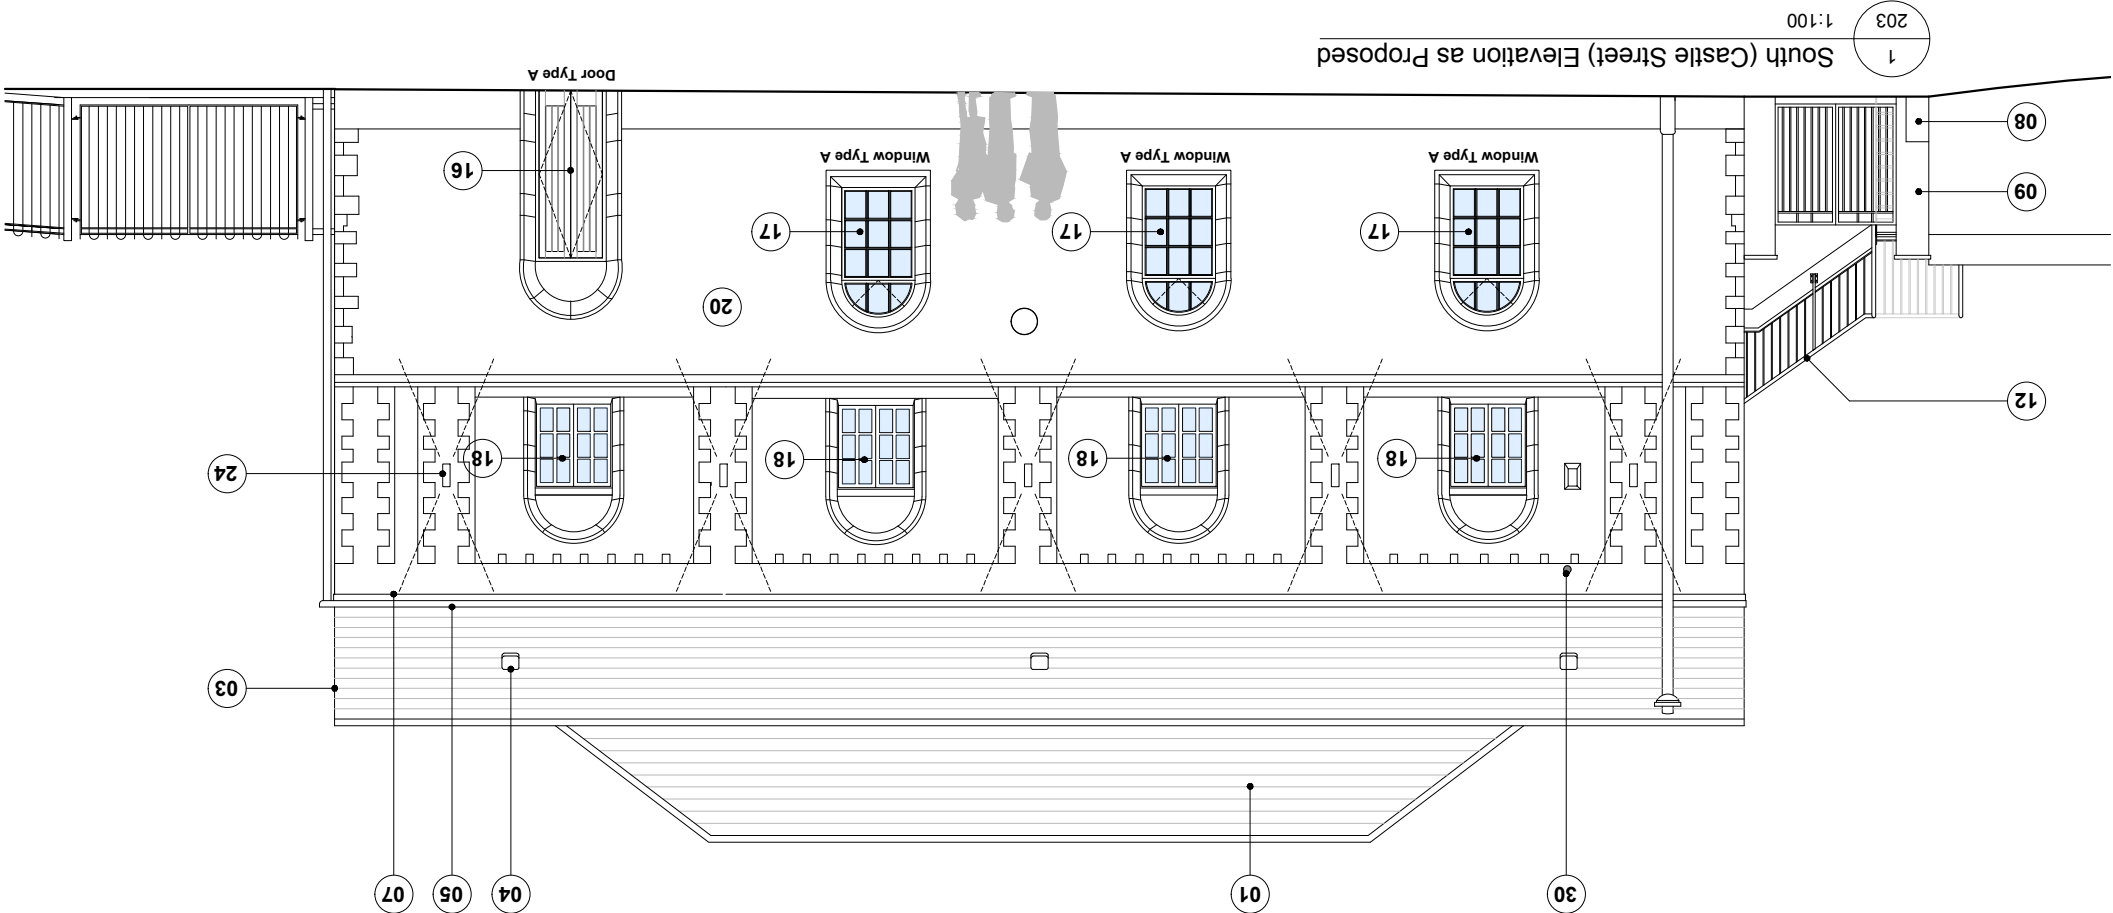
- Existing slate roof to be retained with local repairs as required to be undertaken on a purely like-for-like basis to match existing material, size, colour and texture.

- Existing staged lead valley between the pitched roofs to be reconfigured in accordance with LSA details. Existing lead to be replaced in full with minimum code 6 lead.

- The *Structural Surveys (Inspection)* report identifies a lack of ventilation to the existing roof void with signs of historic condensation and moisture damage to existing roof structure. Therefore, new Klobert Universal 20K vent to be incorporated into existing roof structure. The existing roof void to be incorporated into existing roof structure.

- Existing shallow half-round gutter to be replaced with deep profiled UPVC half-round gutter and fixings, colour black.
- Existing combination metal and UPVC gutters (including missing sections) to be replaced with ogee profile UPVC gutters and fixings, colour black.

- Existing timber fascias to be inspected and repaired as required on a purely like-for-like basis to match existing. Where existing fascias are missing or damaged beyond repair, sections to be replaced on a like-for-like basis to match existing. All fascias to be prepared for redecoration, colour black.

- New 6 panel steel entrance door to match existing. Existing canopy to be retained.
- The *Structural Survey (Inspection)* report identifies cracking and weathering to the existing stonework to the Castle Street elevation. All cracked, defective and/or cement mortar to be raked out and all loose/deleterious material blown out to receive new lime based mortar pointing to ensure the solid stone wall can 'breathe' in repaired state.

- Existing cementitious/pebble-dash render to be removed entirely and the surfaces re-rendered in lime render to ensure the existing solid walls are able to 'breathe' in repaired state (refer also to drawing 112).

- Existing UPVC sign to be replaced with surface mounted UPVC sign.
- Existing hole in stone elevation to be utilised for gas boiler flue.
