R 01132.01 GROUND FLOOR PLAN (2 of 2)  
SCALE 1:100 @ A1, 1:200 @ A3

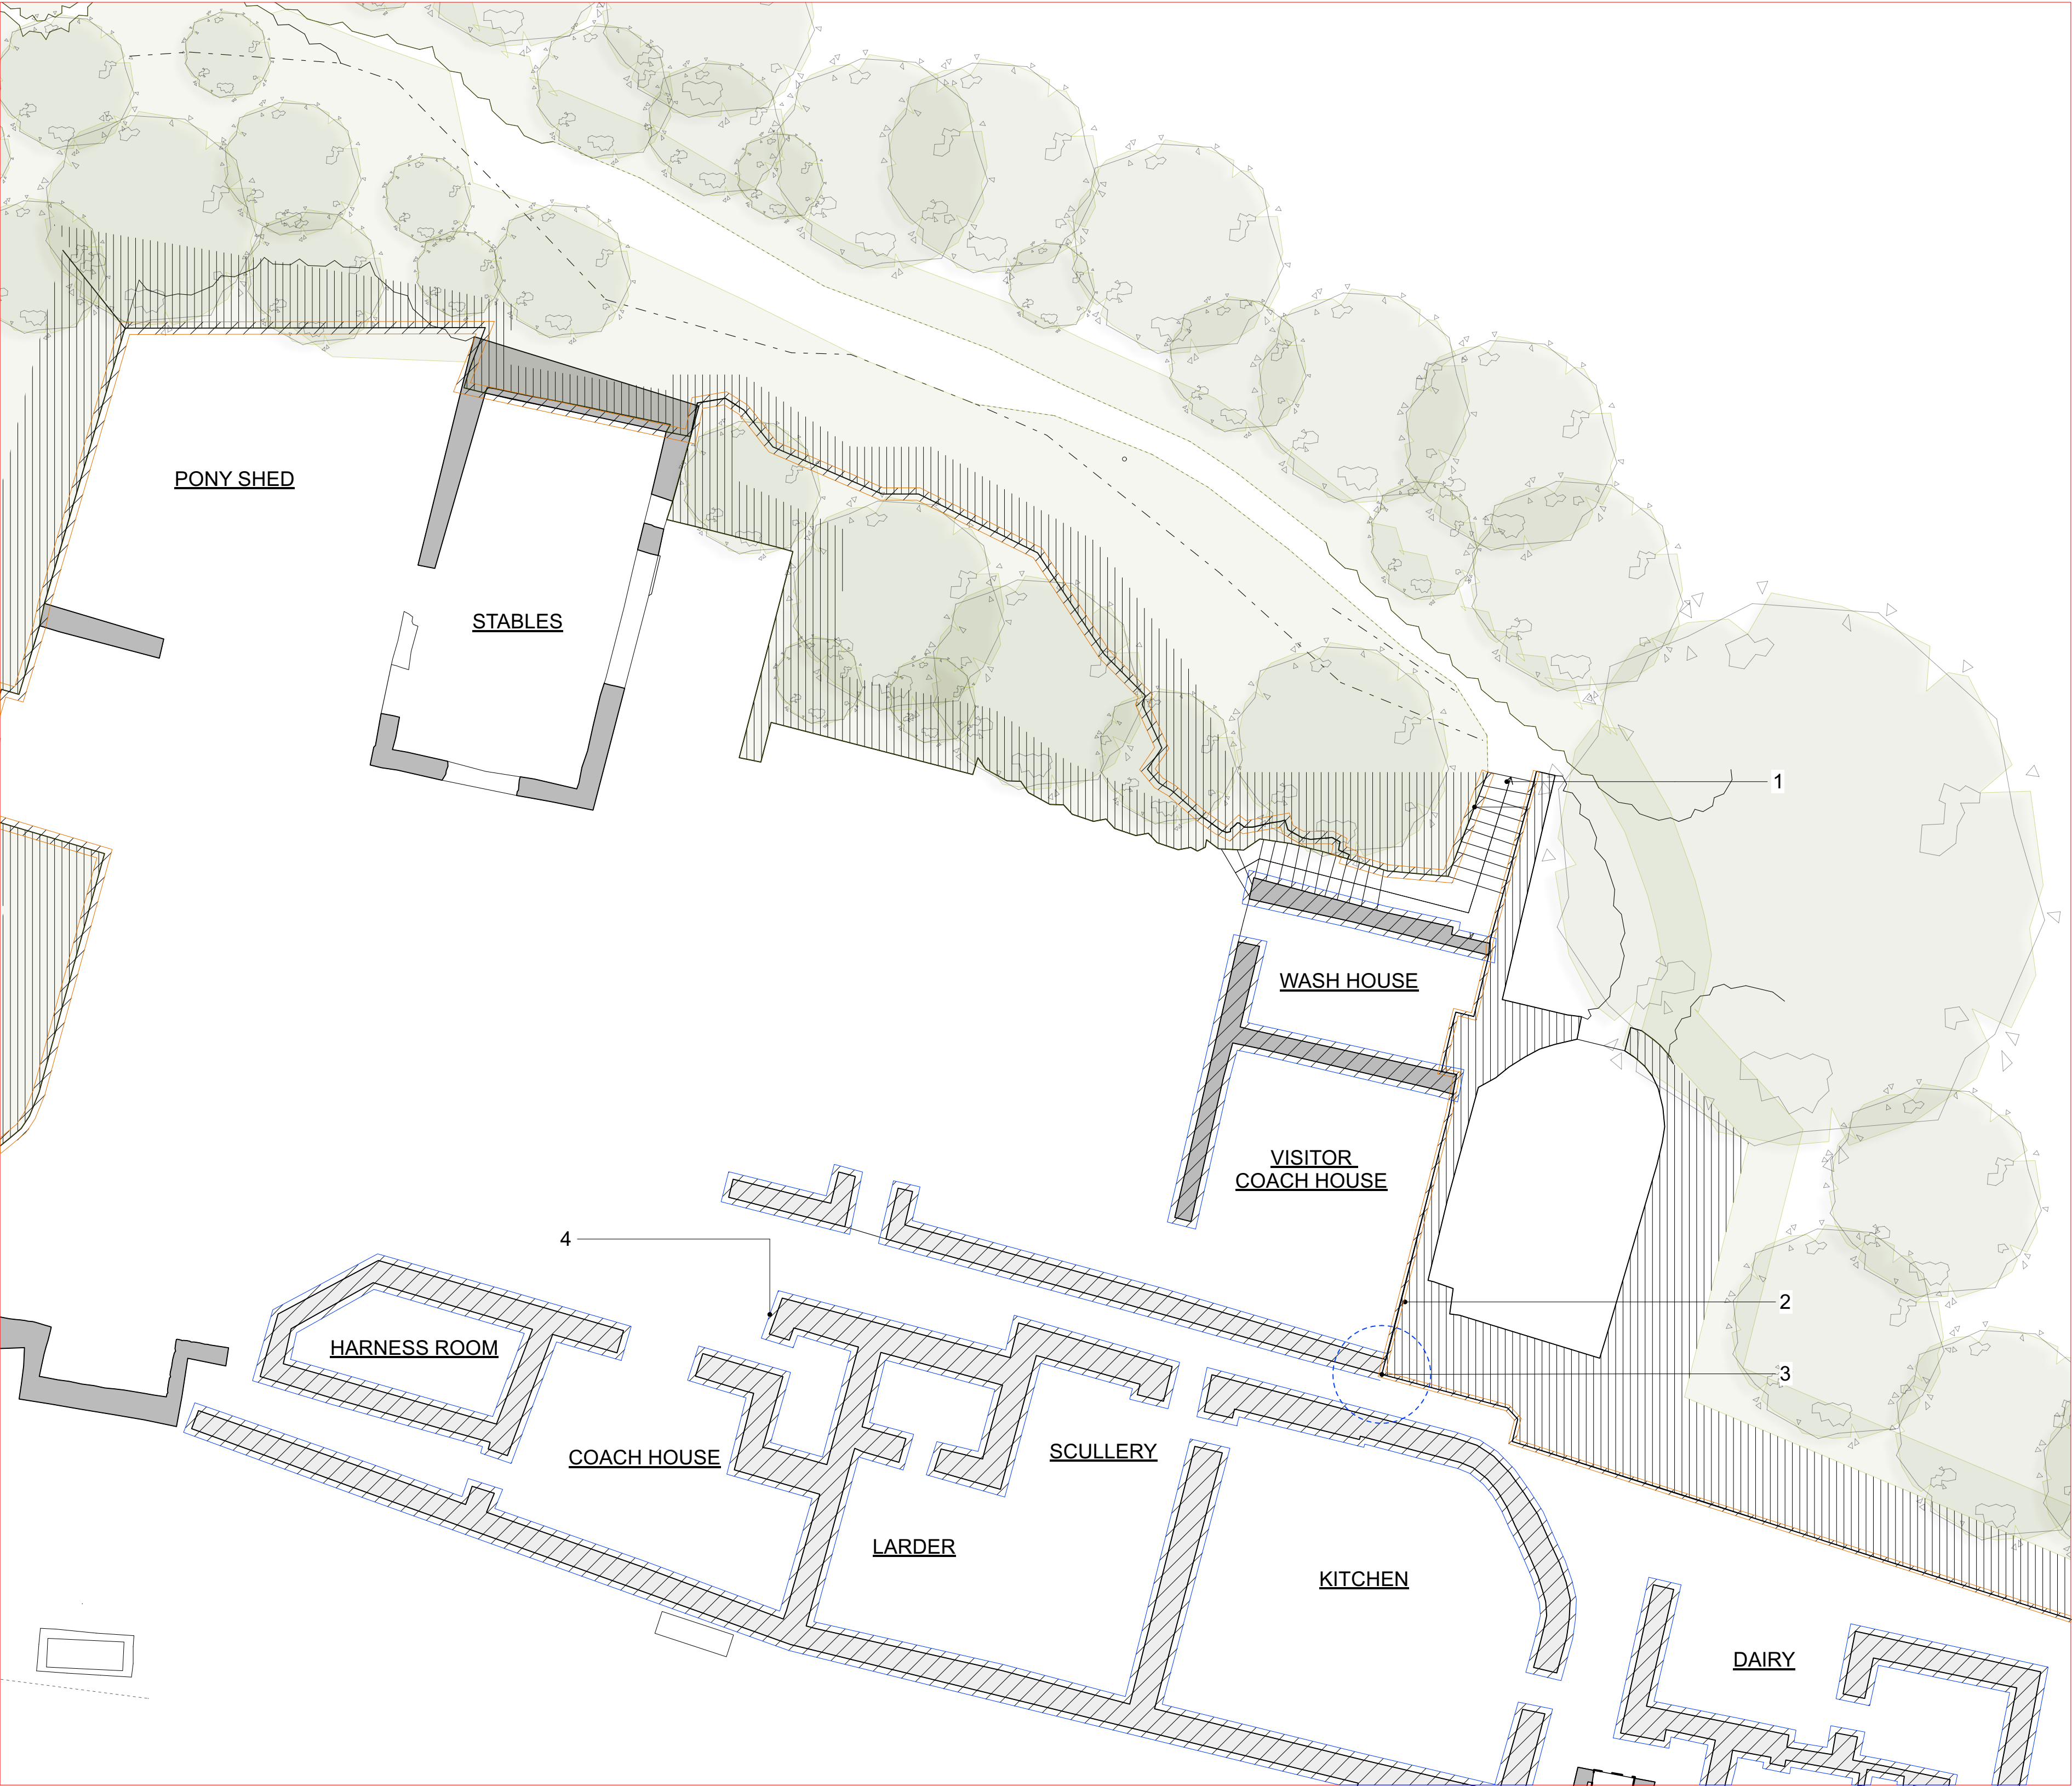
Undertake consolidation of existing walls, and removal of friable stone, and stone repairs in accordance with note 5. Contractor to allow the following percentages:

Consolidation - nominal 30% of all walls to a height of 500mm including 100% of wall cappings  
Removal of friable stone - Allow 50% of wall to be treated

Undertake investigation and appropriate treatment of ivy as outlined in note 2

See drawings 1140 and 1141 for further clarification on Consolidation and Removal of Friable stone/Ivy.

4. Stone Wall Top Repairs and Consolidation:  
The existing low level masonry is exposed to the elements. The walls are constructed of random rubble stonework. Tops of walls are generally stable but have been constructed in cementitious mortar with crazy paving over the top.

The crazy paving is to be removed. This is to be undertaken without damaging the arises of the masonry, therefore non-powered hand tools are solely to be used such as suitable jointing, plugging and toothed masonry chisels; hacksaw blades and bent spikes may also be used. Hacking hammers, cold chisels and mechanical aids are not to be used. The stone is to be set aside for reuse.

Tops of walls will be rebuilt using a combination of existing and new stone. The coursing of new work is to closely match that of the original stonework. Stones will be re-bedded, all joints being deep-pointed and finished, and the side walls rebuilt locally using a combination of salvaged and new stone. The walls will then be capped with a consistent depth of mortar, reflecting the existing profile. Allow for the following mix: 1 NHL5: 2½ well graded aggregate.
