R 01131.01 GROUND FLOOR PLAN (1 of 2)  
SCALE 1:100 @ A1, 1:200 @ A3

Gnoll Park is a Grade II\* registered parkland. As a consequence of this designation it is statutorily protected. Extreme care should therefore be taken not to cause any unspecified damage to any fabric or part of structures and landscape on or within the site when undertaking any construction works.

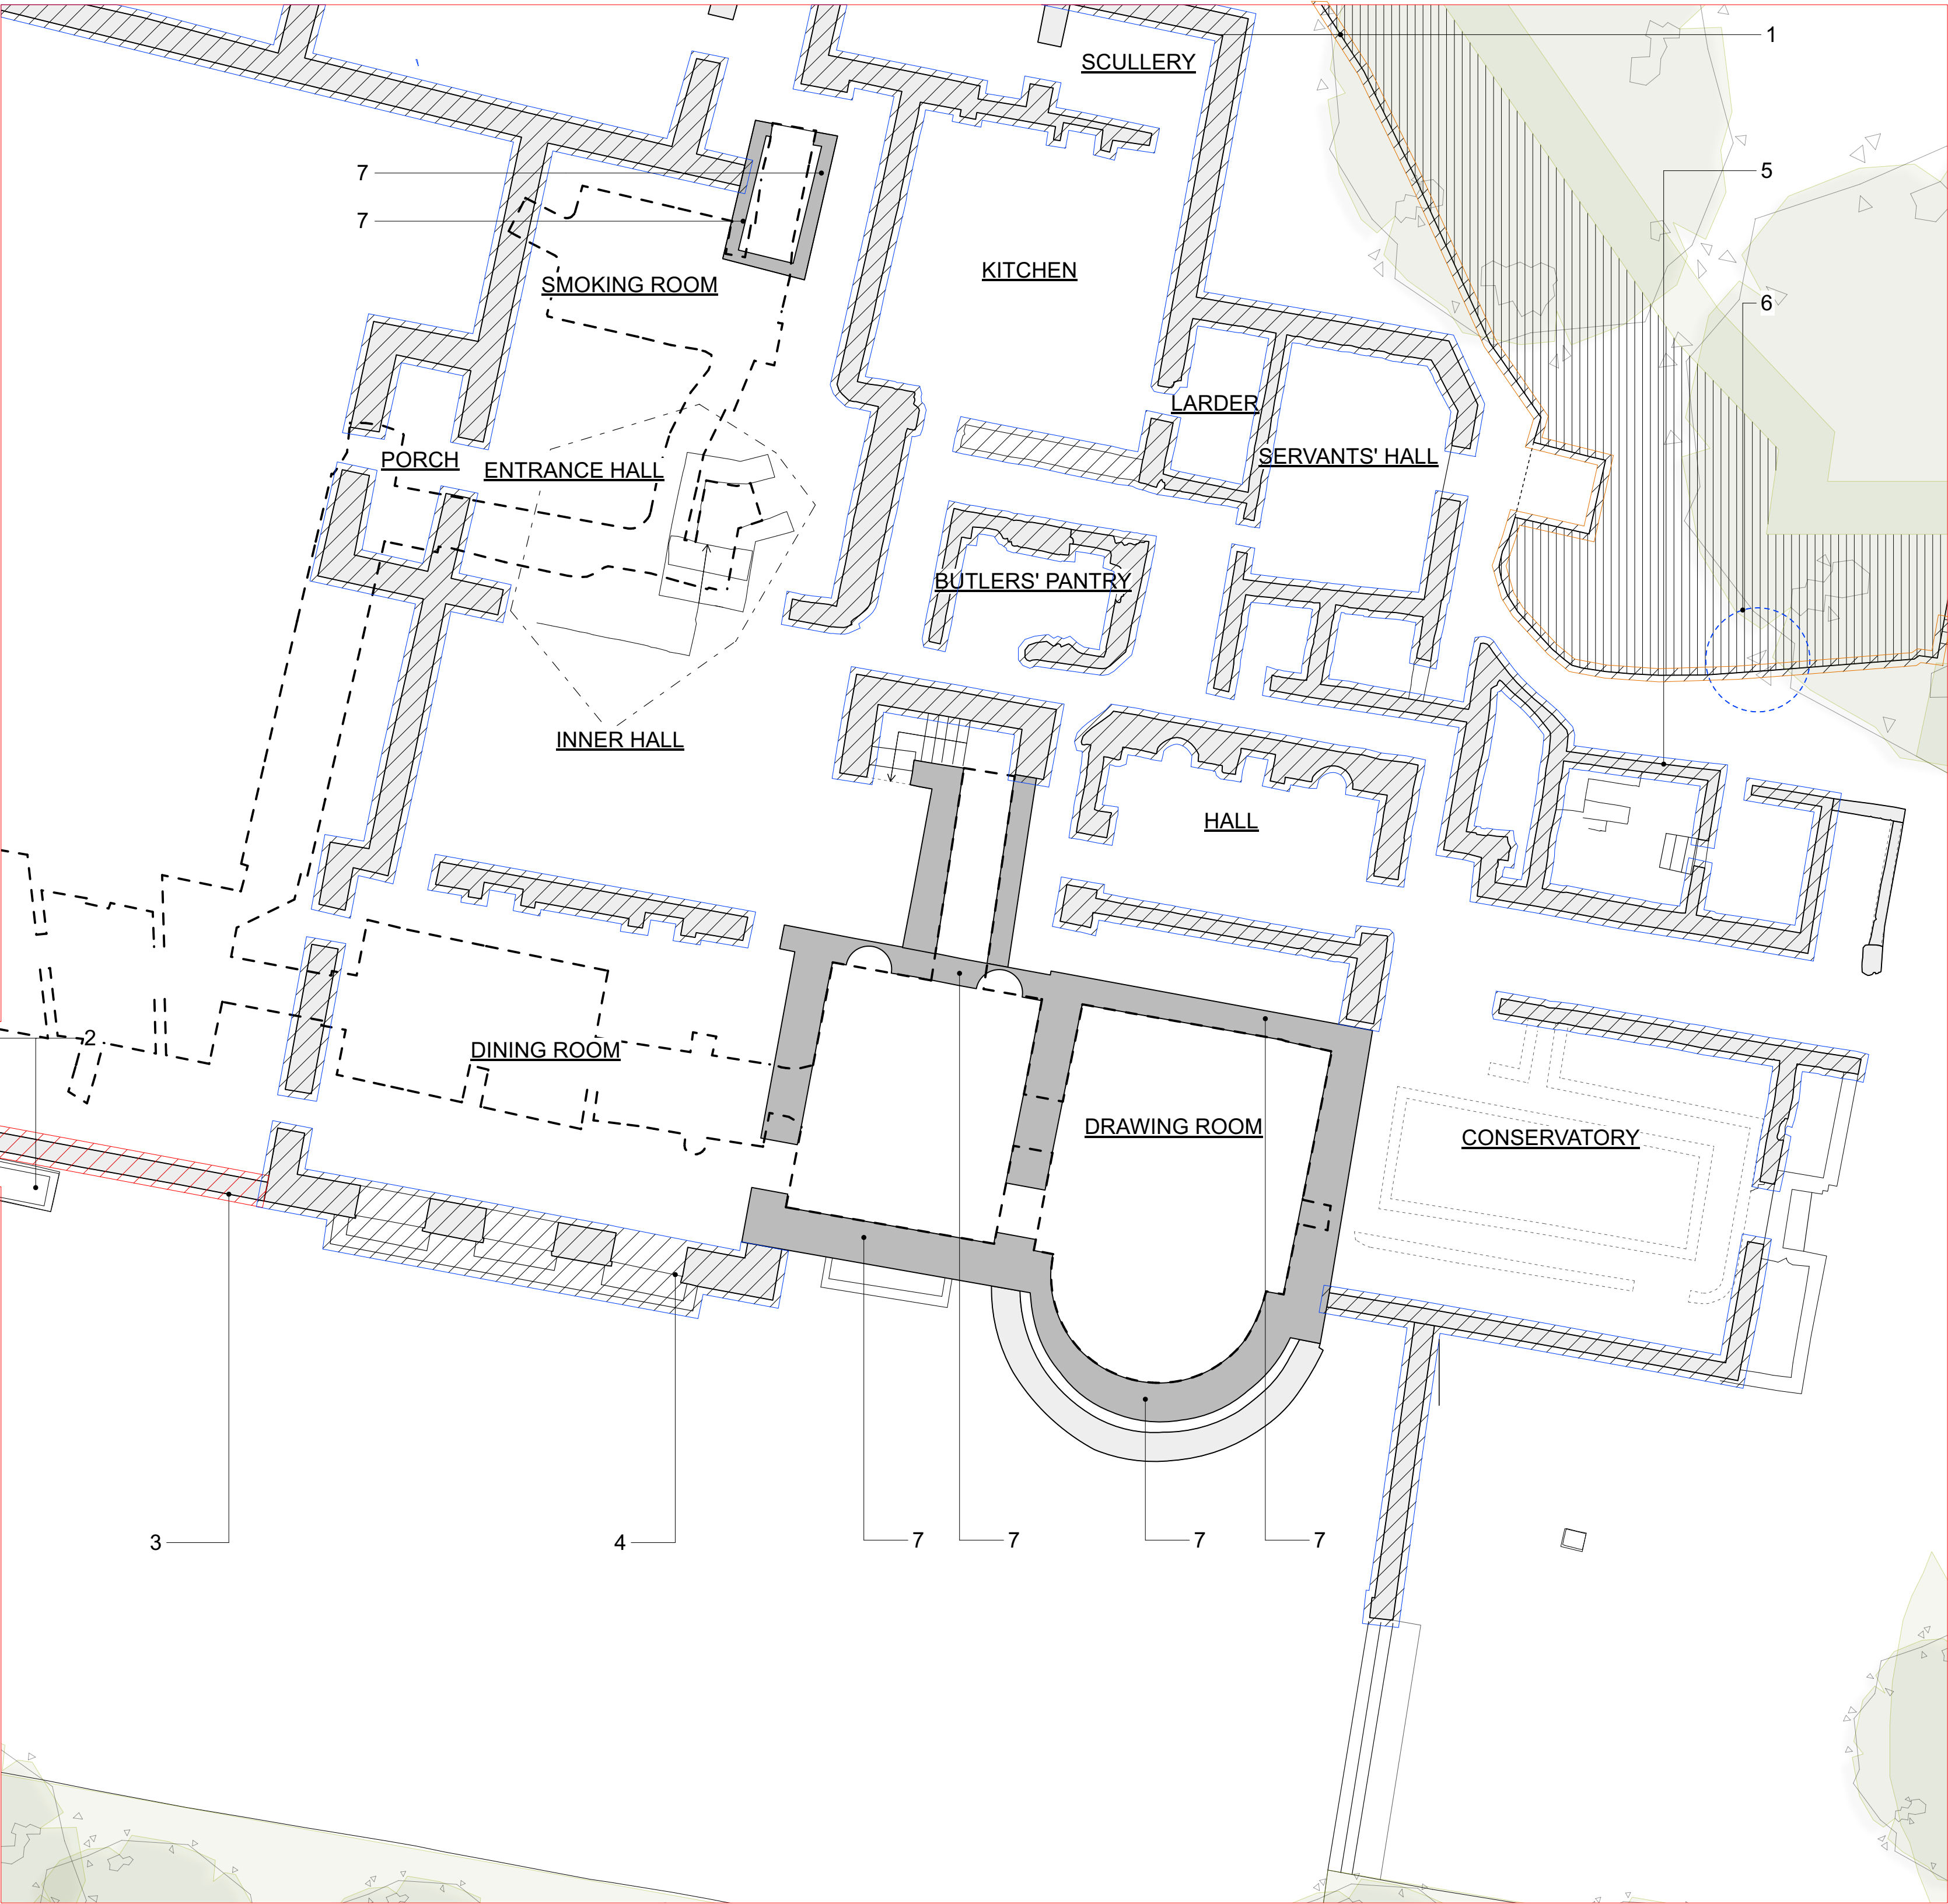
Undertake consolidation of existing walls, and removal of friable stone, and stone repairs in accordance with note 4. Contractor to allow the following percentages:

Consolidation - nominal 30% of all walls to a height of 500mm including 100% of wall cappings  
Removal of friable stone - Allow 50% of wall to be treated

Undertake investigation and appropriate treatment of ivy as outlined in note 1

Take down walls and steps in accordance with Drawing Note no. 3

See drawings 1140 and 1141 for further clarification on Consolidation and Removal of Friable stone/Ivy.

1. Preparing Underlying Masonry for Inspection and Repair as Necessary:  
The high perimeter walls to the Ruins create a positive ecological habitat due to existing vegetation, including climbing ivy. However, this is likely to be concealing underlying issues with the masonry which require investigation. In order to facilitate this, remove dense arboreal growth to the ivy to uncover enough of the structure for inspection. Allow for a section 1m wide to the full height of the wall. If the ivy is particularly dense, additional removal may be required in order to assess. Once the structure is visible, assess the ivy and the underlying masonry in order to investigate the root structure to see whether 'true roots' have formed, which have the potential to cause structural damage. The ivy and underlying structure should be assessed against the following lists and the appropriate methodology followed, dependent on the outcome of the investigations:

3. Wall Removal:  
Carefully take down existing masonry walls and steps to extent shown, to enable reconstruction of historic footprint. Works to be undertaken without damaging the historic masonry, therefore non-powered hand tools are solely to be used such as suitable jointing, plugging and toothed masonry chisels; hacksaw blades and bent spikes may also be used. Hacking hammers, cold chisels and mechanical aids are not to be used. Set aside stone for reuse on completion.

4. Stone Wall Top Repairs and Consolidation:  
The existing low level masonry is exposed to the elements. The walls are constructed of random rubble stonework. Tops of walls are generally stable but have been constructed in cementitious mortar with crazy paving over the top.

The crazy paving is to be removed. This is to be undertaken without damaging the arises of the masonry, therefore non-powered hand tools are solely to be used such as suitable jointing, plugging and toothed masonry chisels; hacksaw blades and bent spikes may also be used. Hacking hammers, cold chisels and mechanical aids are not to be used. The stone is to be set aside for reuse.

Tops of walls will be rebuilt using a combination of existing and new stone. The coursing of new work is to closely match that of the original stonework. Stones will be re-bedded, all joints being deep-pointed and finished, and the side walls rebuilt locally using a combination of salvaged and new stone. The walls will then be capped with a consistent depth of mortar, reflecting the existing profile. Allow for the following mix: 1 NHL5: 2½ well graded aggregate.
