## Geoenvironmental Desk Study

Site: Former Metal Box Unit, Neath

Prepared For: 360 Aquaculture Ltd

**REPORT TITLE :** Geoenvironmental Desk Study and CMRA: Proposed Development, Former Metal Box Unit, Neath

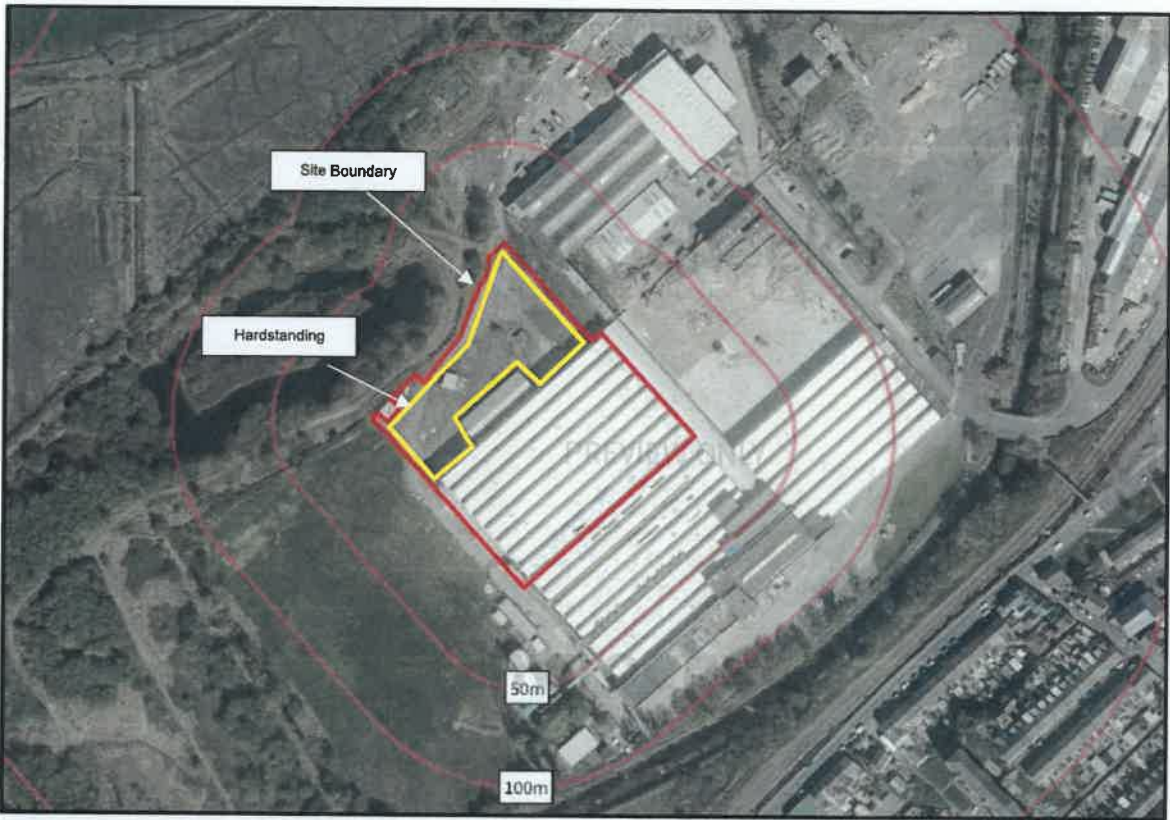
Figure 4.1 Existing Buildings

An annotated aerial photograph can be found in **Figure 4.1** identifying some of the buildings and ruins presents on the site.

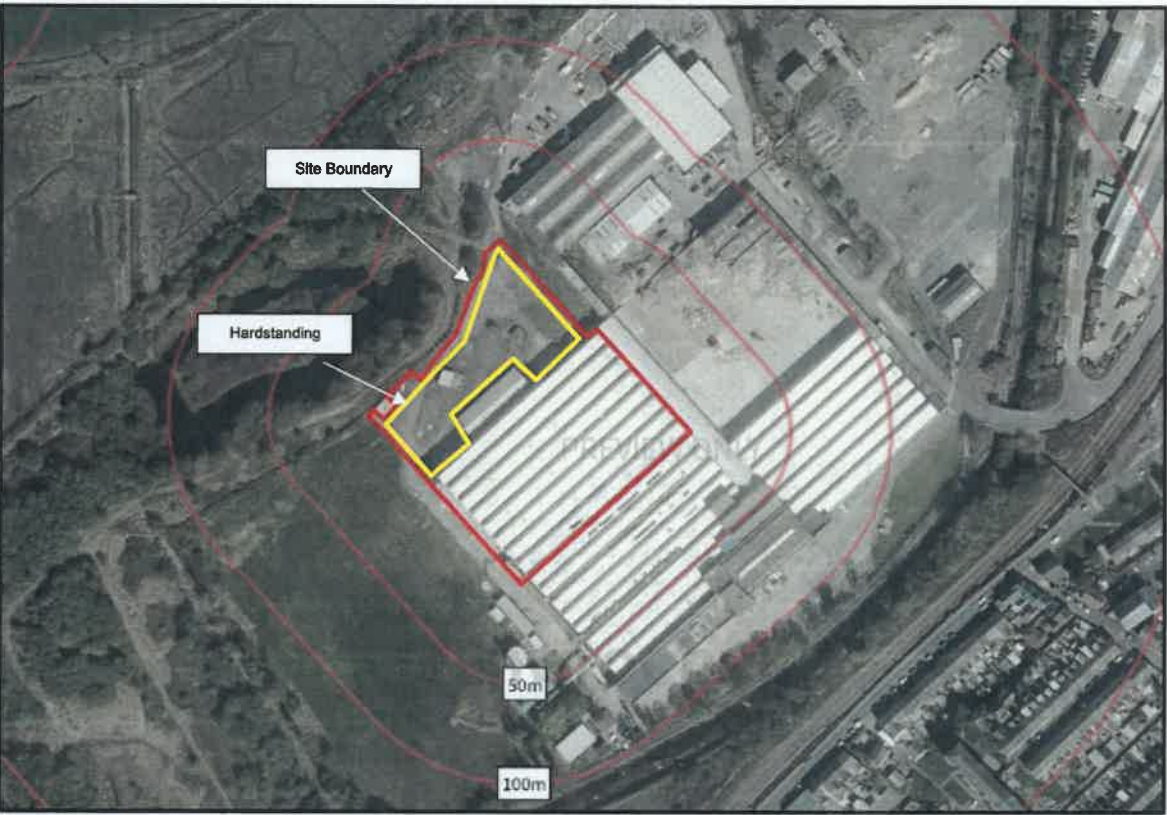
Figure 4.1 Existing Buildings

An annotated aerial photograph can be found in **Figure 4.1** identifying some of the buildings and ruins presents on the site.
