## **DETAILED UXO RISK ASSESSMENT**

## STAGE 2 DETAILED UXO RISK ASSESSMENT

**Client:** TEC Ltd  
**Project Ref:** TWEE89R  
**Site:** Project Dragon, Port Talbot  
**Report Ref:** DRA-23-1532-TWEE89R-ProjectDragon,PortTalbot  
**Revision:** 2  
**Status:** Final  
**Release Date:** 6<sup>th</sup> September 2023

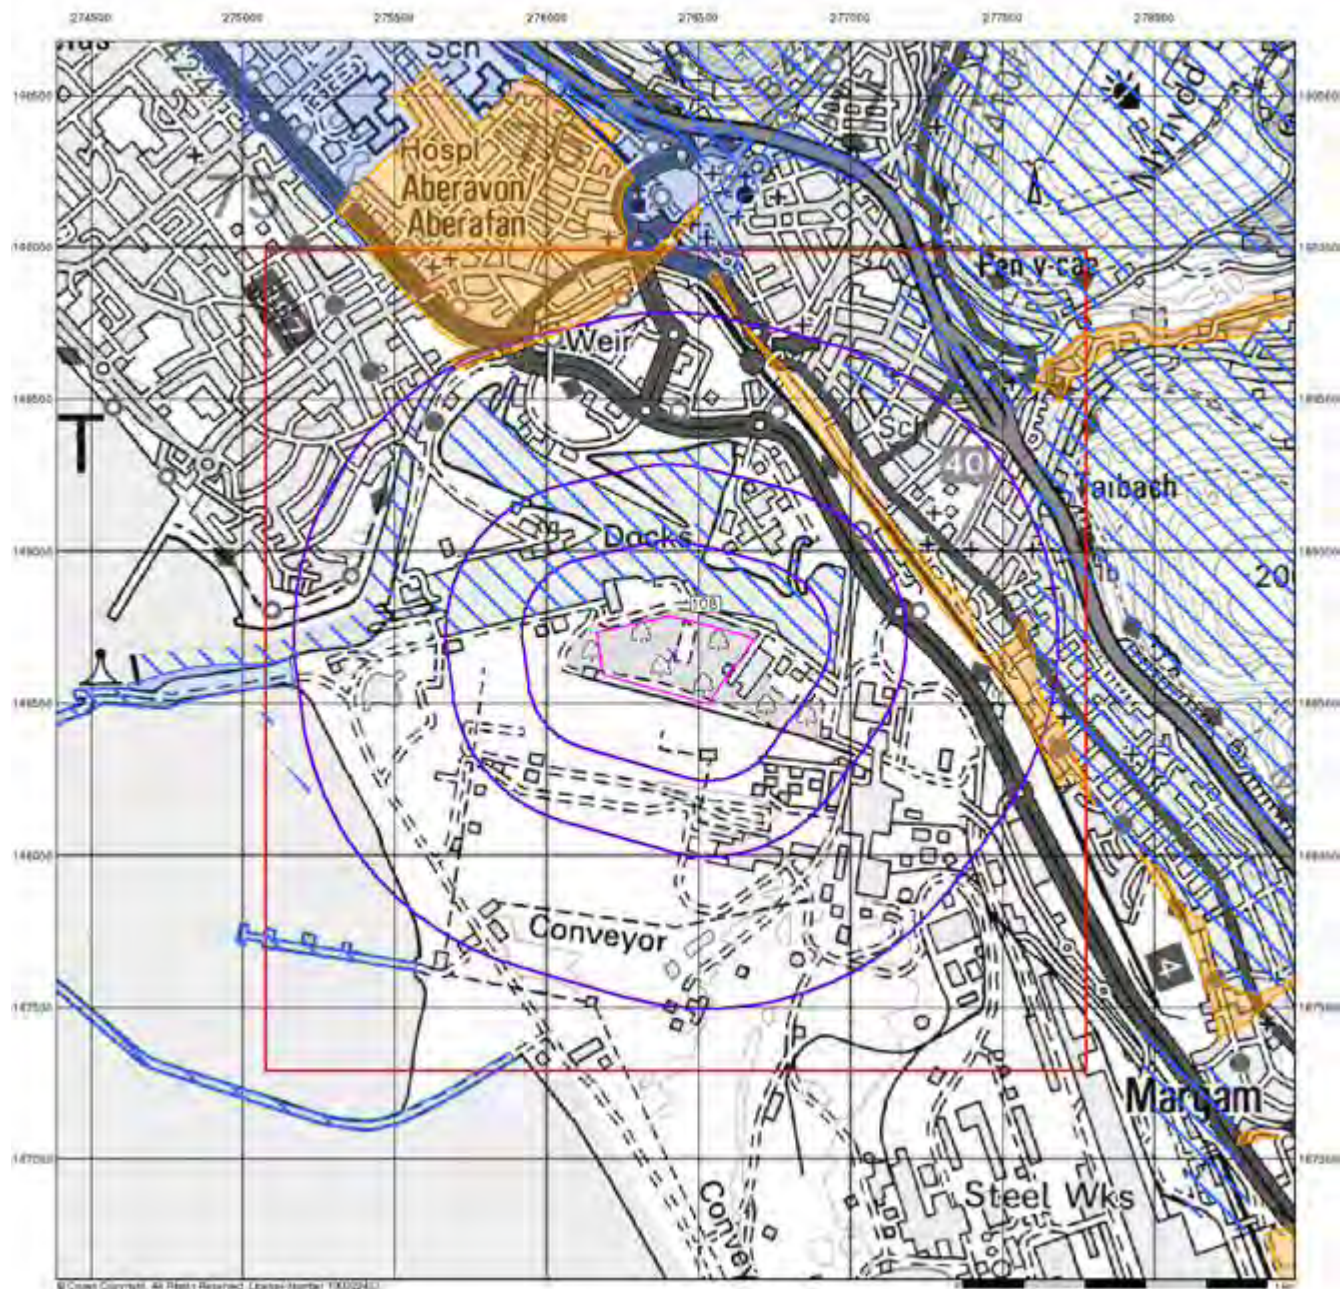
## Ground Stability Data (1:50,000)

### Potential for Compressible Ground Stability Hazards

### Potential for Collapsible Ground Stability Hazards
