*Report No. BC/MB/04.20.07.*

# **Coal Mining Risk Assessment: Land at Abergarwed Farm.**

***Absolute Scaffolding Ltd***

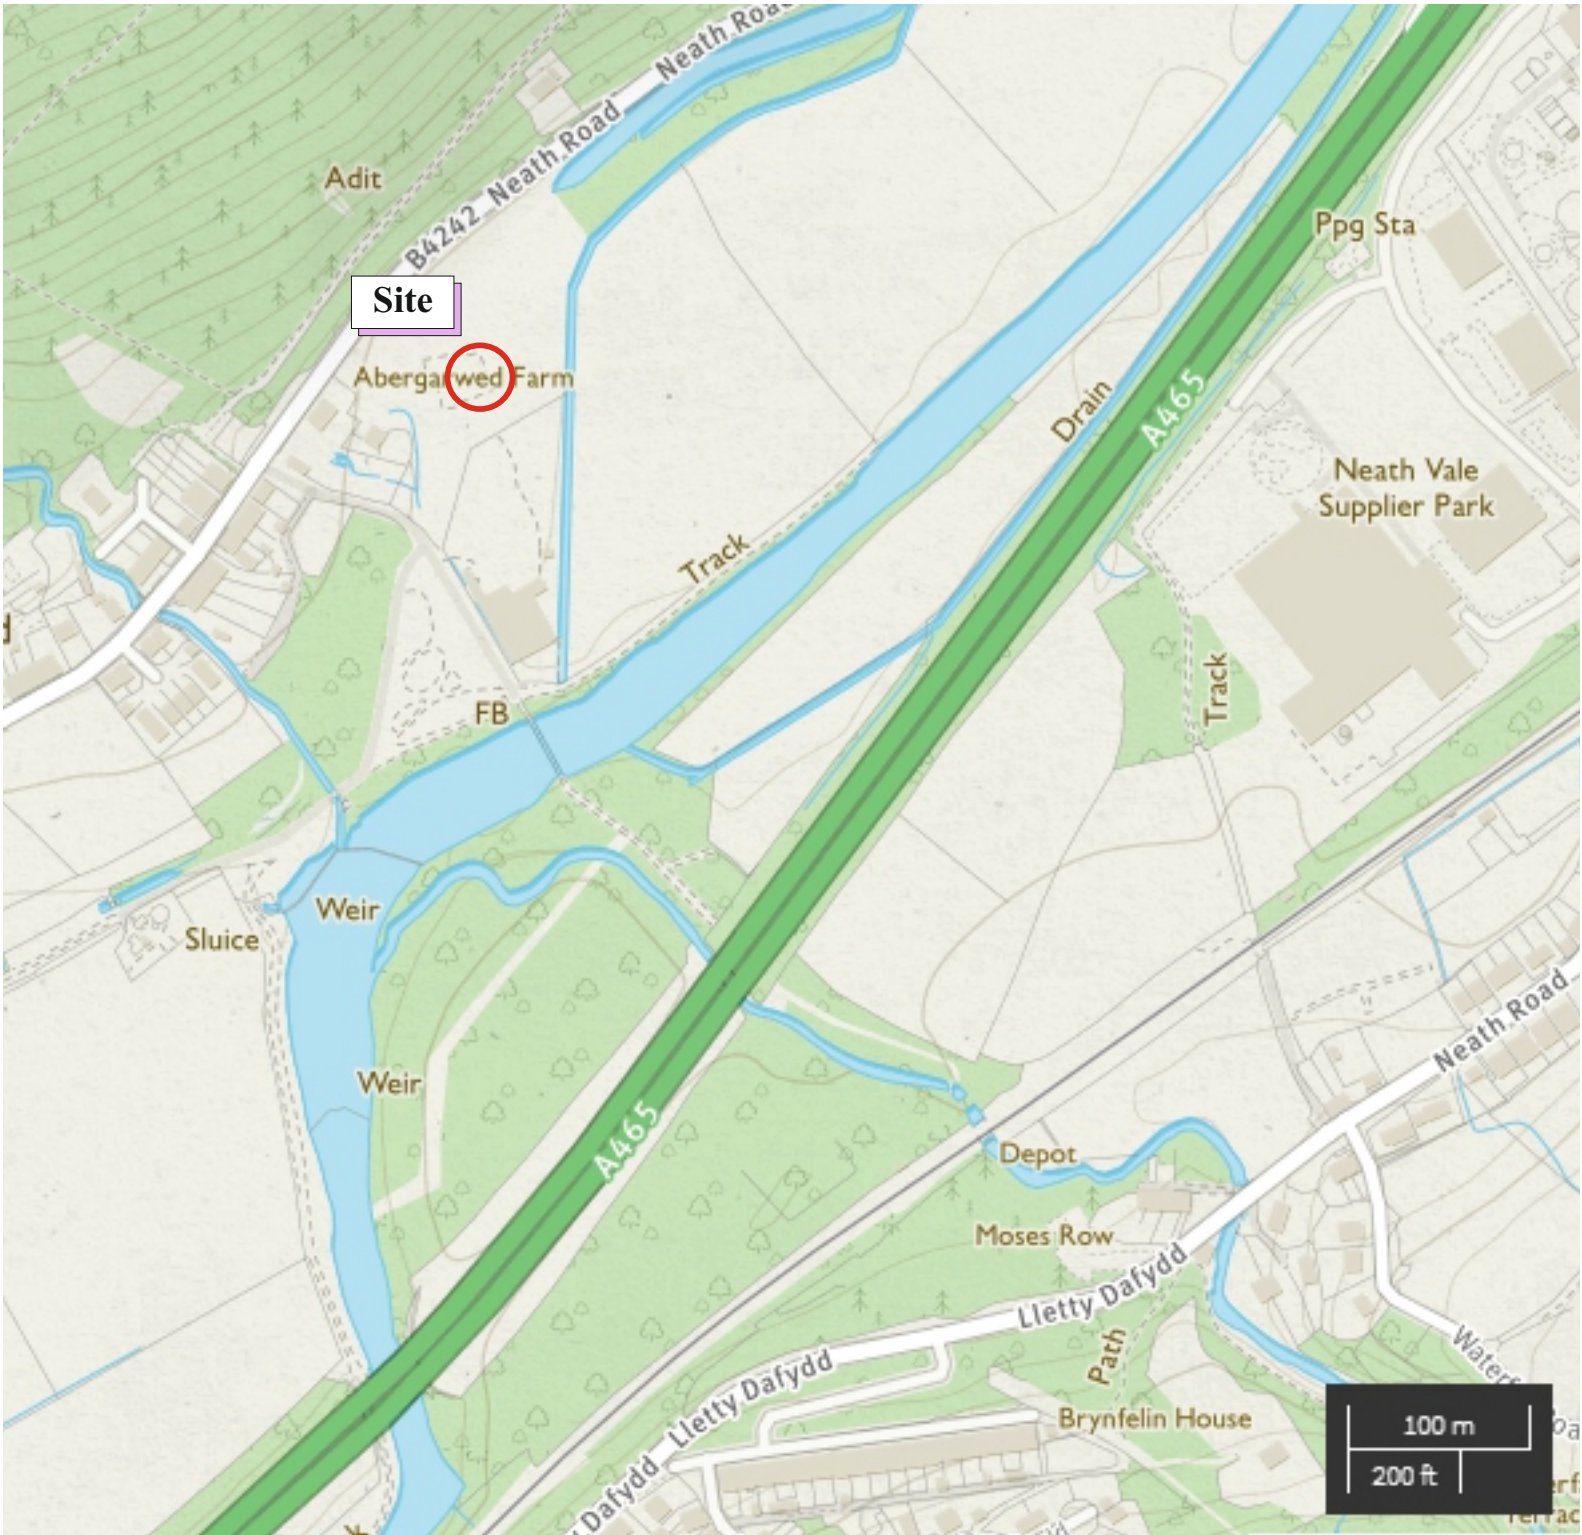
*Detailed Location Plan.*

| <b>Drawing No:</b> | | <b>Scale:</b> |
|---|---|---|
| <i>BC/MB/04.20.07.03.</i> | <i>Detailed Location Plan.</i> | <i>See Plan.</i> |

The plot of land where it is proposed to construct the storage facility, 'the Site' is located in a rural area and is situated on the floor of the Neath Valley, approximately 11km east of the commercial centre of Neath and 7.5m south-west of the centre of Glyn Neath (see Figure 1 and *General Location Plan, drawing no. BC/MB/04.20.07.01*). The Site is located at the eastern fringes of Abergarwed and close to the River Neath and is largely surrounded by a mixture of woodland and agricultural enclosures. The Site is irregular in outline and the proposed storage building has dimensions of approximately 30m by 20m; its location is at an elevation of approximately 22m aod (see Figure 1 and *Detailed Location Plan, drawing no. BC/MB/04.20.07.03*).
