**St. Modwen Developments**

**Crymlyn Tip, Coed Darcy**

**Coal Mining Risk Assessment**

Document Reference: 04020-PJA-24-XX-RP-R-0104

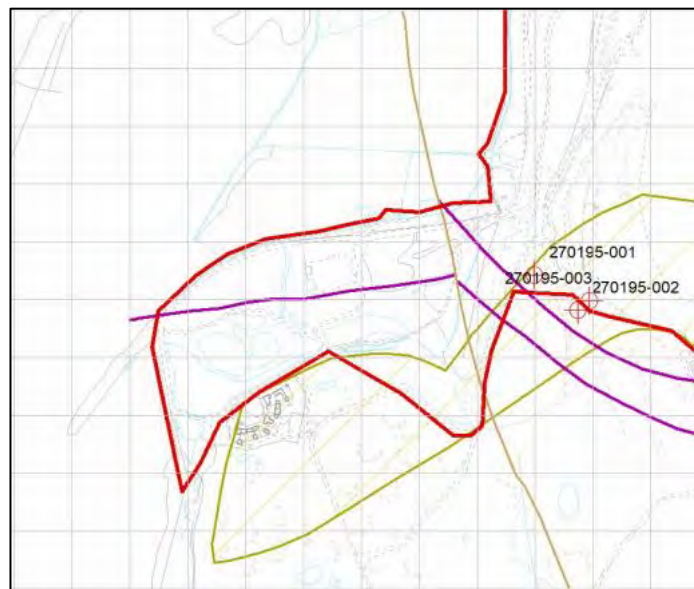
An extract from this Coal Authority plan is provided as Figure 2.

**Figure 2: Extract from the Coal Authority Plan**

The plan accompanying the coal mining report shows a coal seam sub cropping across the Site orientated east-west. Cross referencing this with the geological maps suggests that this represents the Swansea Three-Feet seam. In the eastern part of the Site, to the east of the north-south trending 'Gardeners Fault' two additional sub cropping coal seams are shown. These are the Hughes seam and an unnamed coal seam. Three mine entries are shown to the east of the Site.

- The coal mining report states all three of these seams have been subject to past underground mining at depths ranging from 5m to 131m. The last recorded mining dates range from 1900 to 1914. Extraction thicknesses are recorded as 94cm to 110cm.
- There are no probable unrecorded shallow mine workings within the Site.
- There are no spine roadways recorded at shallow depth.
- There are no recorded mine entries within the site boundary. Three shafts are recorded between 80 and 190m to the east of the site. There are no records of the treatment of these mine shafts.
- There are no opencast mines recorded within 500m of the enquiry boundary.

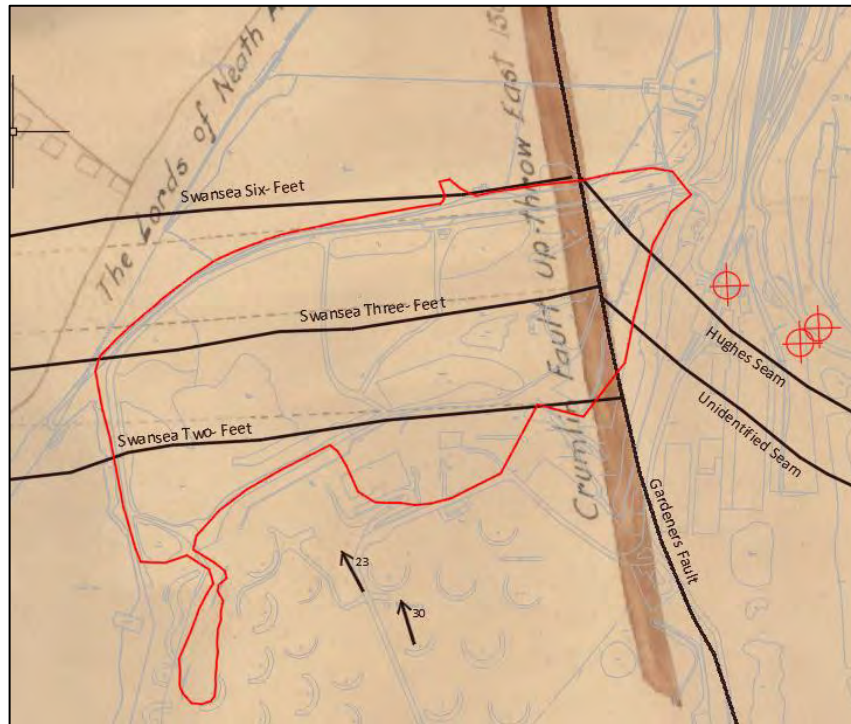
Figure 3: Excerpt from the abandoned mine recordings of various collieries (circa 1821) overlain with coal seam sub crops, geological faults and the Site boundary.

The Coal Authority was commissioned by PJA in July 2024 to carry out an abandoned mines catalogue search for the Site. The Coal Authority have provided abandonment plans held on record. Relevant extracts of these plans are shown in Figure 3 and Figure 4 below.

Figure 3 shows an excerpt from an abandonment plan covering several collieries including Llansamlet, Crymlyn and Glay Y Wern. The date of abandonment is given on the plan as 1821. This shows no workings under the Site, and the nearest workings are associated with the Glan Y Wern colliery to the northeast of the Site.

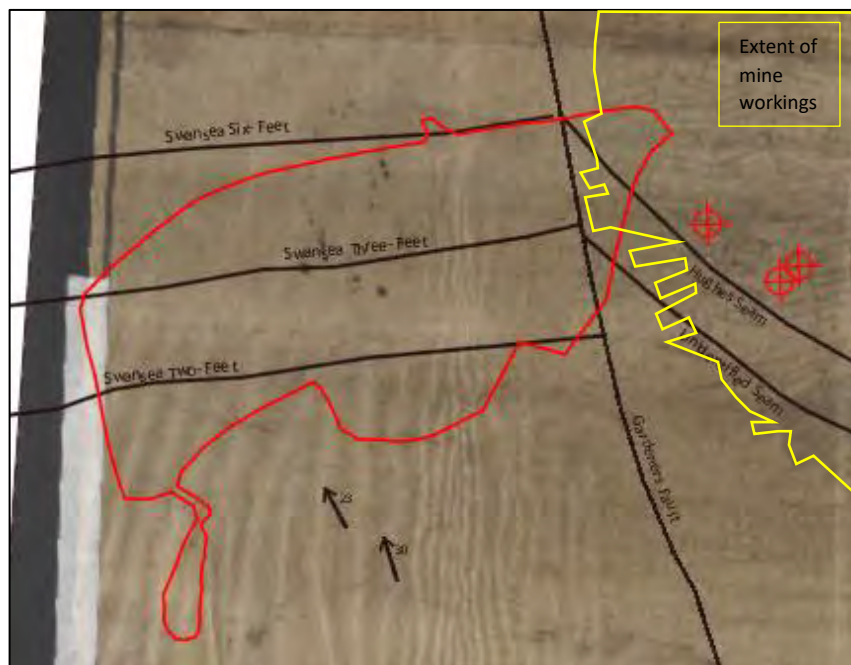
Figure 4: Excerpt from Cwrt-Y-Bettws abandoned mine recordings circa (1914) overlain with coal seam sub crops, geological faults and the Site boundary

Figure 4 shows an excerpt from an abandonment plan for Cwrt-y-Bettws Colliery from circa 1914. This shows workings in the northeastern corner of the Site, to the east of Gardeners Fault.
