## **Former Tudor Inn – Cimla, Neath Proposed Residential Development Phase One Coal Mining Risk Assessment**

Report Reference: ESP.8398.03.4163

## Former Tudor Inn – Cimla, Neath Proposed Residential Development Phase One Coal Mining Risk Assessment

Prepared for:  
Tai Tarian Ltd.  
Tŷ Gwyn  
Brunel Way  
Neath SA11 2FP

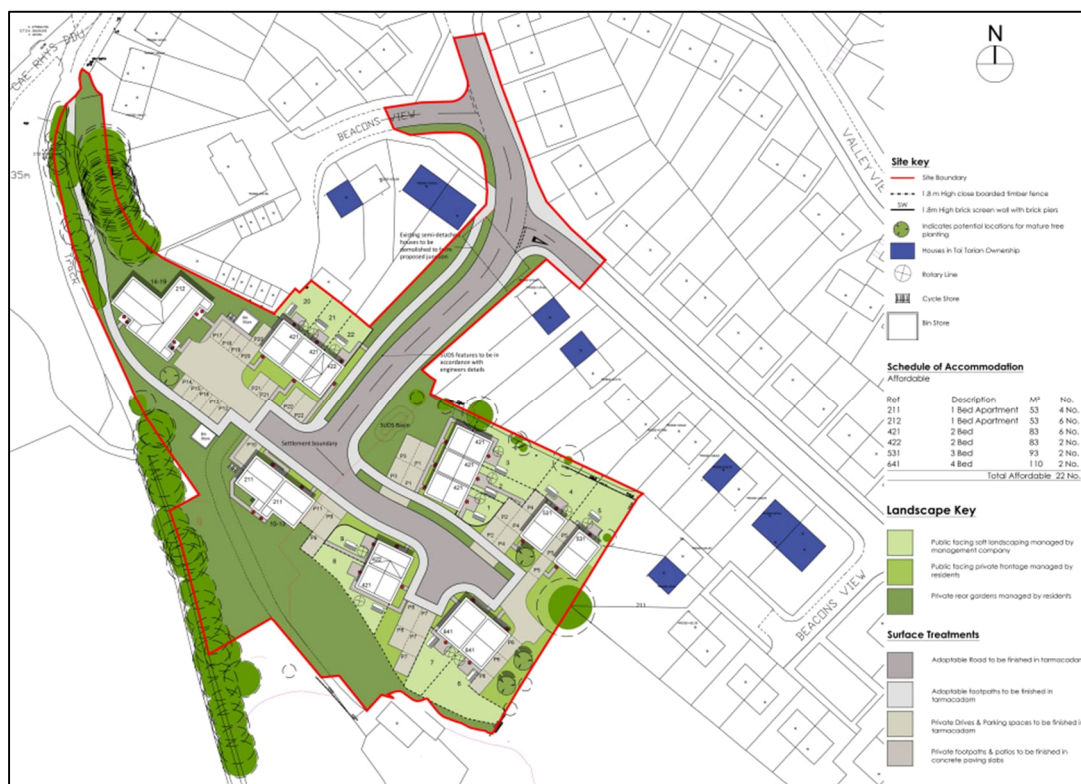
Insert 1 – Proposed Site Block Plan (Provided by Spring Design)

The proposed development will comprise conventional two-storey residential dwellings with private gardens, landscaping and estate roads. The proposed development layout is presented as Insert 1 below, and shows a large apartment block in the north-west, with link of three dwellings and six further residential structures around a central north-west to south-east orientated estate road. A new access road for the development will be constructed from Beacons View to the north-east, created by the demolition of existing properties. An infiltration basin (for SuDS) is shown just to the east of the new access.
