89 WENALLT ROAD  
TONNA

PROPOSED  
NEW DWELLING

SITE REMEDIATION

OPTIONS APPRAISAL  
&  
REMEDICATION  
STRATEGY

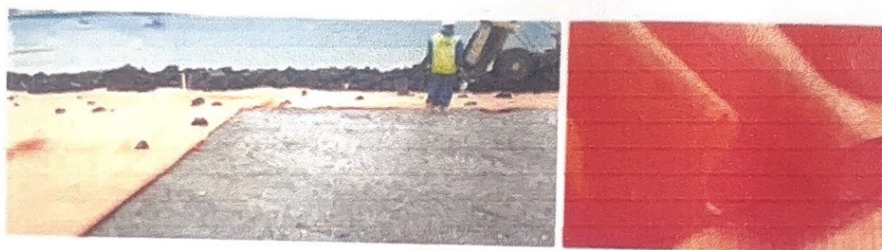
### Alert™ Woven Polypropylene Geotextile and Contamination Indicator

Alert™ was developed by Geosynthetics Limited to provide a cost effective and practical way to indicate the break between potentially contaminated ground and imported or site won clean fill. The large roll size combined with industrial leading technical specifications and strength have lead to the vivid orange Alert™ woven geotextile being the product of choice in the UK.
