RHONDDA  
GEOTECHNICAL  
SERVICES

PHASE 1  
CONTAMINATED LAND ASSESSMENT  
OLD SCHOOL COURT  
FORMER BRYN PRIMARY SCHOOL  
NEATH ROAD, BRYN  
PORT TALBOT  
SA13 2RS

10/09/2018

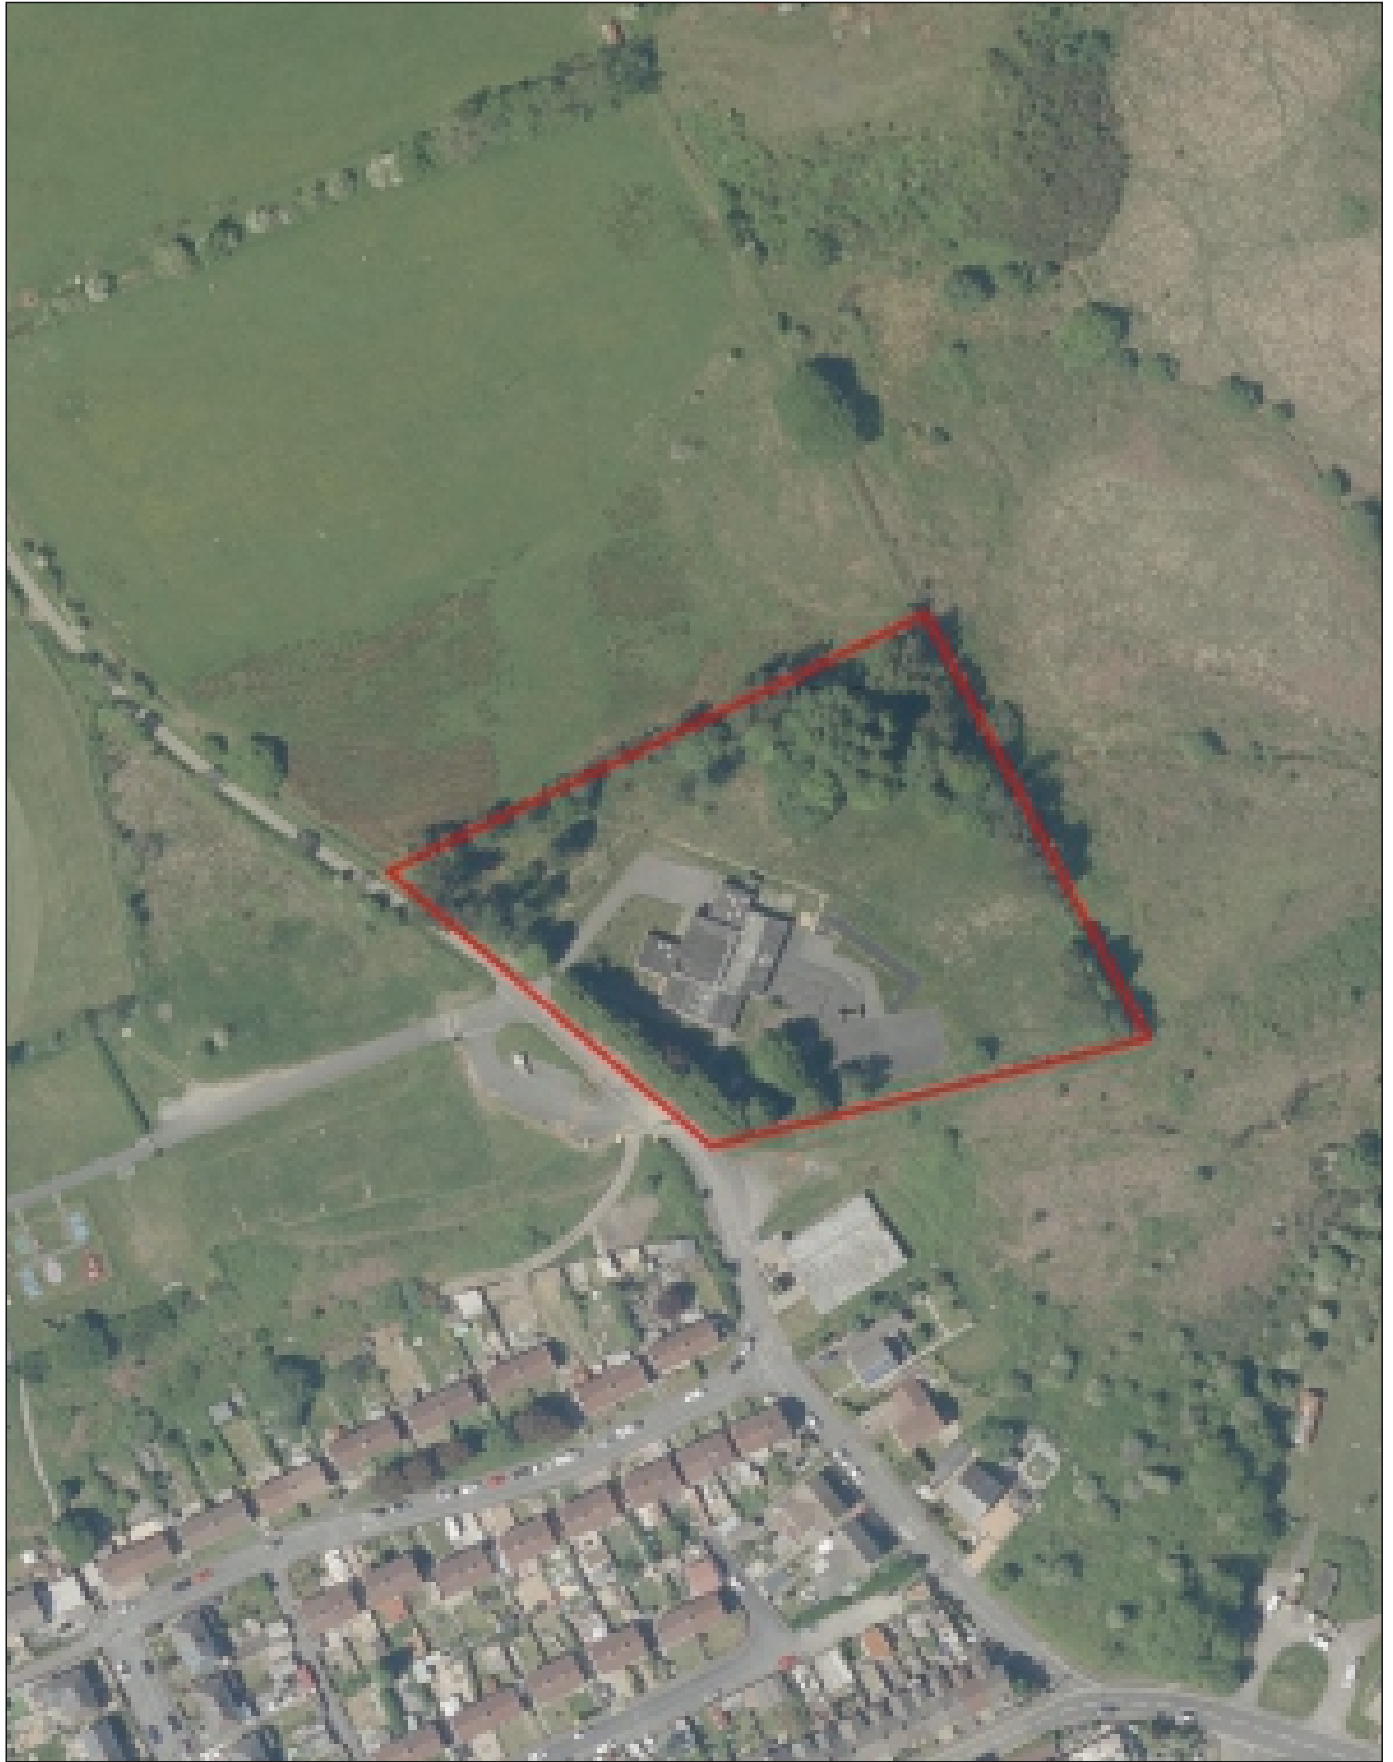
FIGURE 3

2014 AERIAL PHOTOGRAPH OF THE SITE  
(GROUNDSURE COPYRIGHT)

The site is centred on grid reference 281450, 192500 and is at an average elevation of approximately 170m. A.O.D. The site comprises of a former primary school and the surrounding grounds. These are roughly trapezoidal in shape, covering an area of approximately 1.3 hectare. The site is bounded on three sides by fields with Neath Road forming the western boundary. There are no surface watercourses although a small spring emerges just off the eastern boundary. The site location and site boundary can be seen overleaf in Figures 1 and 2 with an aerial photograph of the site in Figure 3.

As can be seen in Figure 3, at the present time the school buildings are still intact and in good condition. For this reason the school buildings will not be considered as a possible source of contamination. They undoubtedly contain asbestos, as it is ubiquitous in buildings of this age. N.P.T. have been asked for the asbestos register for the building but at the current time it has not been located. The buildings will be eventually be demolished. Prior to this licensed contractors will strip any asbestos out for disposal. Similar consideration will be given to the heating system, particularly if oil fired. For this reason it is entirely

By 1977 all mining in the region had ceased. The signs of past activity remain everywhere. In Figure 9 it can be seen that the school has been constructed. The layout is identical to that seen in the aerial photograph in Figure 3. The old level on the northern boundary of all previous maps has gone. There was no trace of it on the walkover survey. It is very likely it was stopped up and levelled during the construction and landscaping of the school and grounds. The Coal Authority have no records of this, as is normal for work that they have not carried out themselves since their inception in 1994.
