# **Coal Mining Risk Assessment**

**Client: Lidl Great Britain  
Ltd**

**Briton Ferry Road, Neath**

**Report No: 769.01.03**

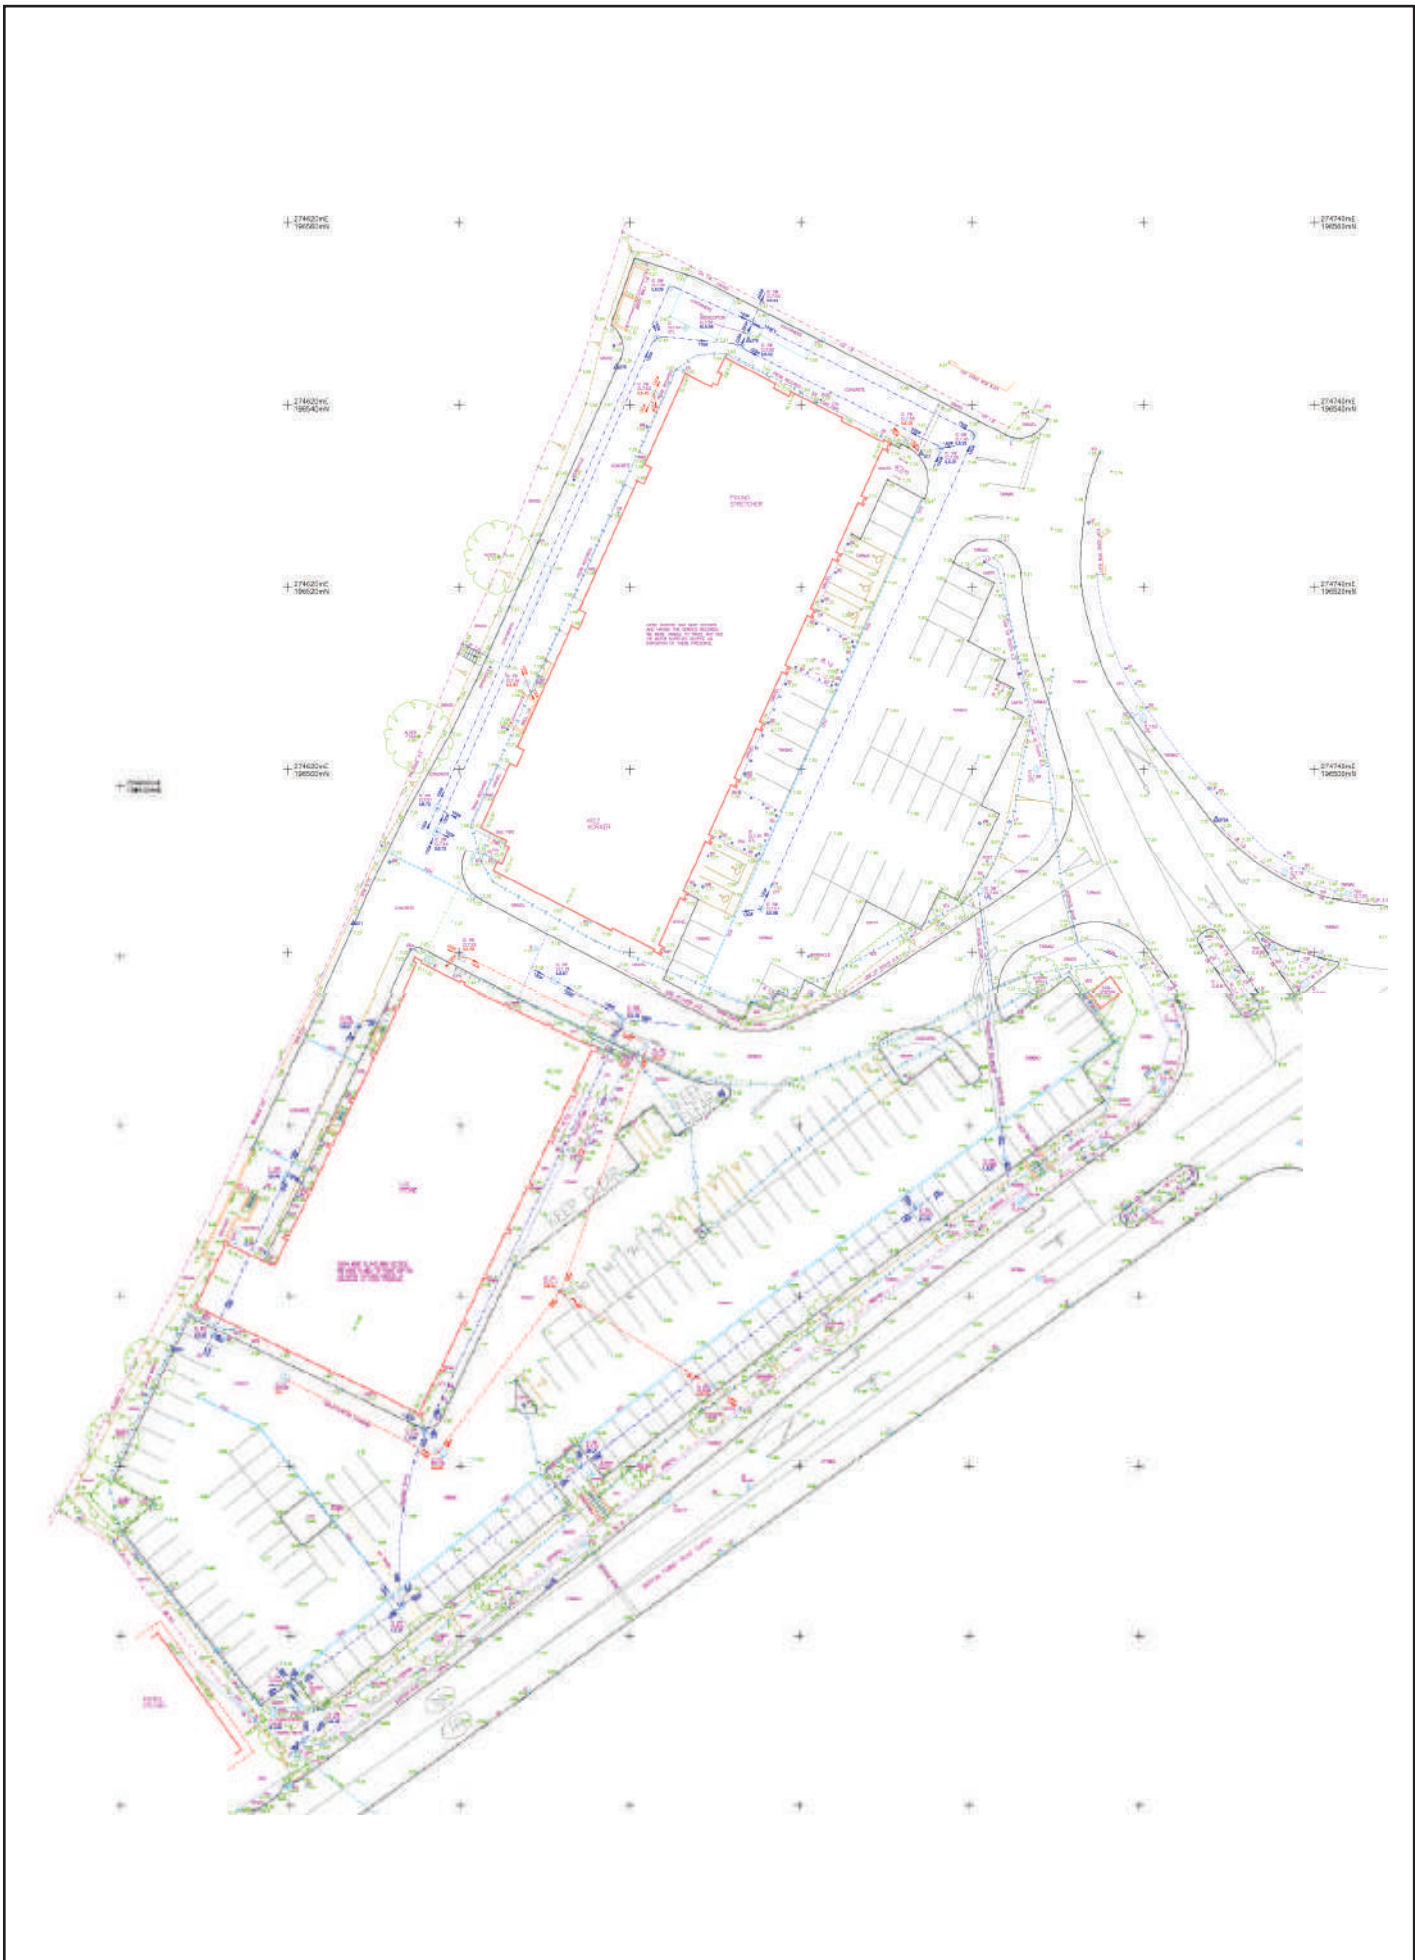
| <b>Figure 2</b> | <b>Existing Site Layout</b> |

| <b>Notes</b><br><br>Existing site layout plan reproduced from client-supplied EDI Surveys Ltd's Topographic Survey, drawing ref: 14433/T/01-02 Rev A, dated 2015. | Revision | Approved | Date | Project Title | Scale | Drawn | Size |

**Site Description** The study site occupies an irregular (but very broadly triangular) plot to the west of A474 Briton Ferry Road and south-west of Neath town centre, as indicated in **Figure 2**.

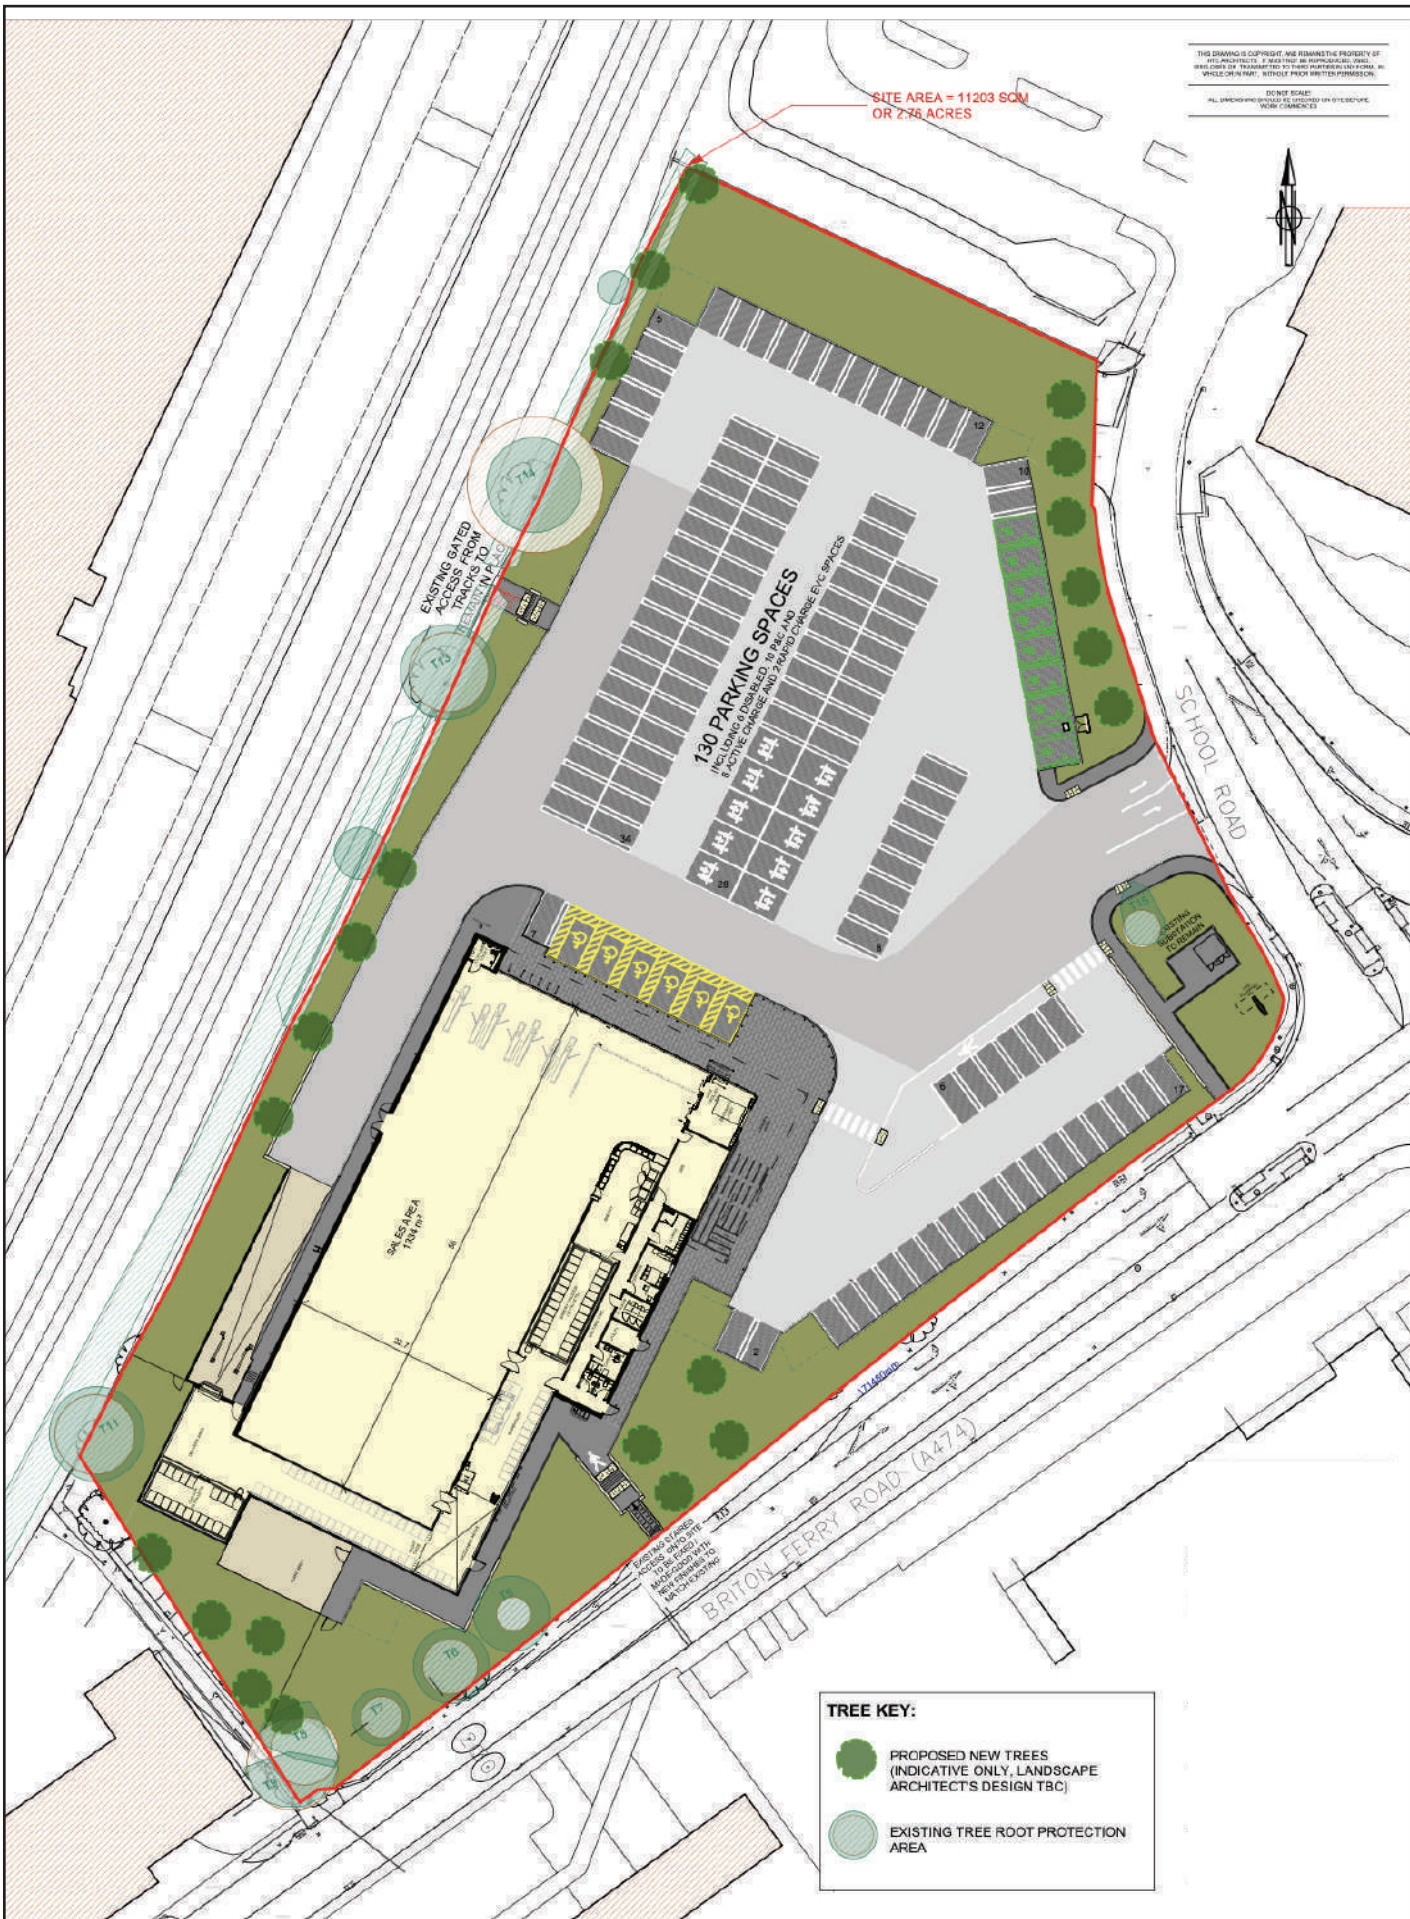
| <b>Figure 3</b> | <b>Proposed Indicative Site Layout</b> |

| <b>Notes</b><br><br>Proposed site layout plan reproduced from client-supplied HTC Architects' Proposed Lidl Site Plan, drawing ref: 2782-P4403-Rev H dated October 2024.<br><br>The proposed site layout plan is indicative only and subject to change following publication of Remada's Phase 1 report. | Revision | Approved | Date | Project Title | Scale | Drawn | Size |

It is understood that the proposed site use for the site will be a Lidl retail store with associated car park and soft landscaping. A proposed indicative site layout plan is presented as **Figure 3**, with the site being accessed off School Road along the eastern boundary. The proposed store footprint is indicated to be in the south-western area of the site, with the remaining areas being a combination of car parking, HGV access and soft landscaping.

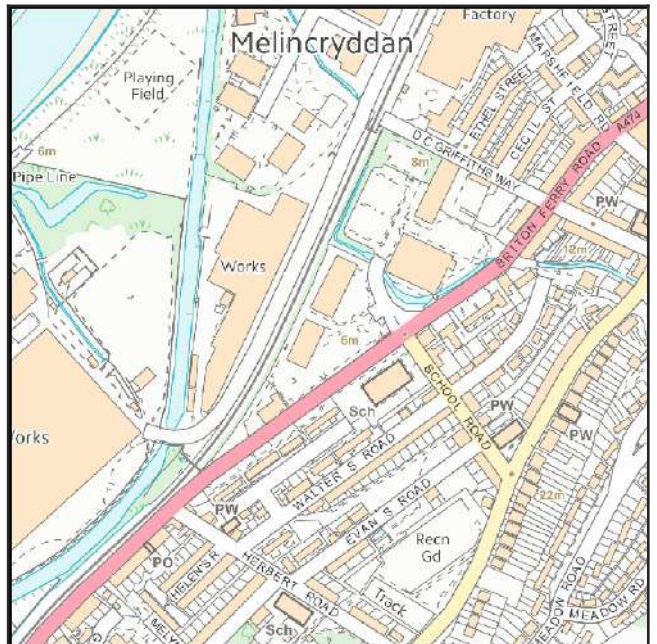
Approximate position of property

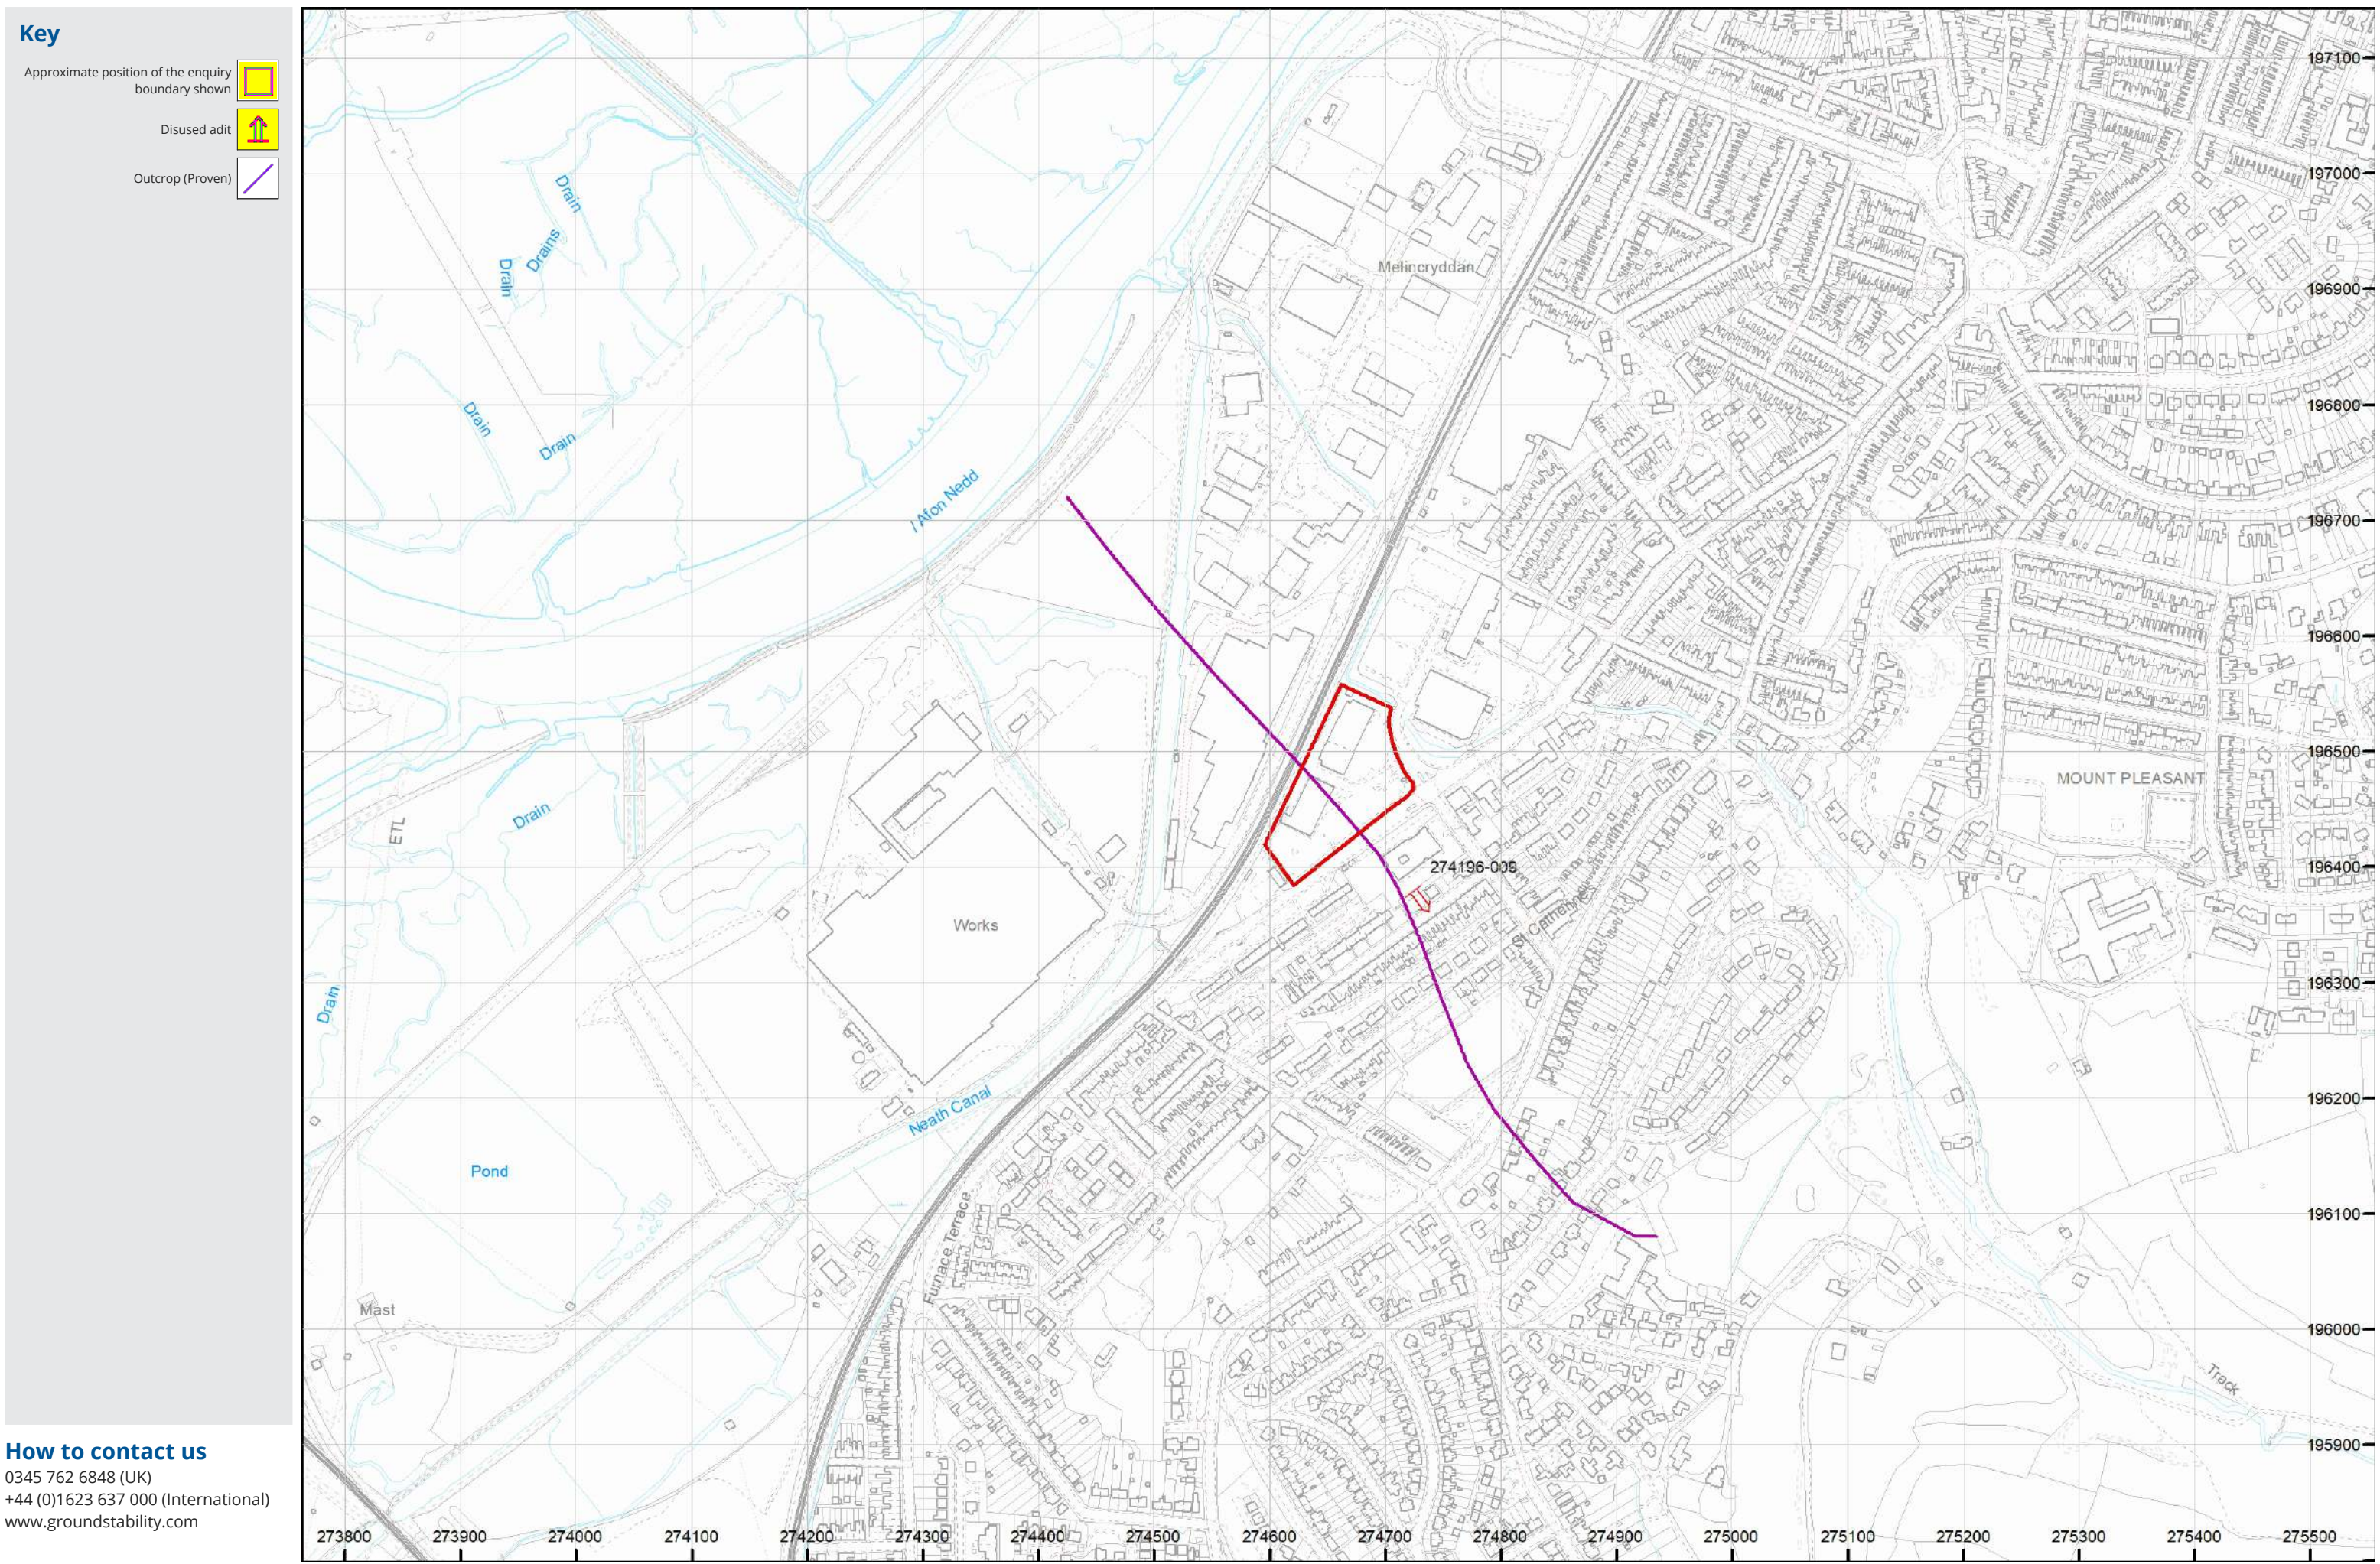
The map highlights any specific surface or subsurface features within or near to the boundary of the site.
