# Remediation Strategy

Client: Lidl Great Britain  
Ltd

Briton Ferry Road, Neath

Report No: 769.09.03

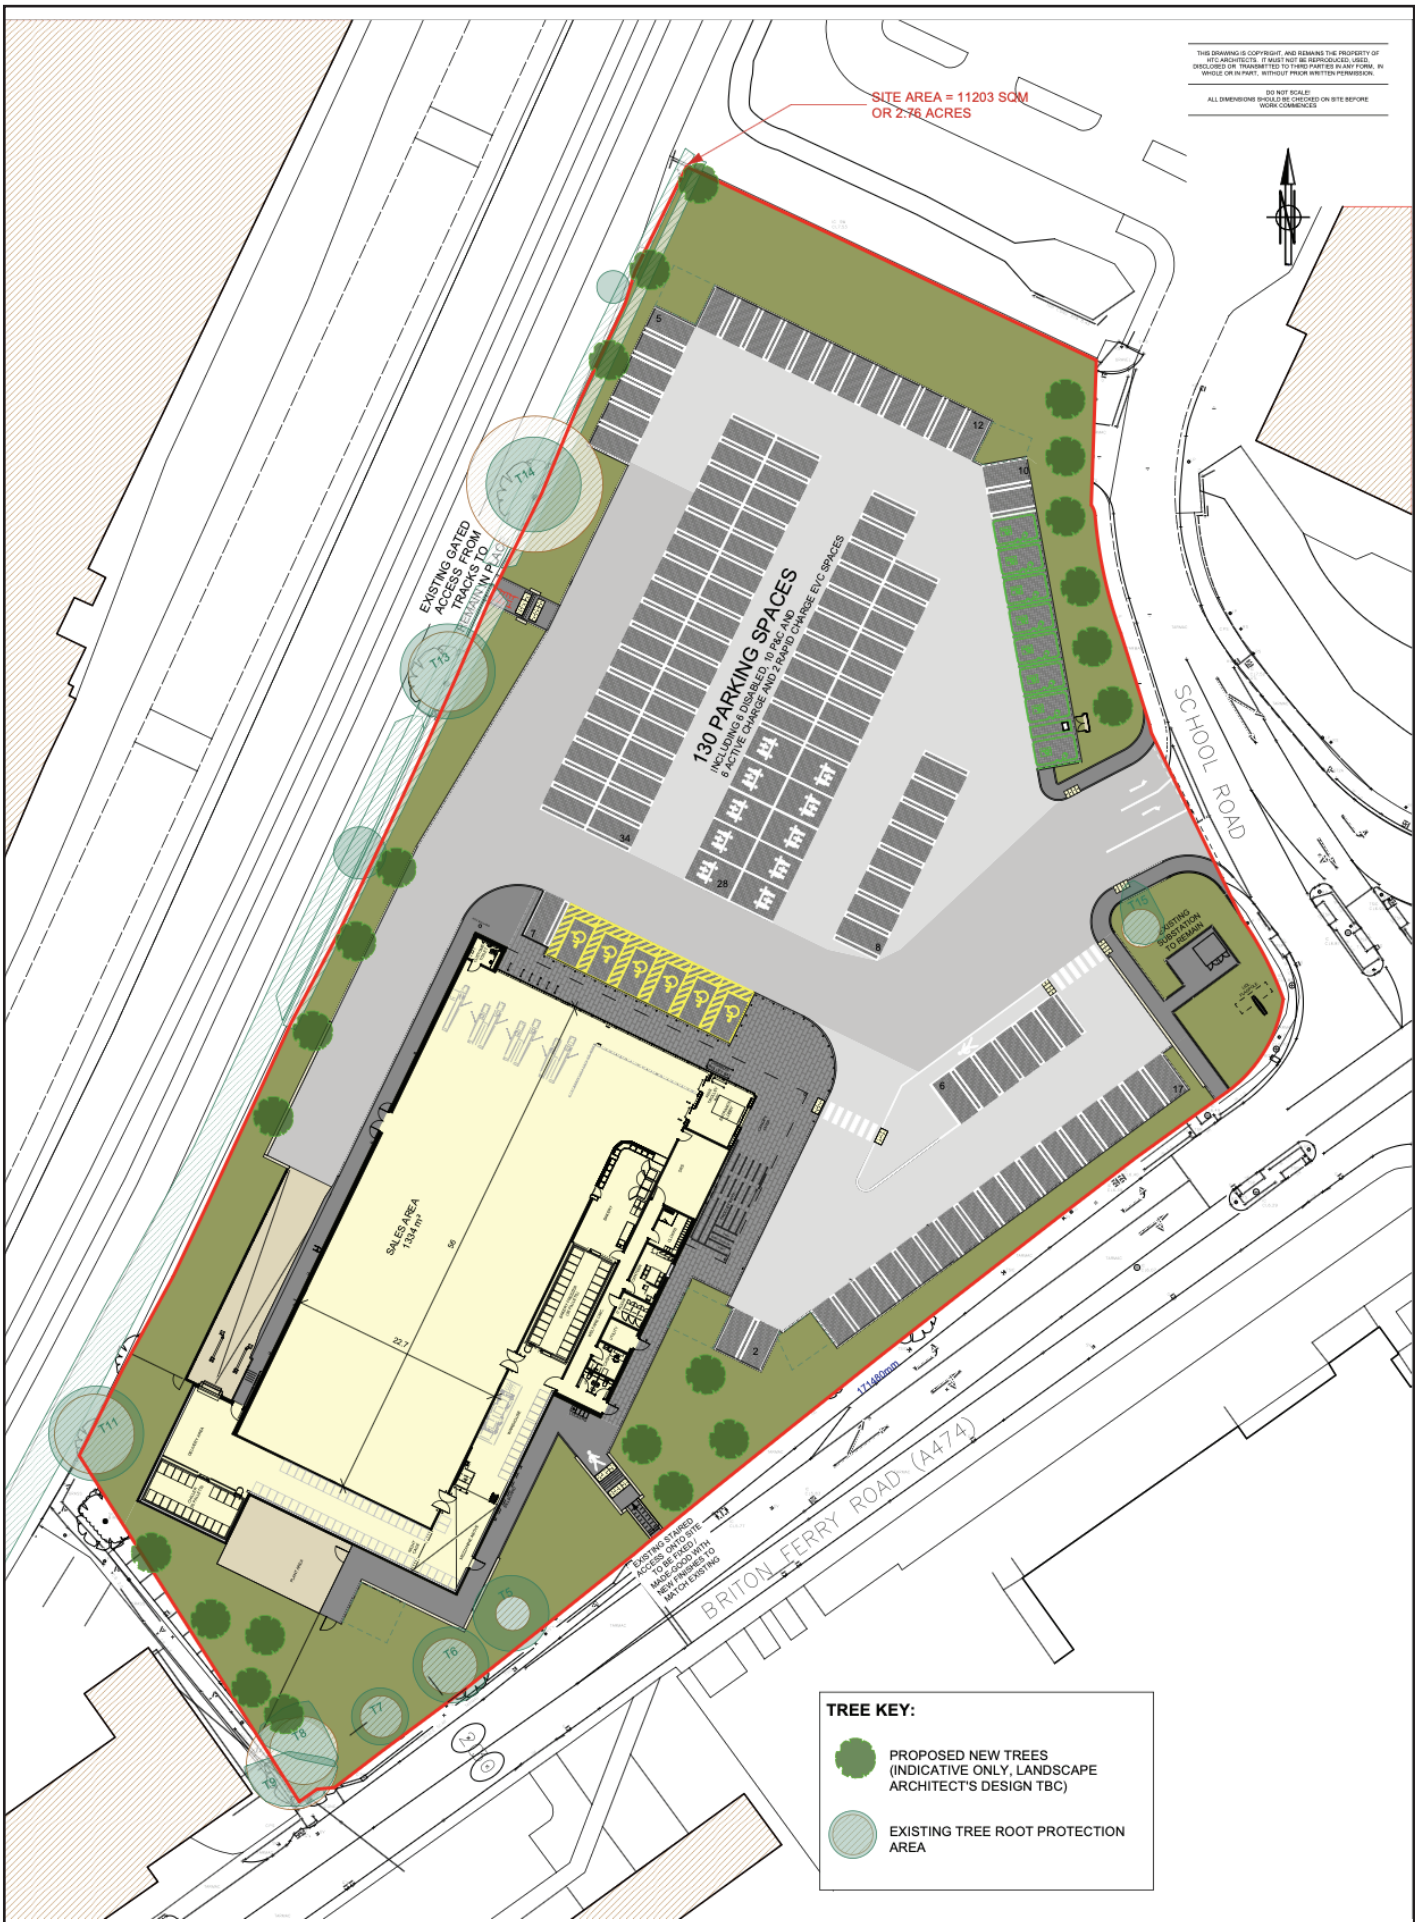
| <b>Notes</b><br><br>Proposed site layout plan reproduced from client-supplied HTC Architects' Proposed Lidl Site Plan, drawing ref: 2782-P4403-Rev H dated October 2024.<br><br>The proposed site layout plan is indicative only and subject to change following publication of Remada's Phase 1 report. | Revision | Approved | Date | Project Title | Scale | Drawn | Size |

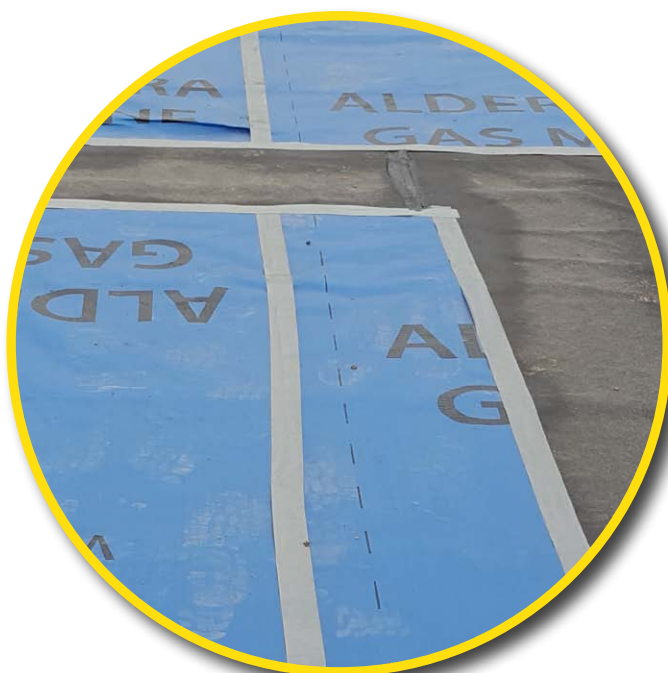
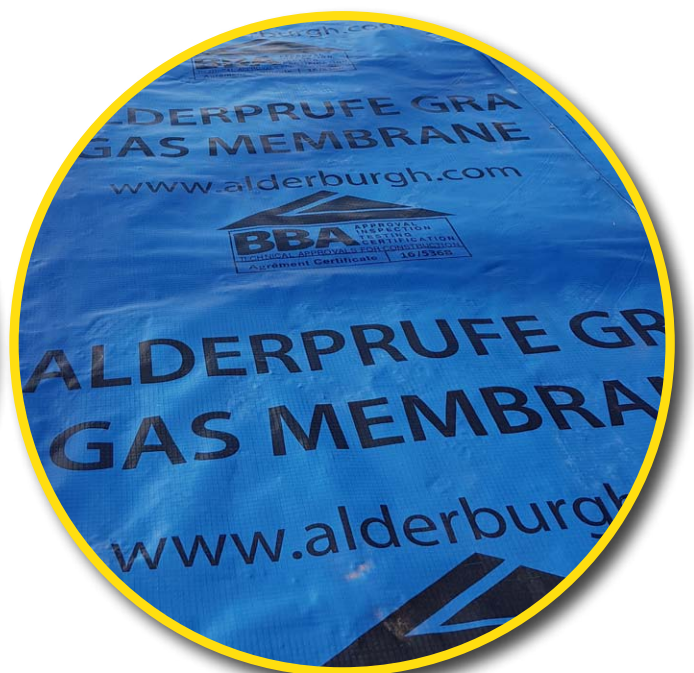
## ALDERPRUFE GRA GAS BARRIER

**Alderprufe GRA** may be installed under all conditions normal to the construction of ground floor slabs.

The membranes remain flexible and do not soften at the extreme temperatures likely to occur in practice. When used in accordance with the manufacturer's instructions there will be no adverse effect on the membranes from underfloor heating under normal conditions of use, **Alderprufe GRA** will provide an effective barrier to the transmission of gases, liquid water and water vapour for the life of the concrete slab in which it is installed.

**Use with:** Aldercourse GRA gas dpc \* Gastite Tape \* Preformed pipe collars, column cloaks, pile collars \* Geotex 300PP or Backerboard HD protection \* Membrane Holdfast \* Alderprufe MR50
