RENEWAL OF FLAT ROOF STRUCTURE  
REBUILD AND RAISE OUTER WALLS

WATKINS WELDING

QUARR ROAD, MELYN, NORTH

AUGUST 2019

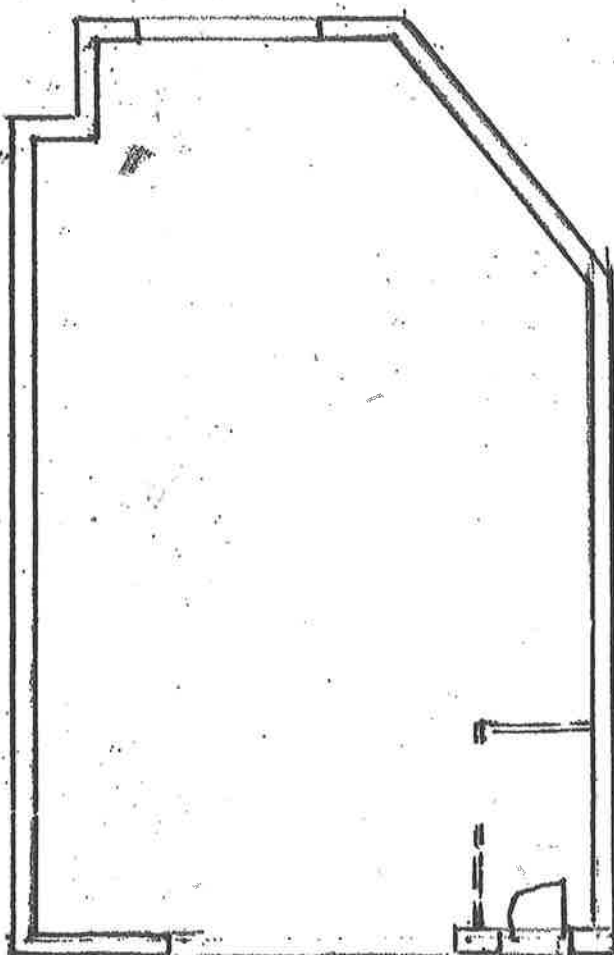
PROPOSED PLAN OF WORKSHOP

NOTE

CAVITY WALL REBUILT

1400 HEIGHT =

400mm RAISED  
1.00m REBUILT

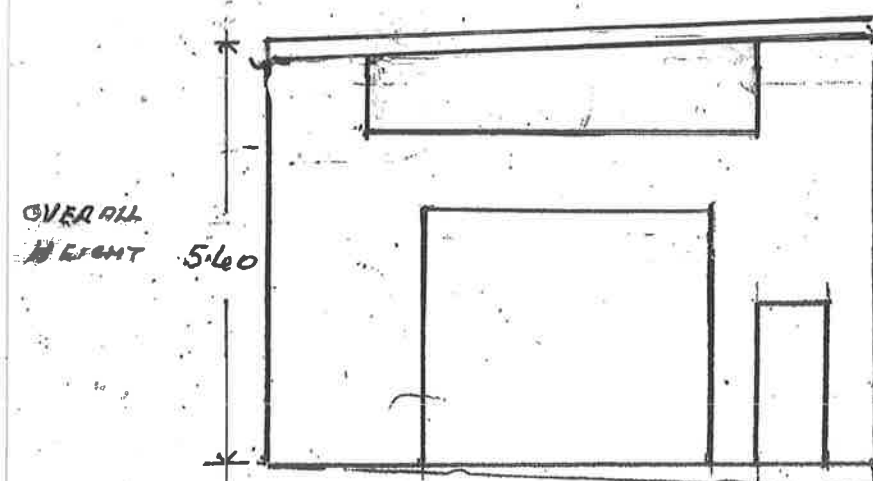
PROPOSED FRONT ELEVATION

PROVIDE LIGHT OPPOSED GLASS OR SHEET  
GIVE NATURAL LIGHT INTERNALLY

OVERALL  
HEIGHT 5.40

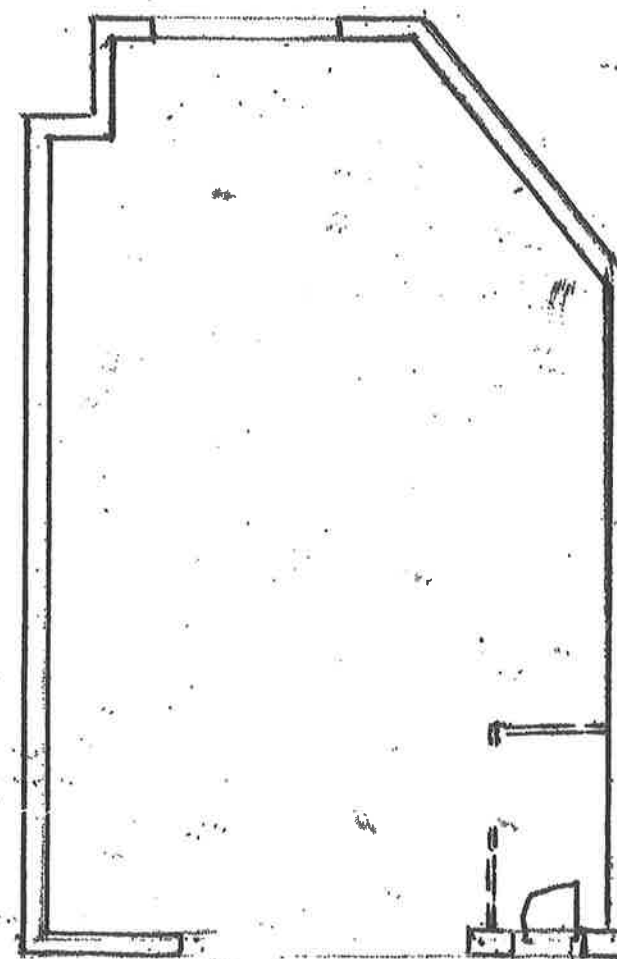
EXISTING PLAN OF WORKSHOP

NOTE

TOP 1.00 OF

ALL CAVITY WALLS

FOUND TO BE UNSTABLE

HAVE BEEN REMOVED

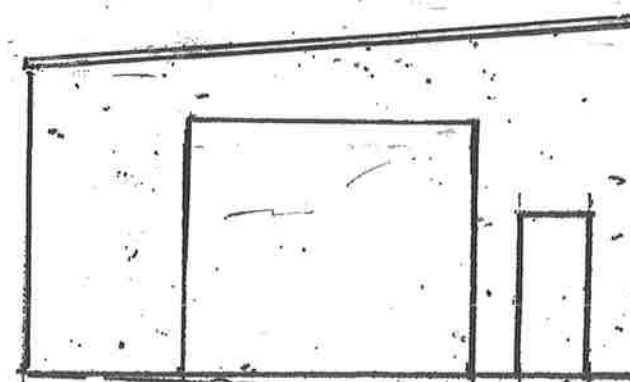
EXISTING FRONT ELEVATION  
BEFORE DEMOLITION

OVERALL  
HEIGHT 4.90

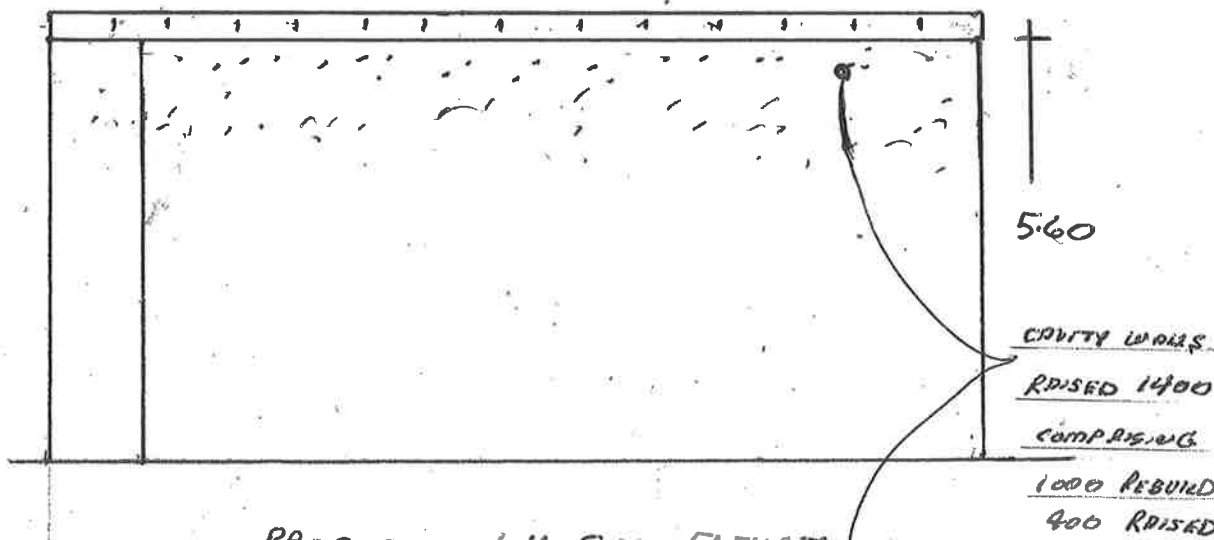
PROPOSED L.H. SIDE ELEVATION

MATCHING EXTERNAL  
RENDER TO  
REBUILD/RAISED  
WORKS
