Project name: Sandvik Osprey

Report title: Ground Investigation Report

**ALUMINIUM SIZING FACILITY, RED JACKET WORKS,  
MILLAND ROAD, NEATH SA11 1NJ**

**REPORT ON GROUND INVESTIGATION**

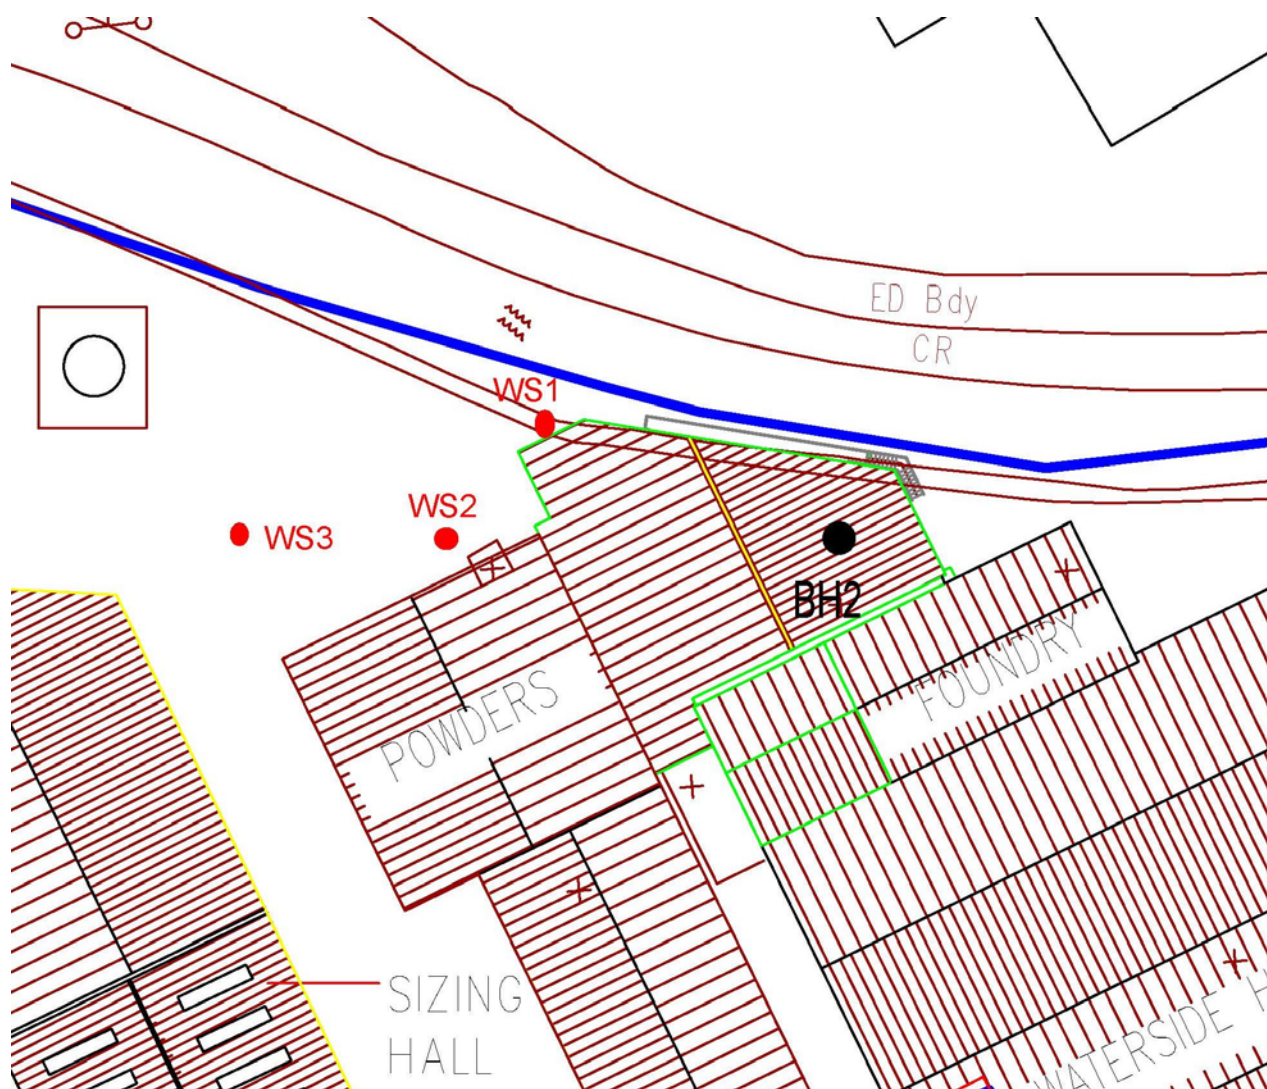
**Figure  
A1.1**

**Site Plan**

- 4.2 Three boreholes, designated WS1 to WS3, were undertaken by tracked windowless sampler technique at the positions shown on the site plan, Appendix 1, Figure A1.1. The depths of boreholes, descriptions of strata encountered and comments on groundwater conditions are given in the borehole records, Appendix 2, Figures A2.1 to A2.3.

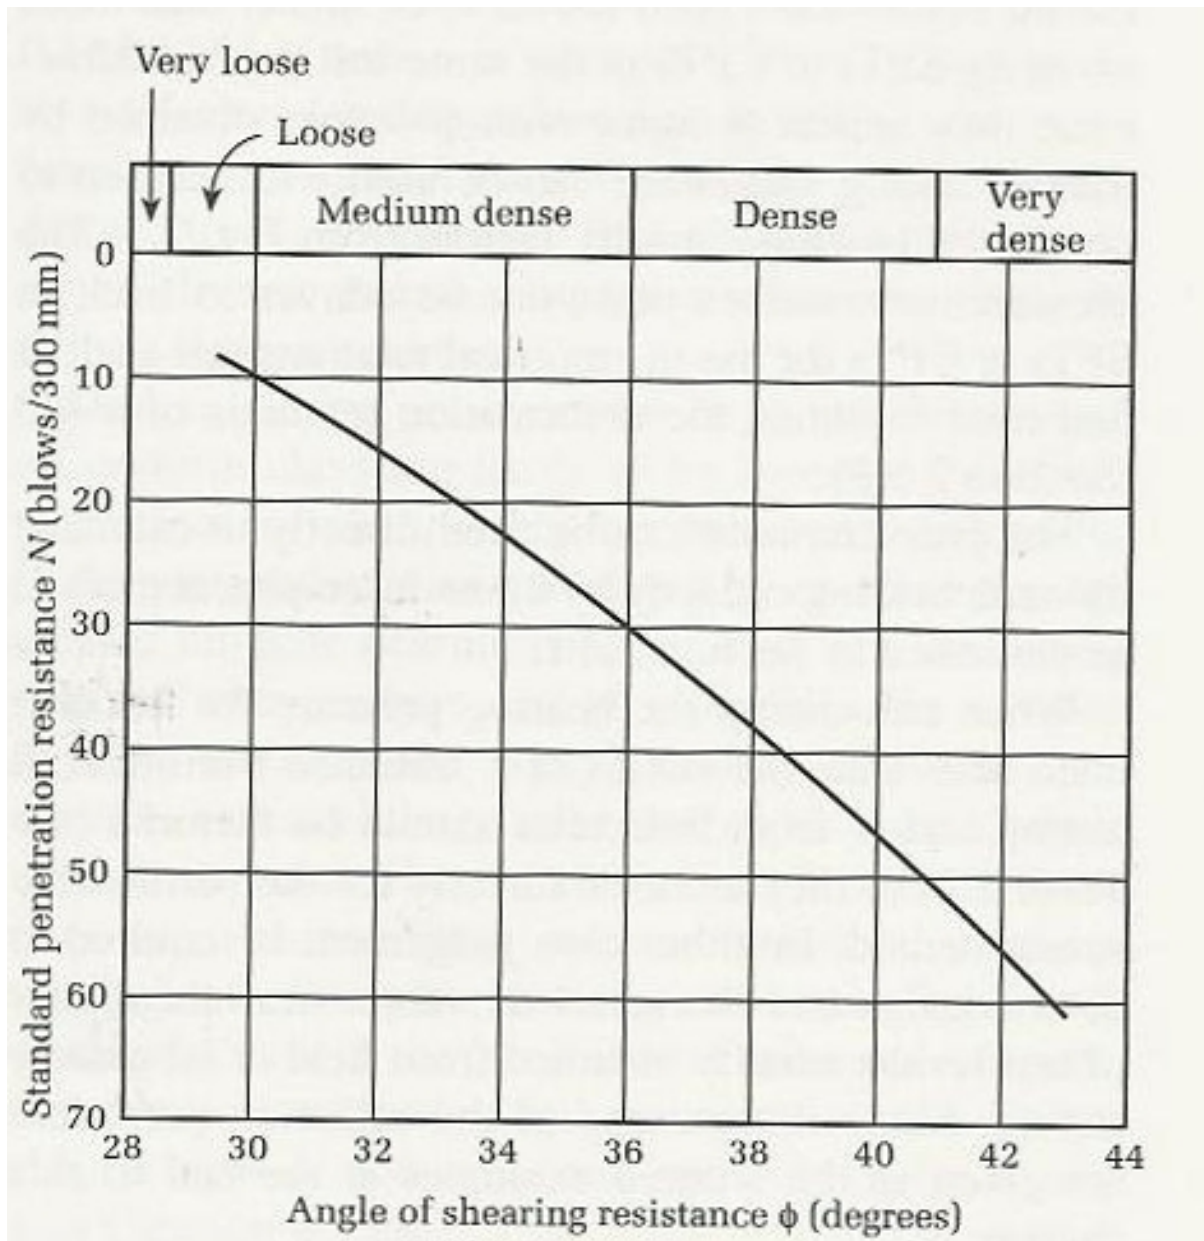
**Figure  
A5.1**

**Angle of Shearing Resistance**

- 7.3.3 It is recommended that consideration be given to the adoption of piled foundations. Guidelines for the design of piles are given in Appendix 5, which may be used with the Standard Penetration Test N values in the borehole records. It is likely that the piles will end bear onto the sand and gravel which was encountered at between 2.80m and 3.20m below ground level.

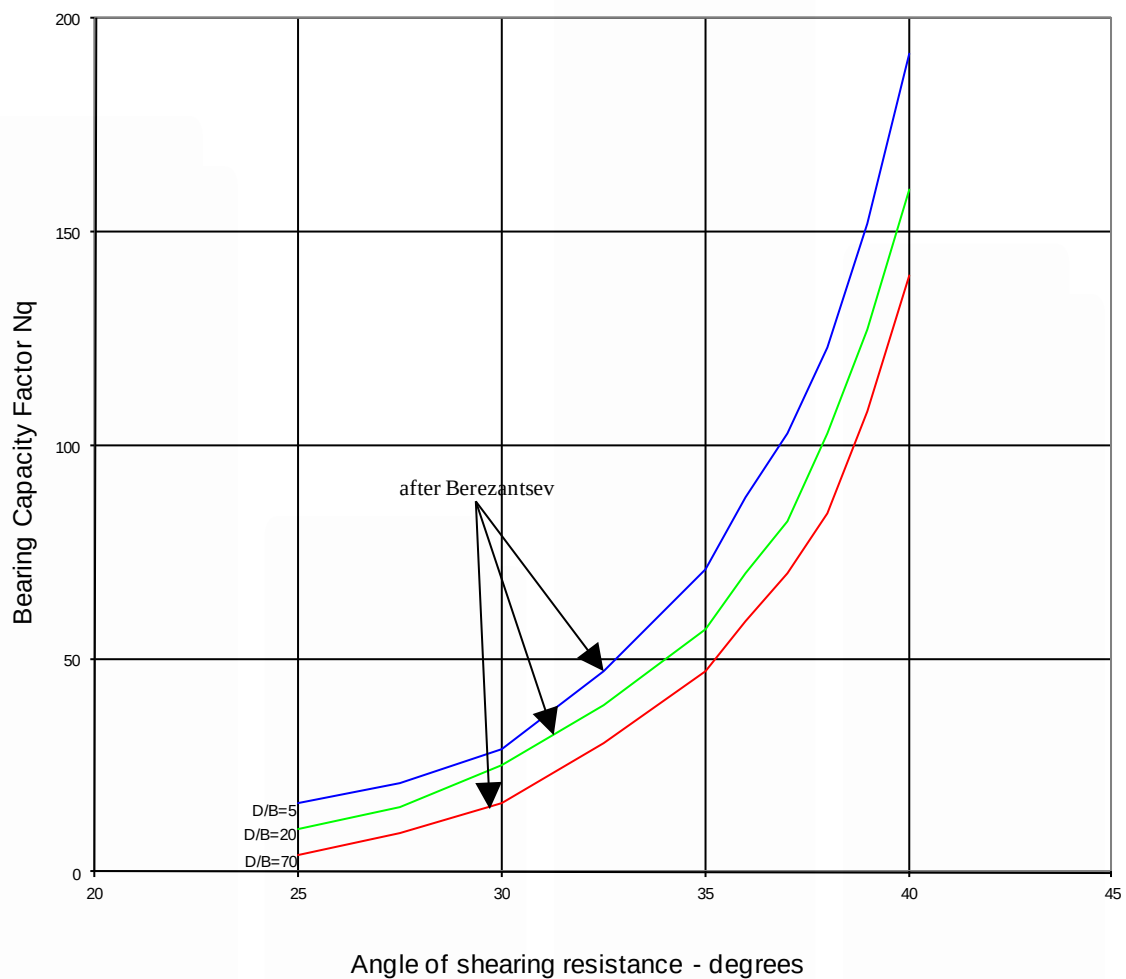
D = Penetration of bearing stratum  
B = Pile diameter or least width

**Bearing Capacity Factor**
