# 24 ORMES ROAD, SKEWEN, NEATH

## Ground Investigation Report

Report No. Q0177/GIR

February 2020

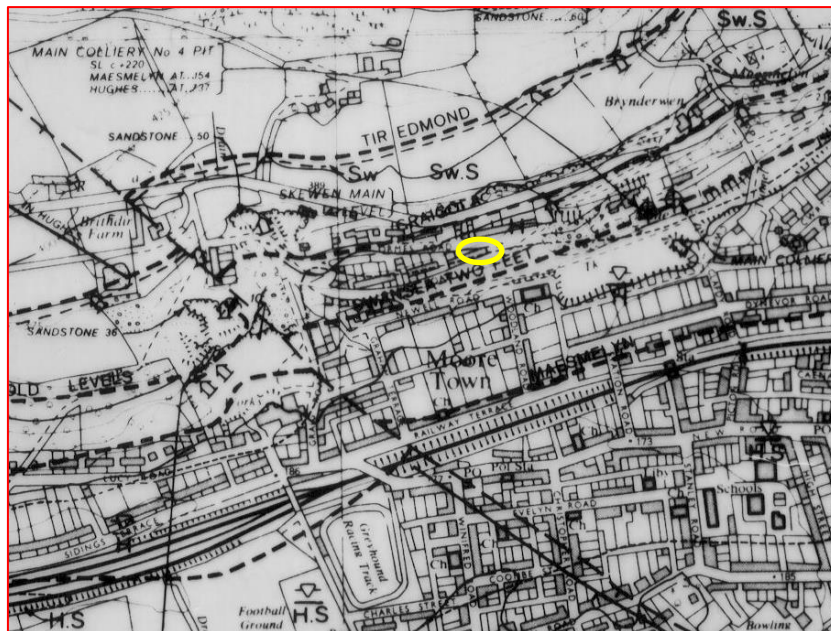
Figure 2: BGS SS79NW Extract (Not to Scale) British Geological Survey © NERC

This edition map indicates the site to have no superficial/soil cover, although Glacial Till (boulder clay) is mapped close to the south of the site boundary. The underlying solid strata is shown to be from the Hughes Beds of the Upper Coal Measures. The conjectural outcrop of the Swansea Two Feet coal seam is shown approximately 30m south of the site. The strata are shown dipping in a generally northern direction at angles of around 10°.

The current British Geological Survey on-line mapping resource 'Geology of Britain viewer' <http://mapapps.bgs.ac.uk/geologyofbritain/home.html> shows a similar setting to the large scale map, with the Hughes Beds being described as mudstones, siltstones and sandstones.

The map also details historical mining features with two adits to the east of the site; the closest being some 150m distant.

The geological map extract presented in Section 2.2 does not detail any areas of made ground or landslip.

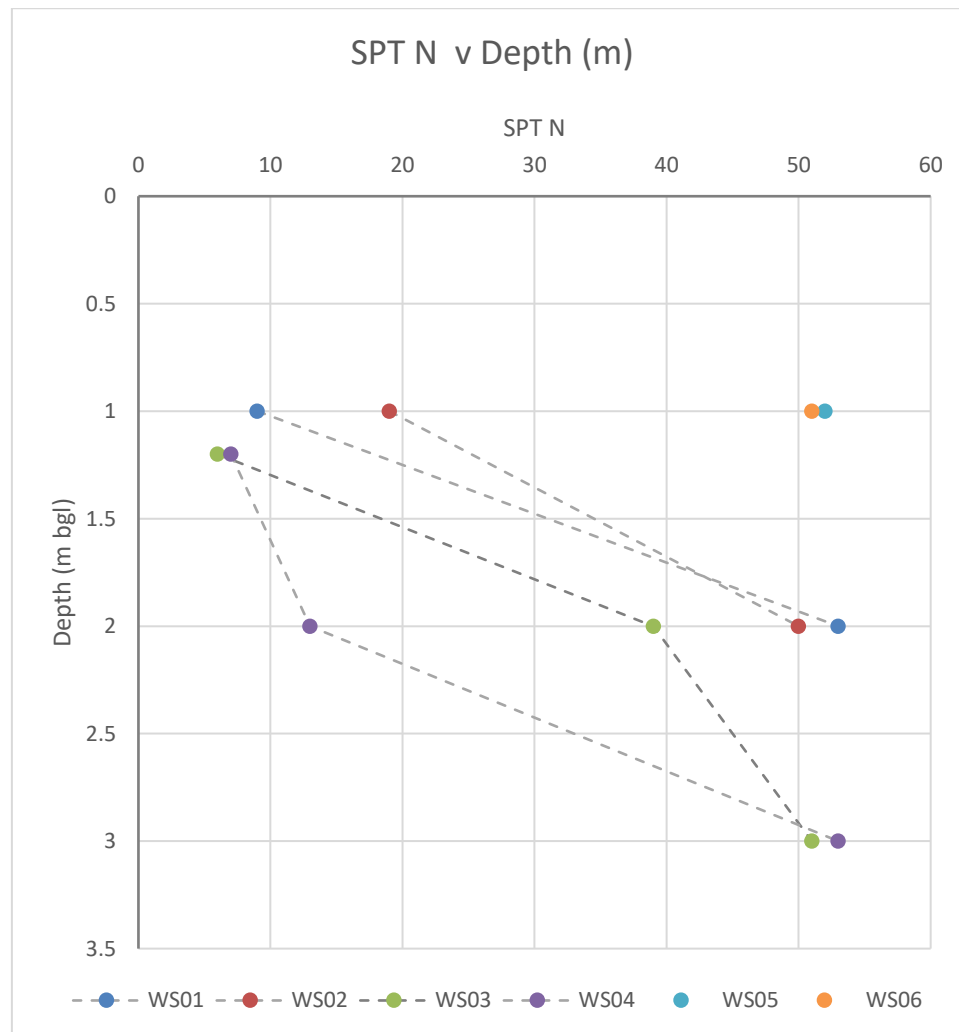
The consistency and relative density of the soil profile was measured by undertaking Standard Penetration Tests in the window sample boreholes. A summary of the results is presented graphically below.

From these results, the overall average SPT N is 33, with a 25<sup>th</sup> percentile value of 12. Taking the mean value of all tests in natural soils where full penetration was achieved; the average N value is 36. Adopting the 25<sup>th</sup> percentile value as indicative of a characteristic value, the  $N_{char}$  is 17.

On the basis of the SPT testing undertaken, given the presence of relatively shallow groundwater, we would recommend an allowable bearing capacity of 85kN/m<sup>2</sup> at a depth below 0.5m in this stratum.

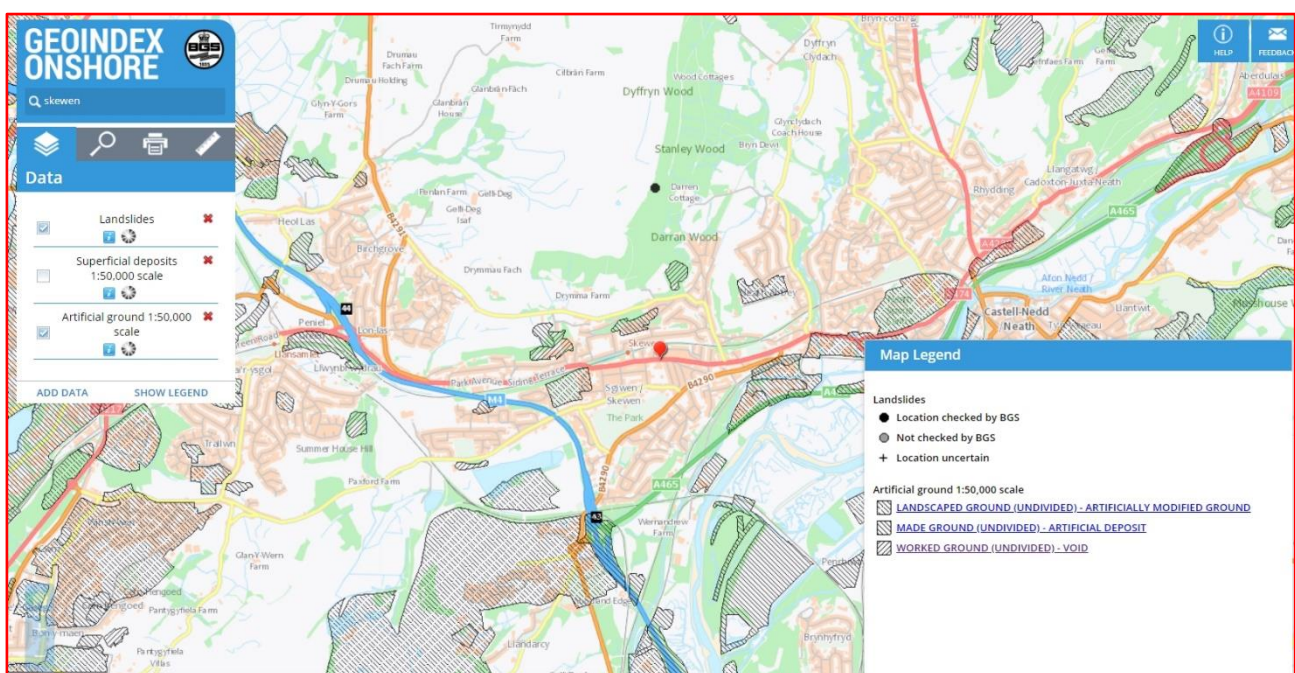
Figure 3: BGS GeoIndex Extract (British Geological Survey © NERC)

The BGS *GeoIndex* on-line resource shows recorded landslides along with areas of *made ground*, *landscaped ground* and *worked ground*. An extract from this is presented below for the Skewen area.

The only recorded landslip is to the north of the site. An area of *Made Ground* is mapped to the east of the site, interpreted to be associated with former coal mining activity.

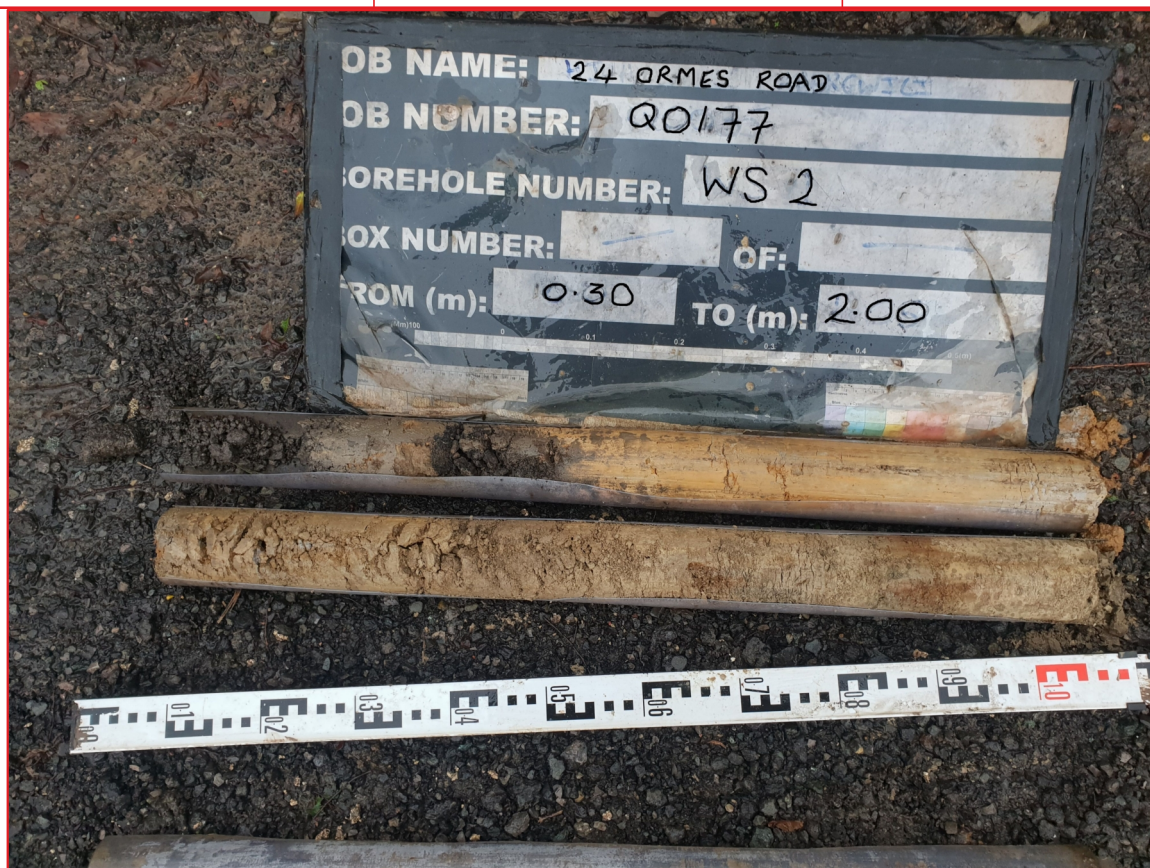
| <b>Contract : 24 Ormes Road, Skewen</b><br><b>Client : Jill Howells</b> | | | | | | | | | | | <b>Dynamic Probe</b><br><b>WS02</b> | |

| Dates : 14/1/20 - 14/1/20<br>Location : Above Gabion baskets | | | | | Job Number : Q0177<br>Engineer : | | | | | Ground Level :<br>Coordinates: | | |

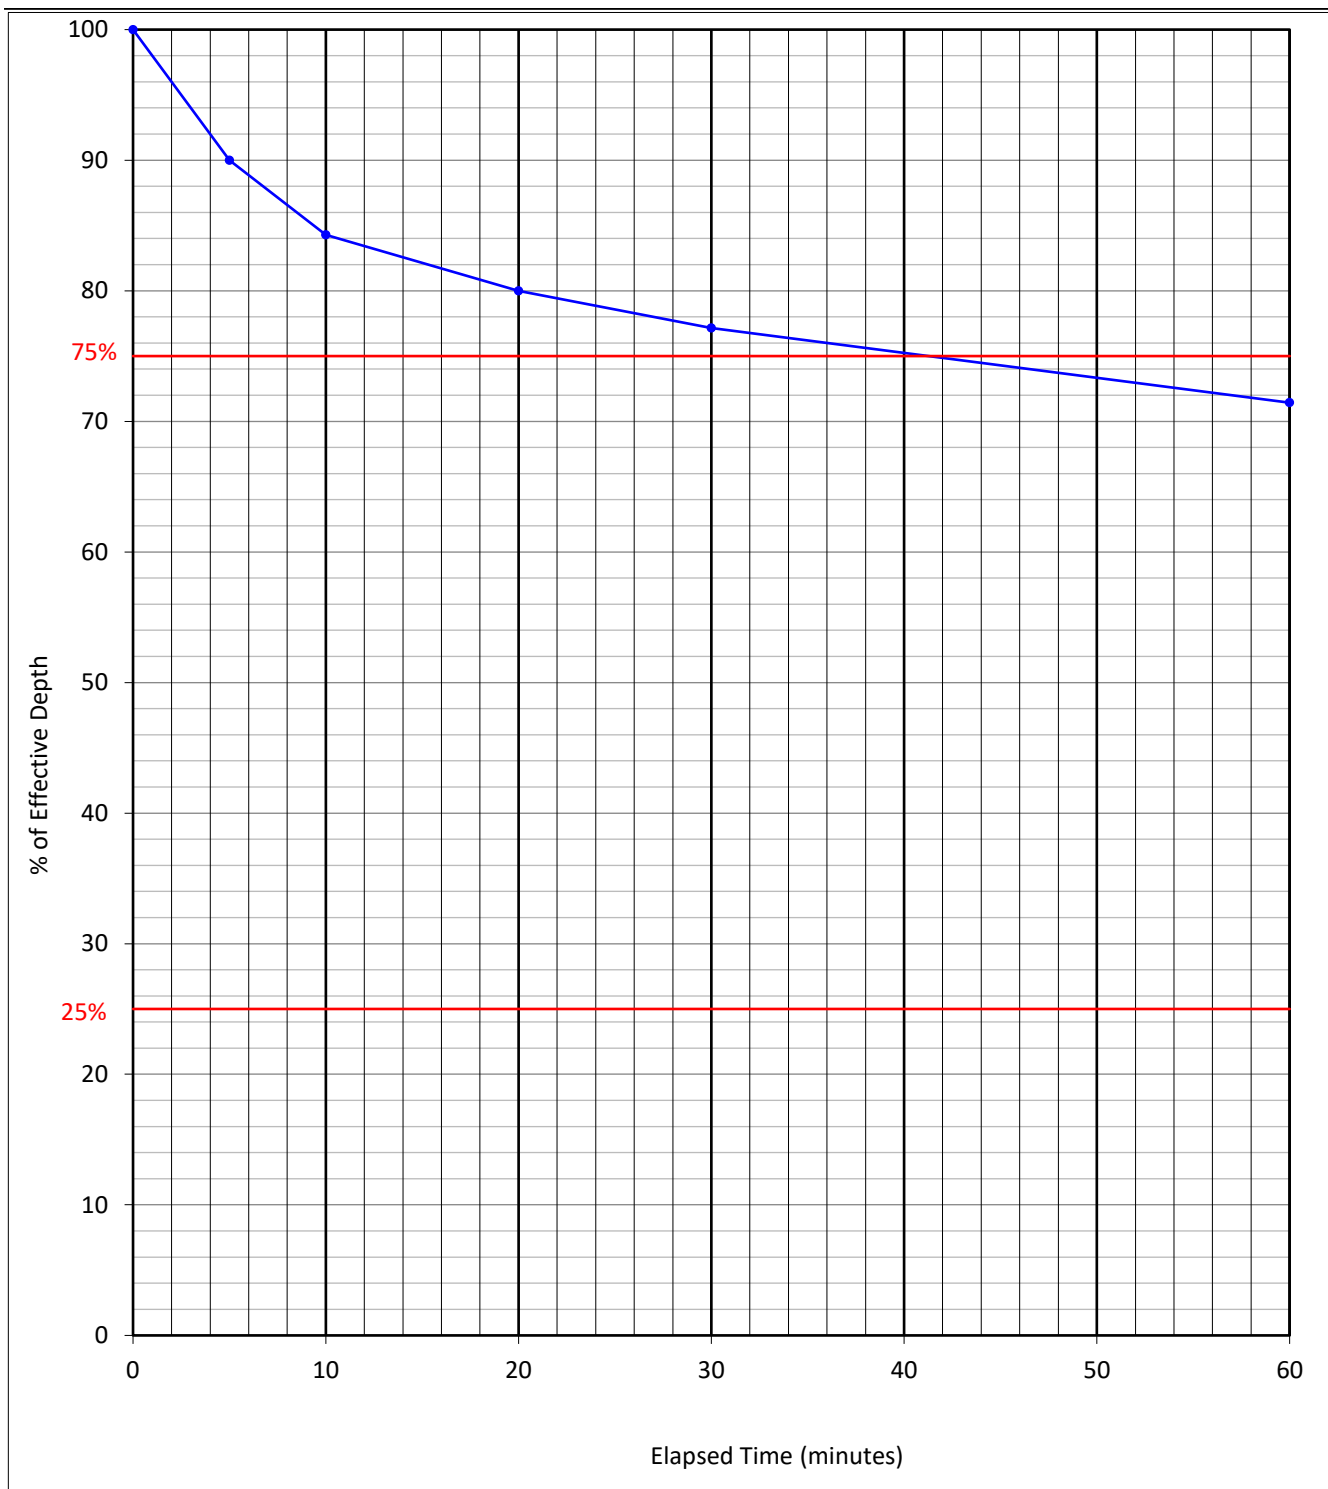
Test Location : WS6  
Test No : 1  
Date : 15/01/2020

Soil Infiltration rate,  $f$  = m/sec  
Unable to determine

The tests did not result in a sufficient drop in water level to allow calculation of the infiltration rate by conventional methods. The infiltration rate was therefore calculated using the procedure within BS5930 for borehole permeability testing by the general approach. The permeability infiltration rates calculated were:

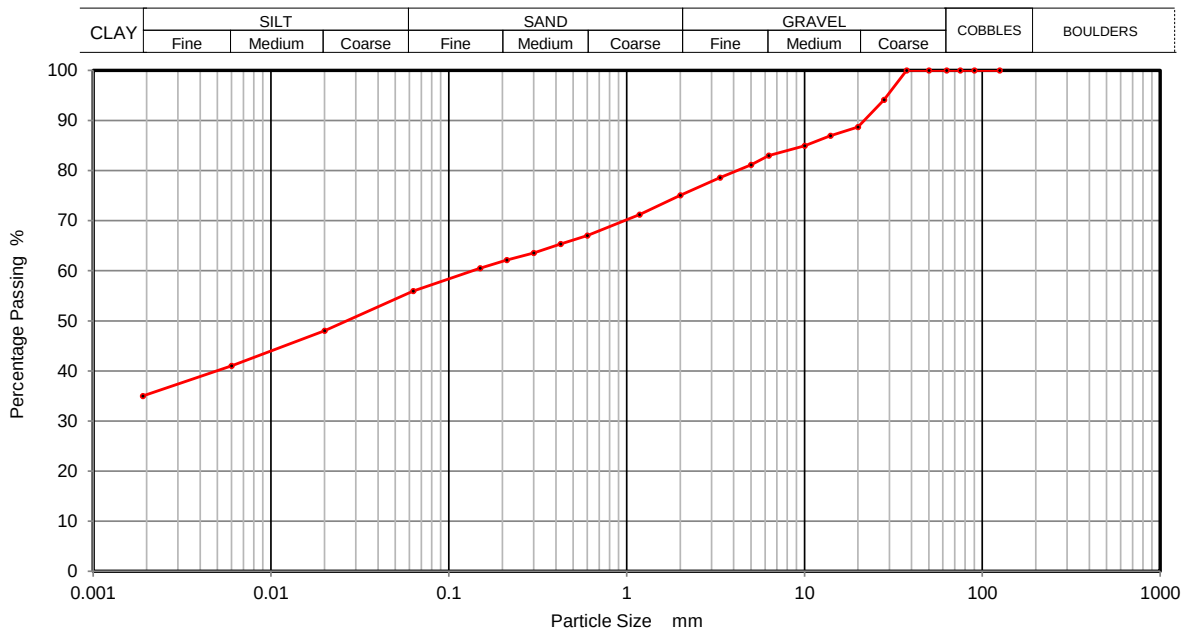
| Soil Description | <b>Brown fine to coarse sandy silty fine to coarse gravelly CLAY</b> |

The results of the Particle Size Distribution curves (PSD) analysis undertaken confirm the range in soil types present.

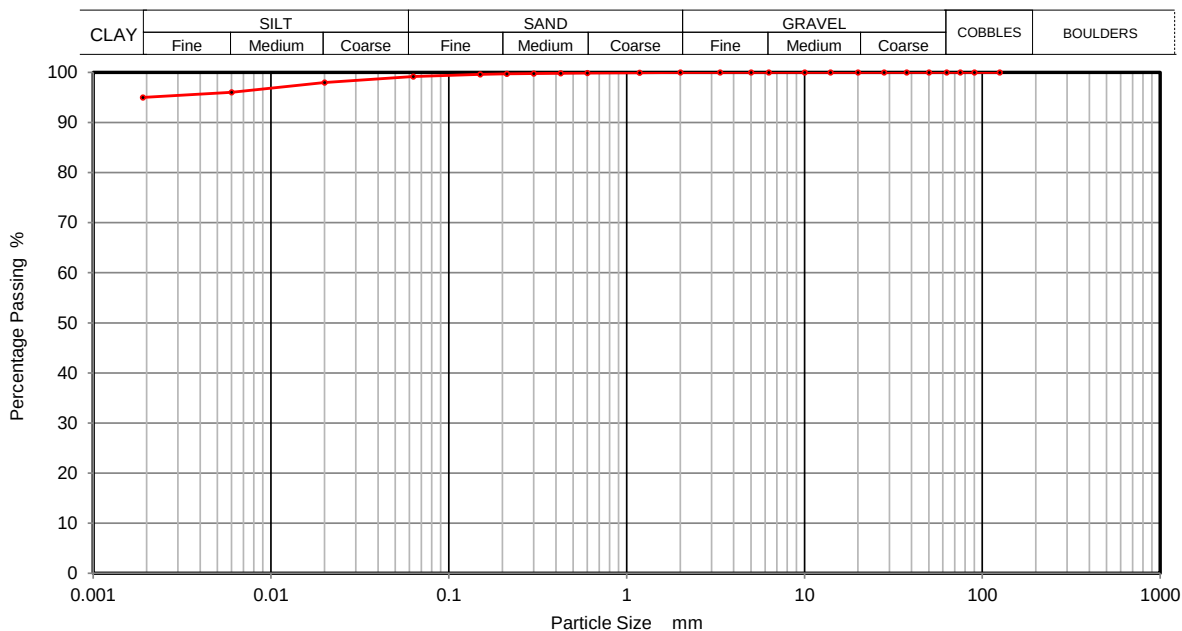
| Soil Description | Brownish grey slightly sandy slightly silty CLAY |

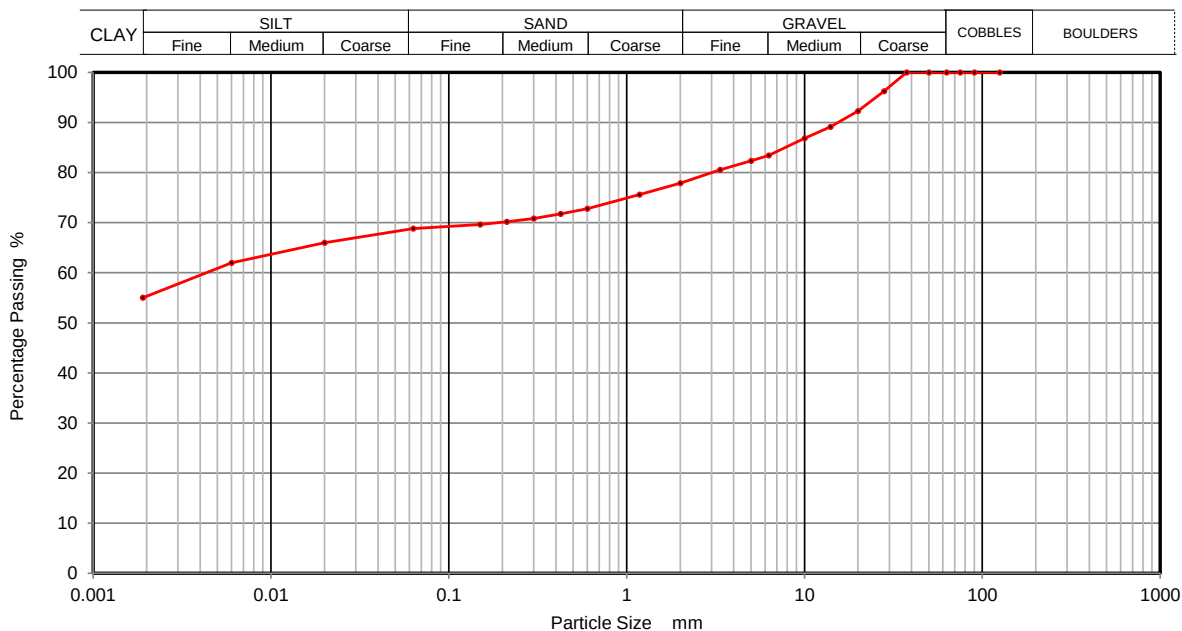
| Soil Description | Grey slightly fine to coarse sandy silty fine to coarse gravelly CLAY |

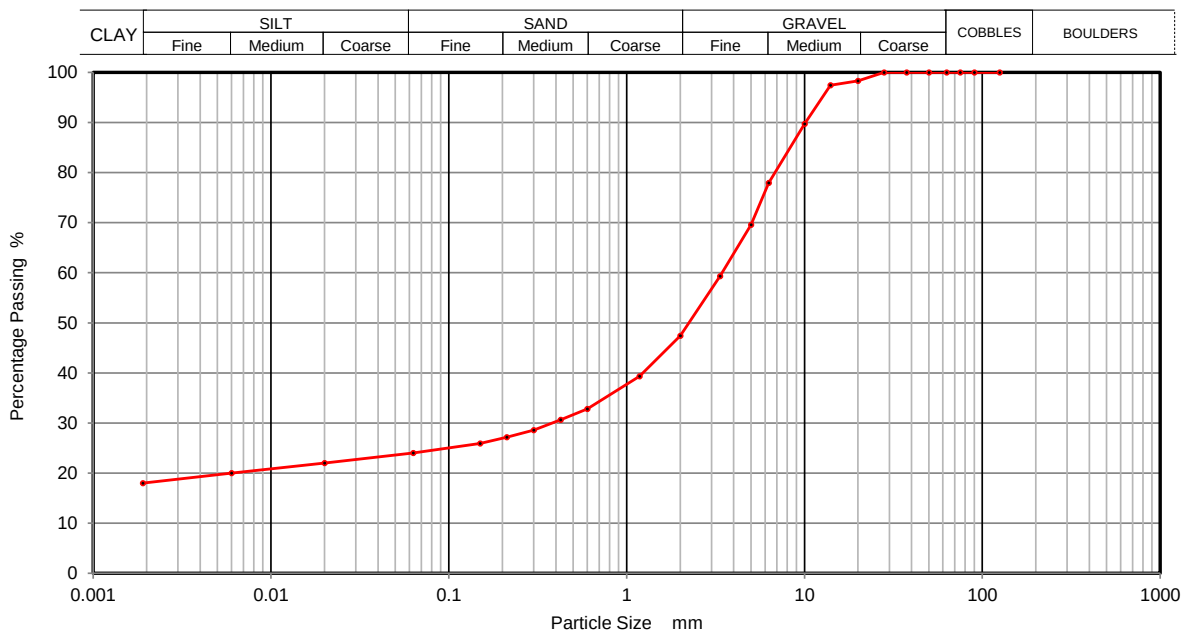
| Soil Description | Grey slightly silty clayey fine to coarse sandy fine to coarse GRAVEL |
