NEATH

9 THE PARADE  
NEATH  
WEST GLAMORGAN, SA11 1RE  
PIM No.

GROUND FLOOR LAYOUT  
AS PROPOSED  
ASSET REPLACEMENT 2019

| Drg.No BY105186_212 | | Date 29/07/2019 |

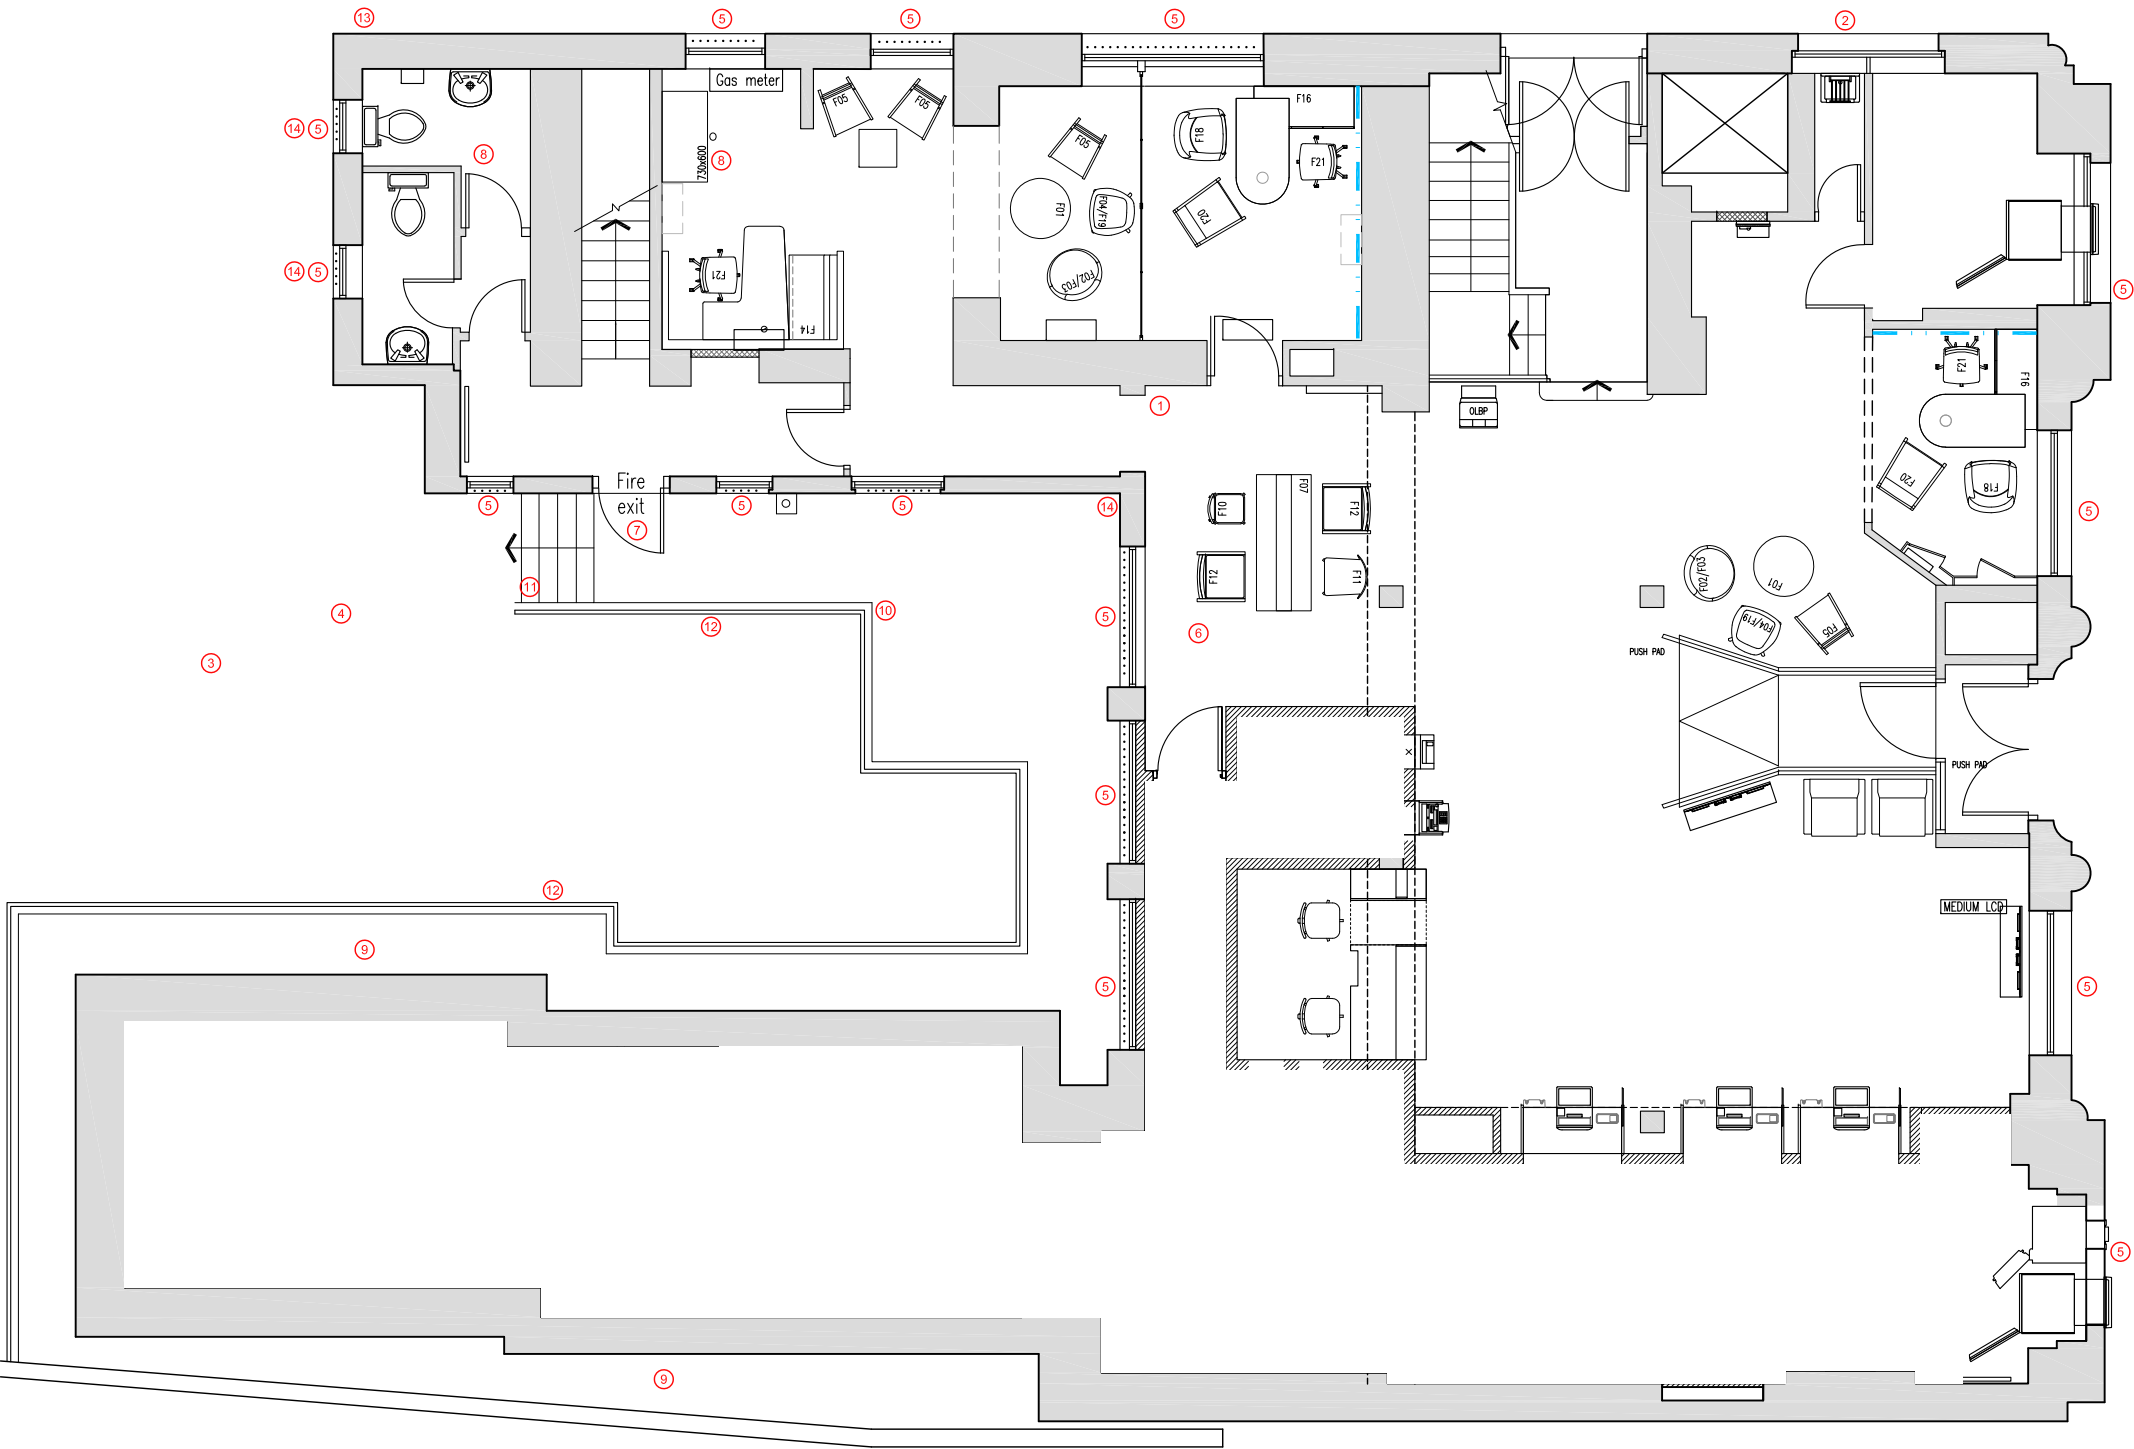
Replace water damaged ceiling tiles, make good water damaged walls, skirting & flooring & replace for new inc decorations

Replace window sill, prepare & decorate window – carryout remedial works to stone
- 3
- De-veg area

Install New FE Walkway across soil area

Make good, prepare & decorate all windows(externally) – inc security bars to rear

Remove debris from side gulley alongside Strong Room & clear area

Address coping stones to retaining wall – remove & re-bed(retain edge rail protection on same line)
