## Land at Princess Way, PORT TALBOT, SA12 6QW

**Report Reference:** SAS\_58455219\_1\_1

**Report Date:** 17-JUL-2014

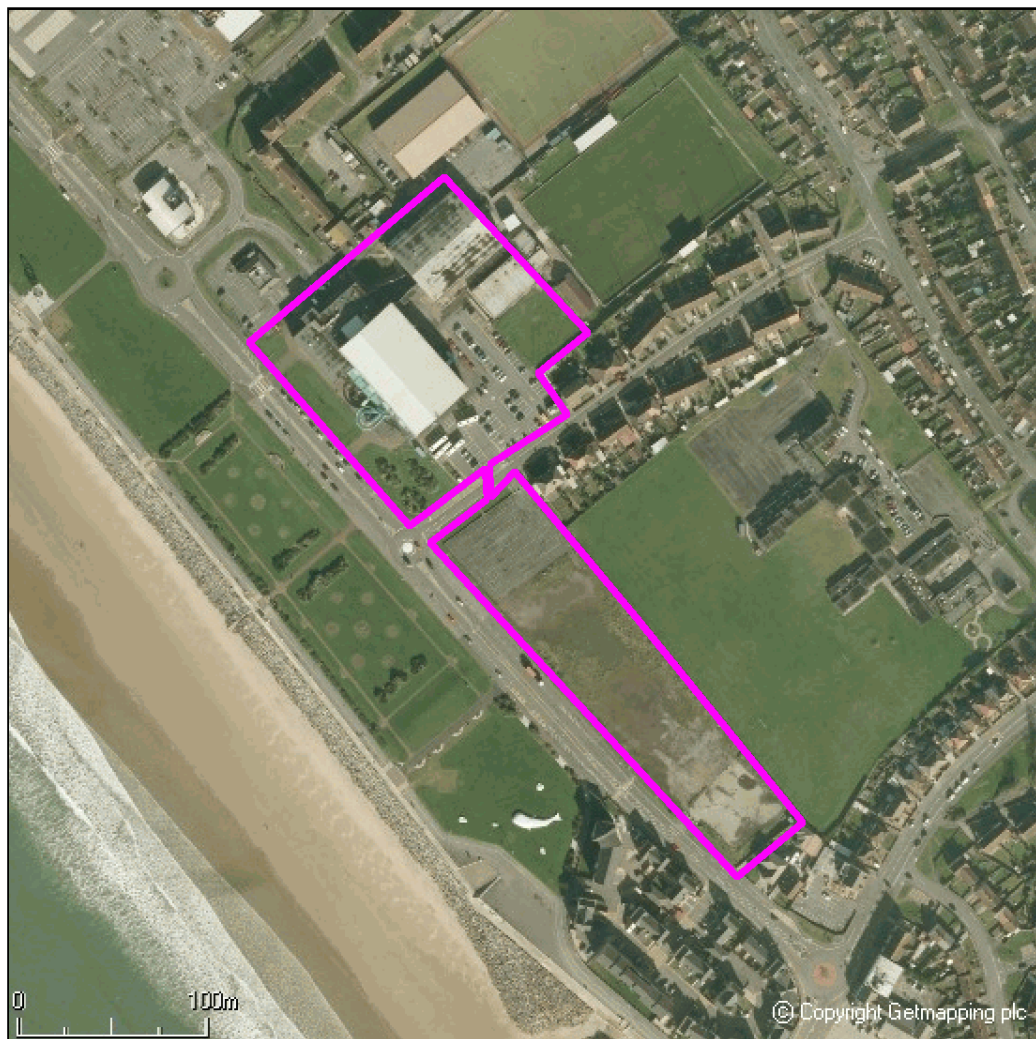
| Report Sections and Details | Page |
|---|---|
| <b>Aerial Photo</b> | 1 |
| The aerial photo gives an overall view of the area. The smaller large-scale Ordnance Survey map includes the site boundary and search zone buffer at 500m. | |

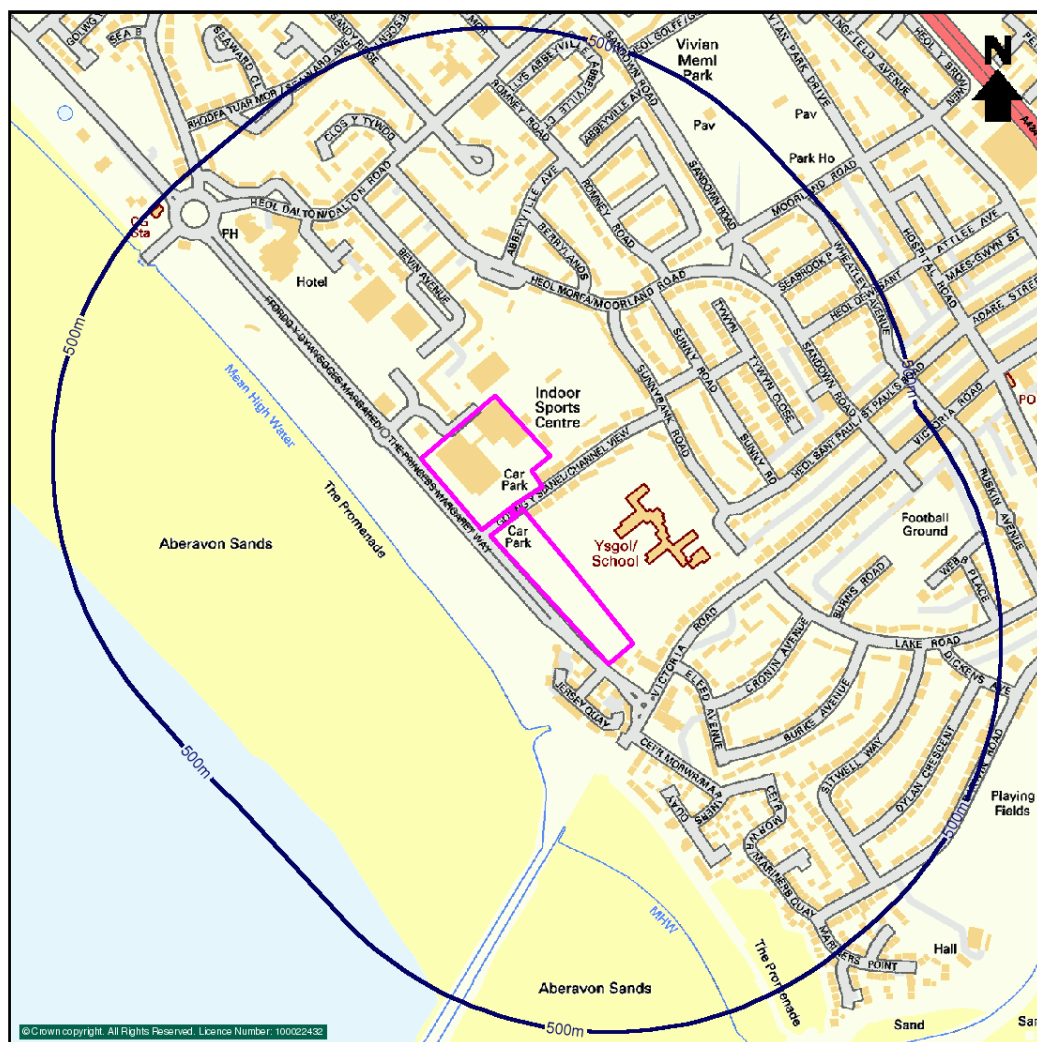
| Report Sections and Details | Page |
|---|---|
| <b>Location Map</b> | 2 |
| The large-scale Ordnance Survey map includes the site boundary and search zone buffer at 500m. The smaller aerial photo also includes the site boundary. | |
