Project  
**MARGAM ORANGERY SCREEN REPLACEMENT 2020**

Drawing Title  
**EXISTING & PROPOSED PLANS**

| Drawing No. | A1197-01 | | | | Rev. A |

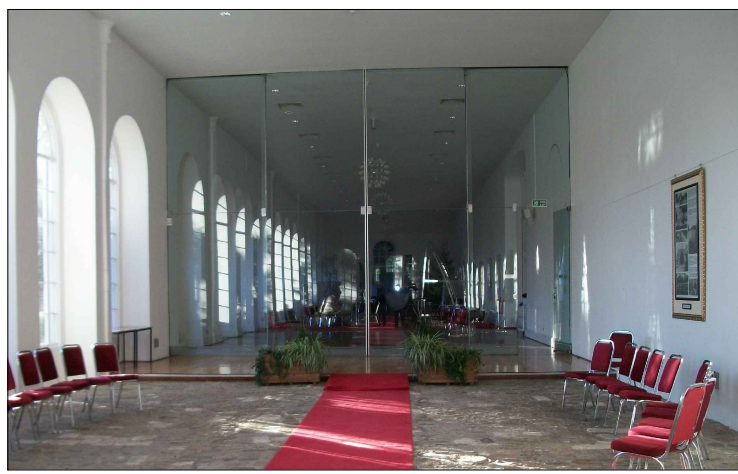
ORIGINAL GRASS SCREEN - PHOTO 1

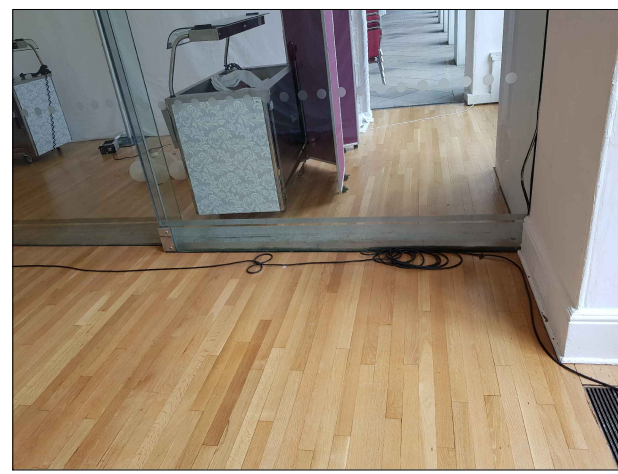
ORIGINAL GRASS SCREEN - PHOTO 2

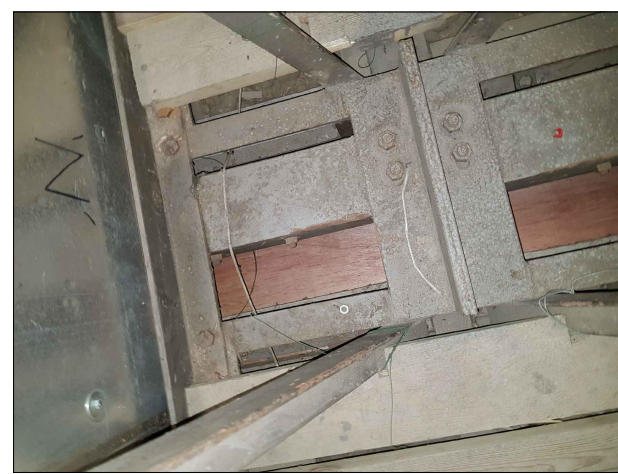
VIEW IN ATTIC LOOKING AT CEILING SUPPORT FOR GLASS SCREEN - PHOTO 1

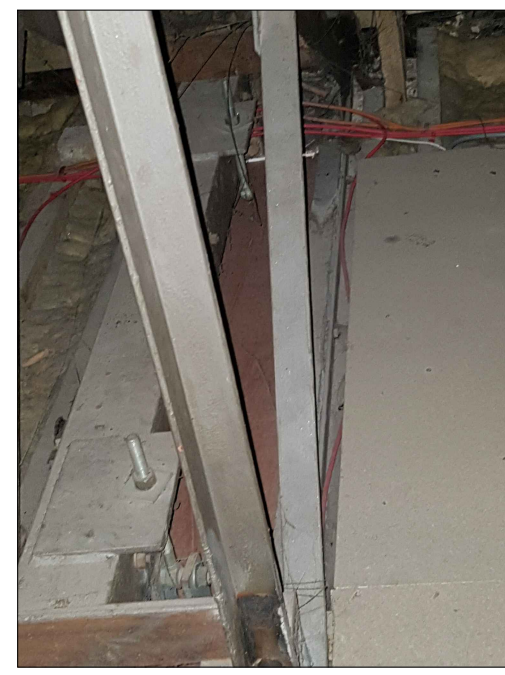
VIEW IN ATTIC LOOKING AT CEILING SUPPORT FOR GLASS SCREEN - PHOTO 2

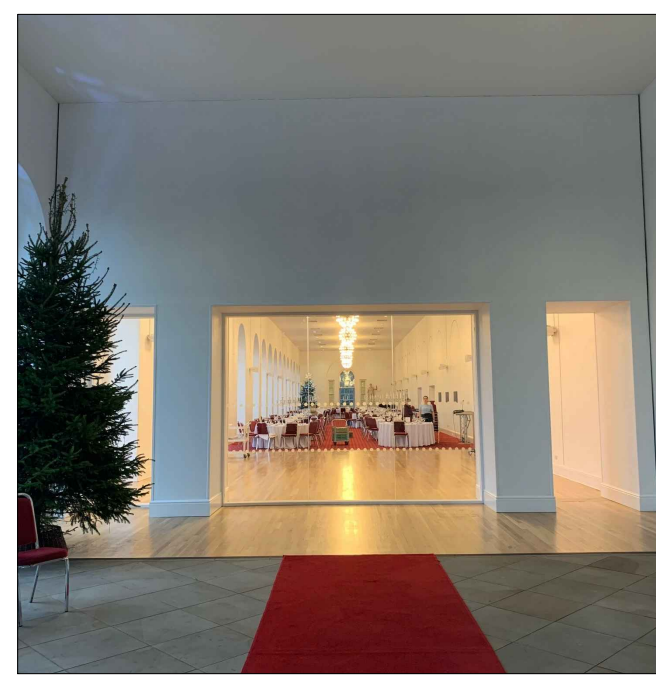
EXISTING TEMPORARY SCREEN - PHOTO 1

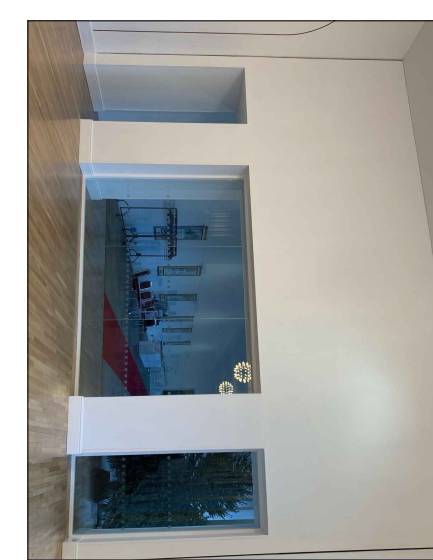
EXISTING TEMPORARY SCREEN - PHOTO 2
