RIVER NEATH SWING  
BRIDGE GRIP 4

TOP OF  
DECK DEFECTS

Drawing Number  
152093-ARC-DRG-ECV-000004

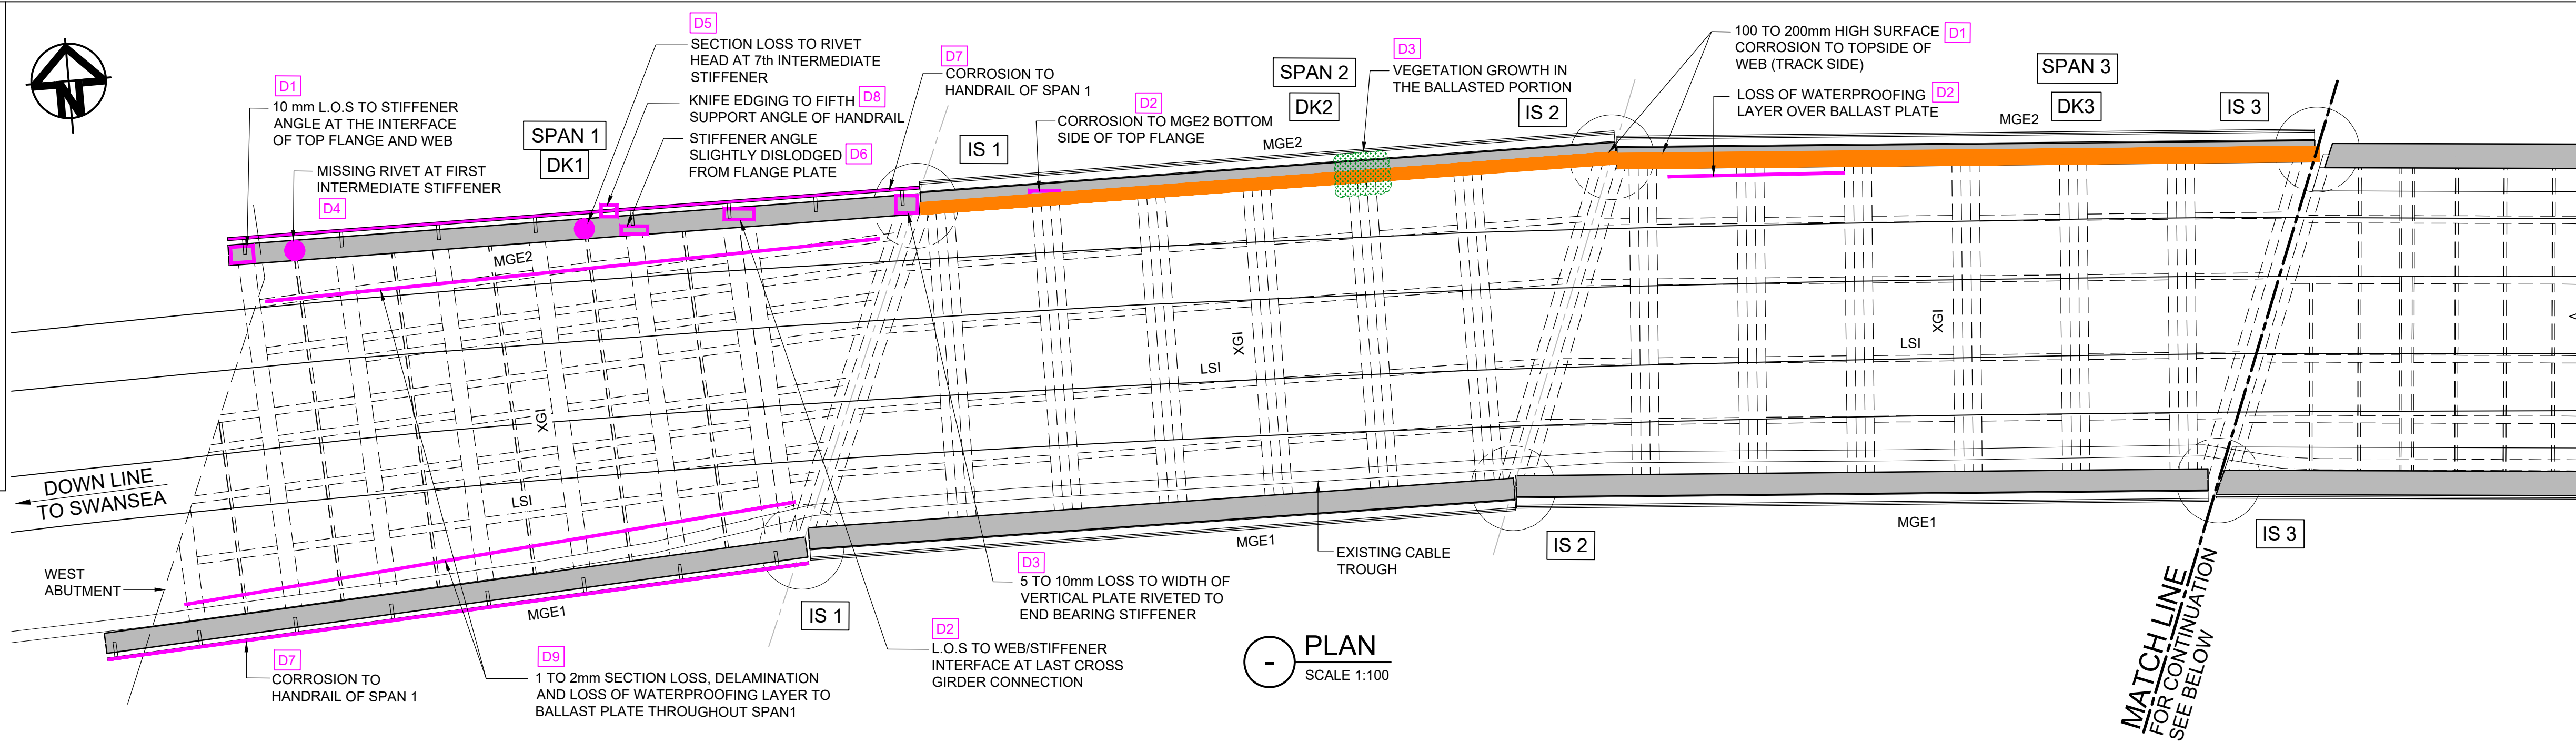
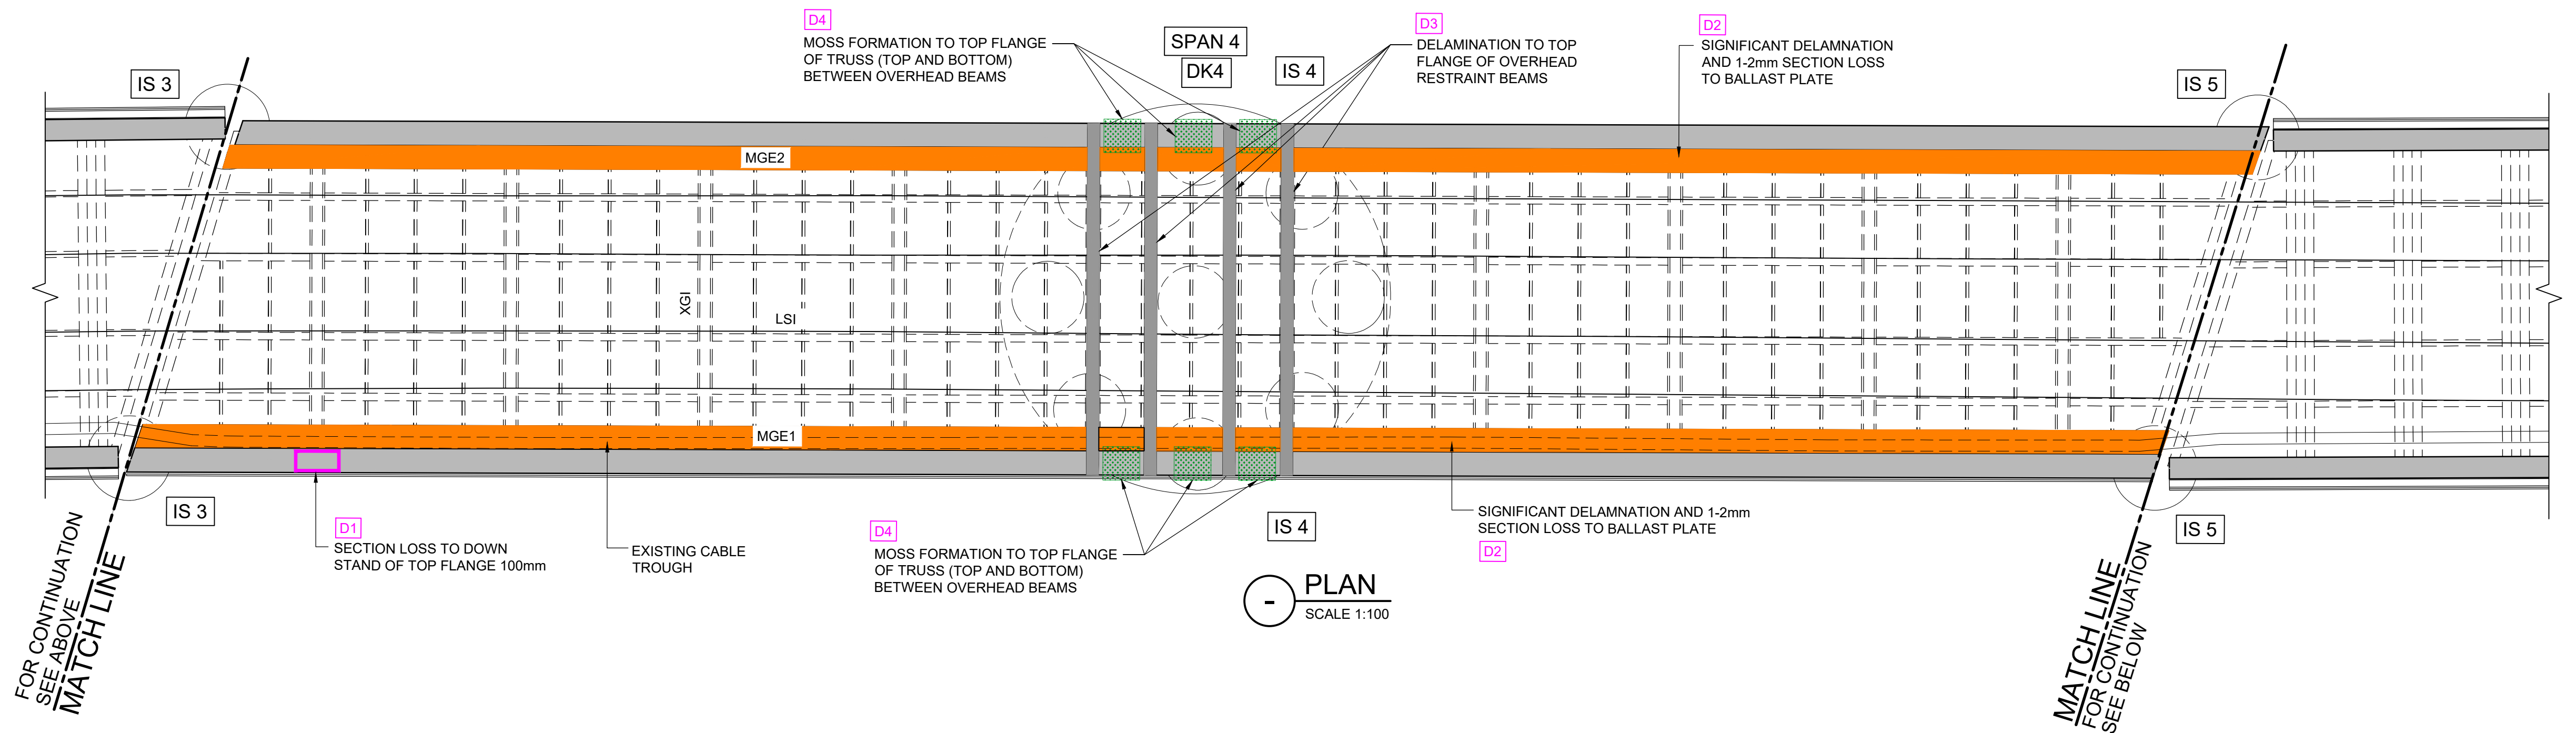
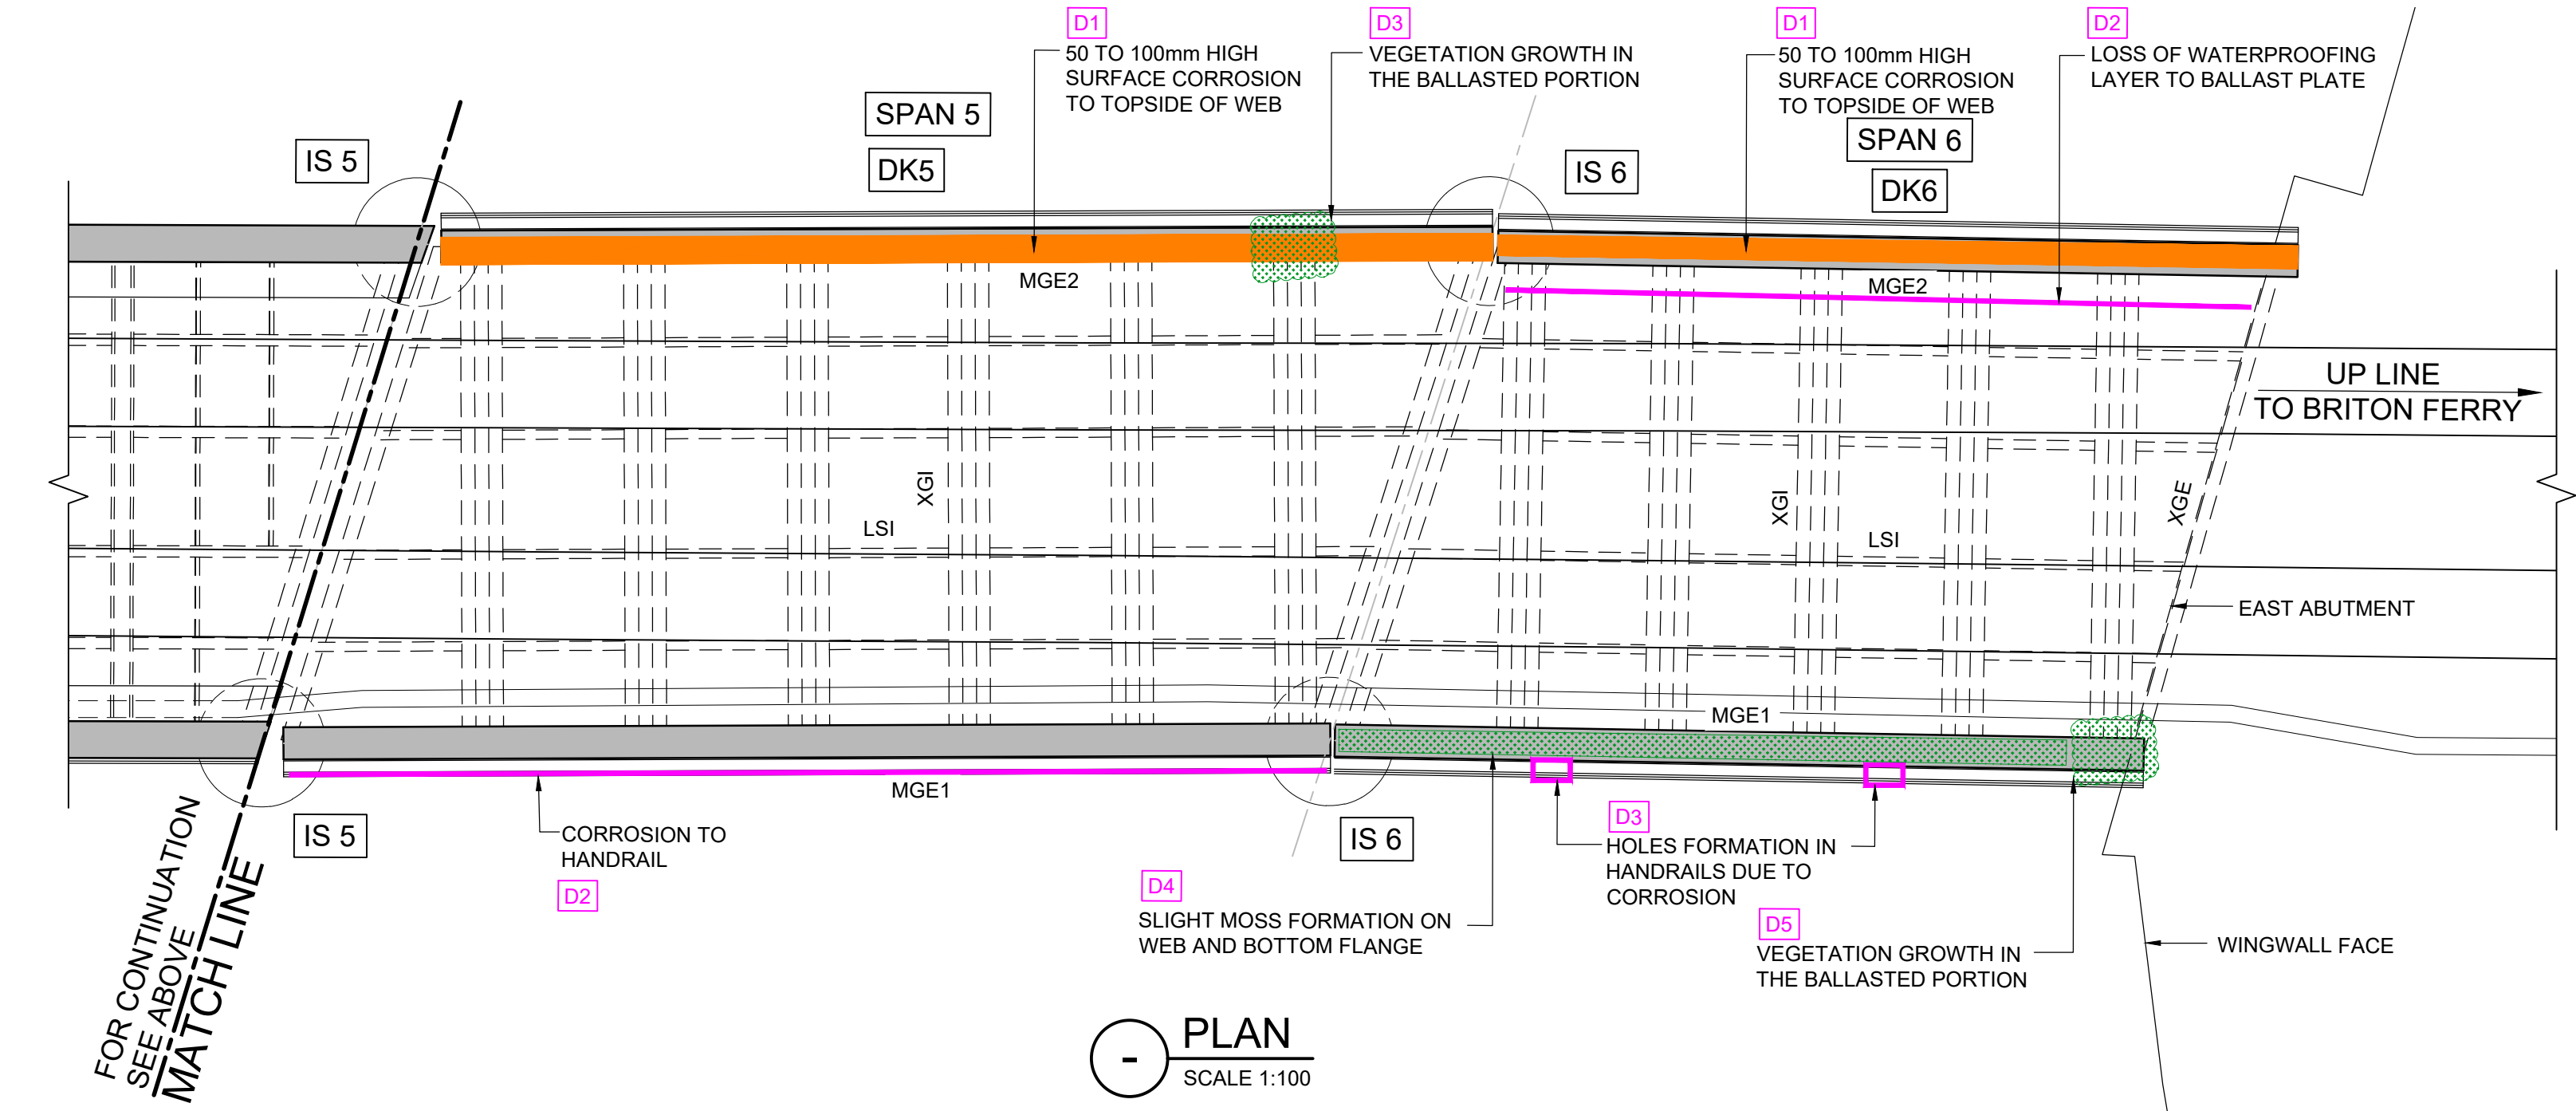
- GENERAL INSPECTION NOTES :-**
- DELAMINATION AND LOSS OF SECTION TO BALLAST PLATE AT EDGES;
  - ACCUMULATION OF DEBRIS IN THE JOINTS BETWEEN ADJACENT DECKS;
  - LOSS OF PAINT WORK TO TOP FLANGE OF BRIDGE GIRDERS.
- L.O.S - LOSS OF SECTION
