Neath Port Talbot Flood Alleviation

Preliminary Ecological Assessment

Figure 1: Rock Street, Phase 1 Habitat Plan

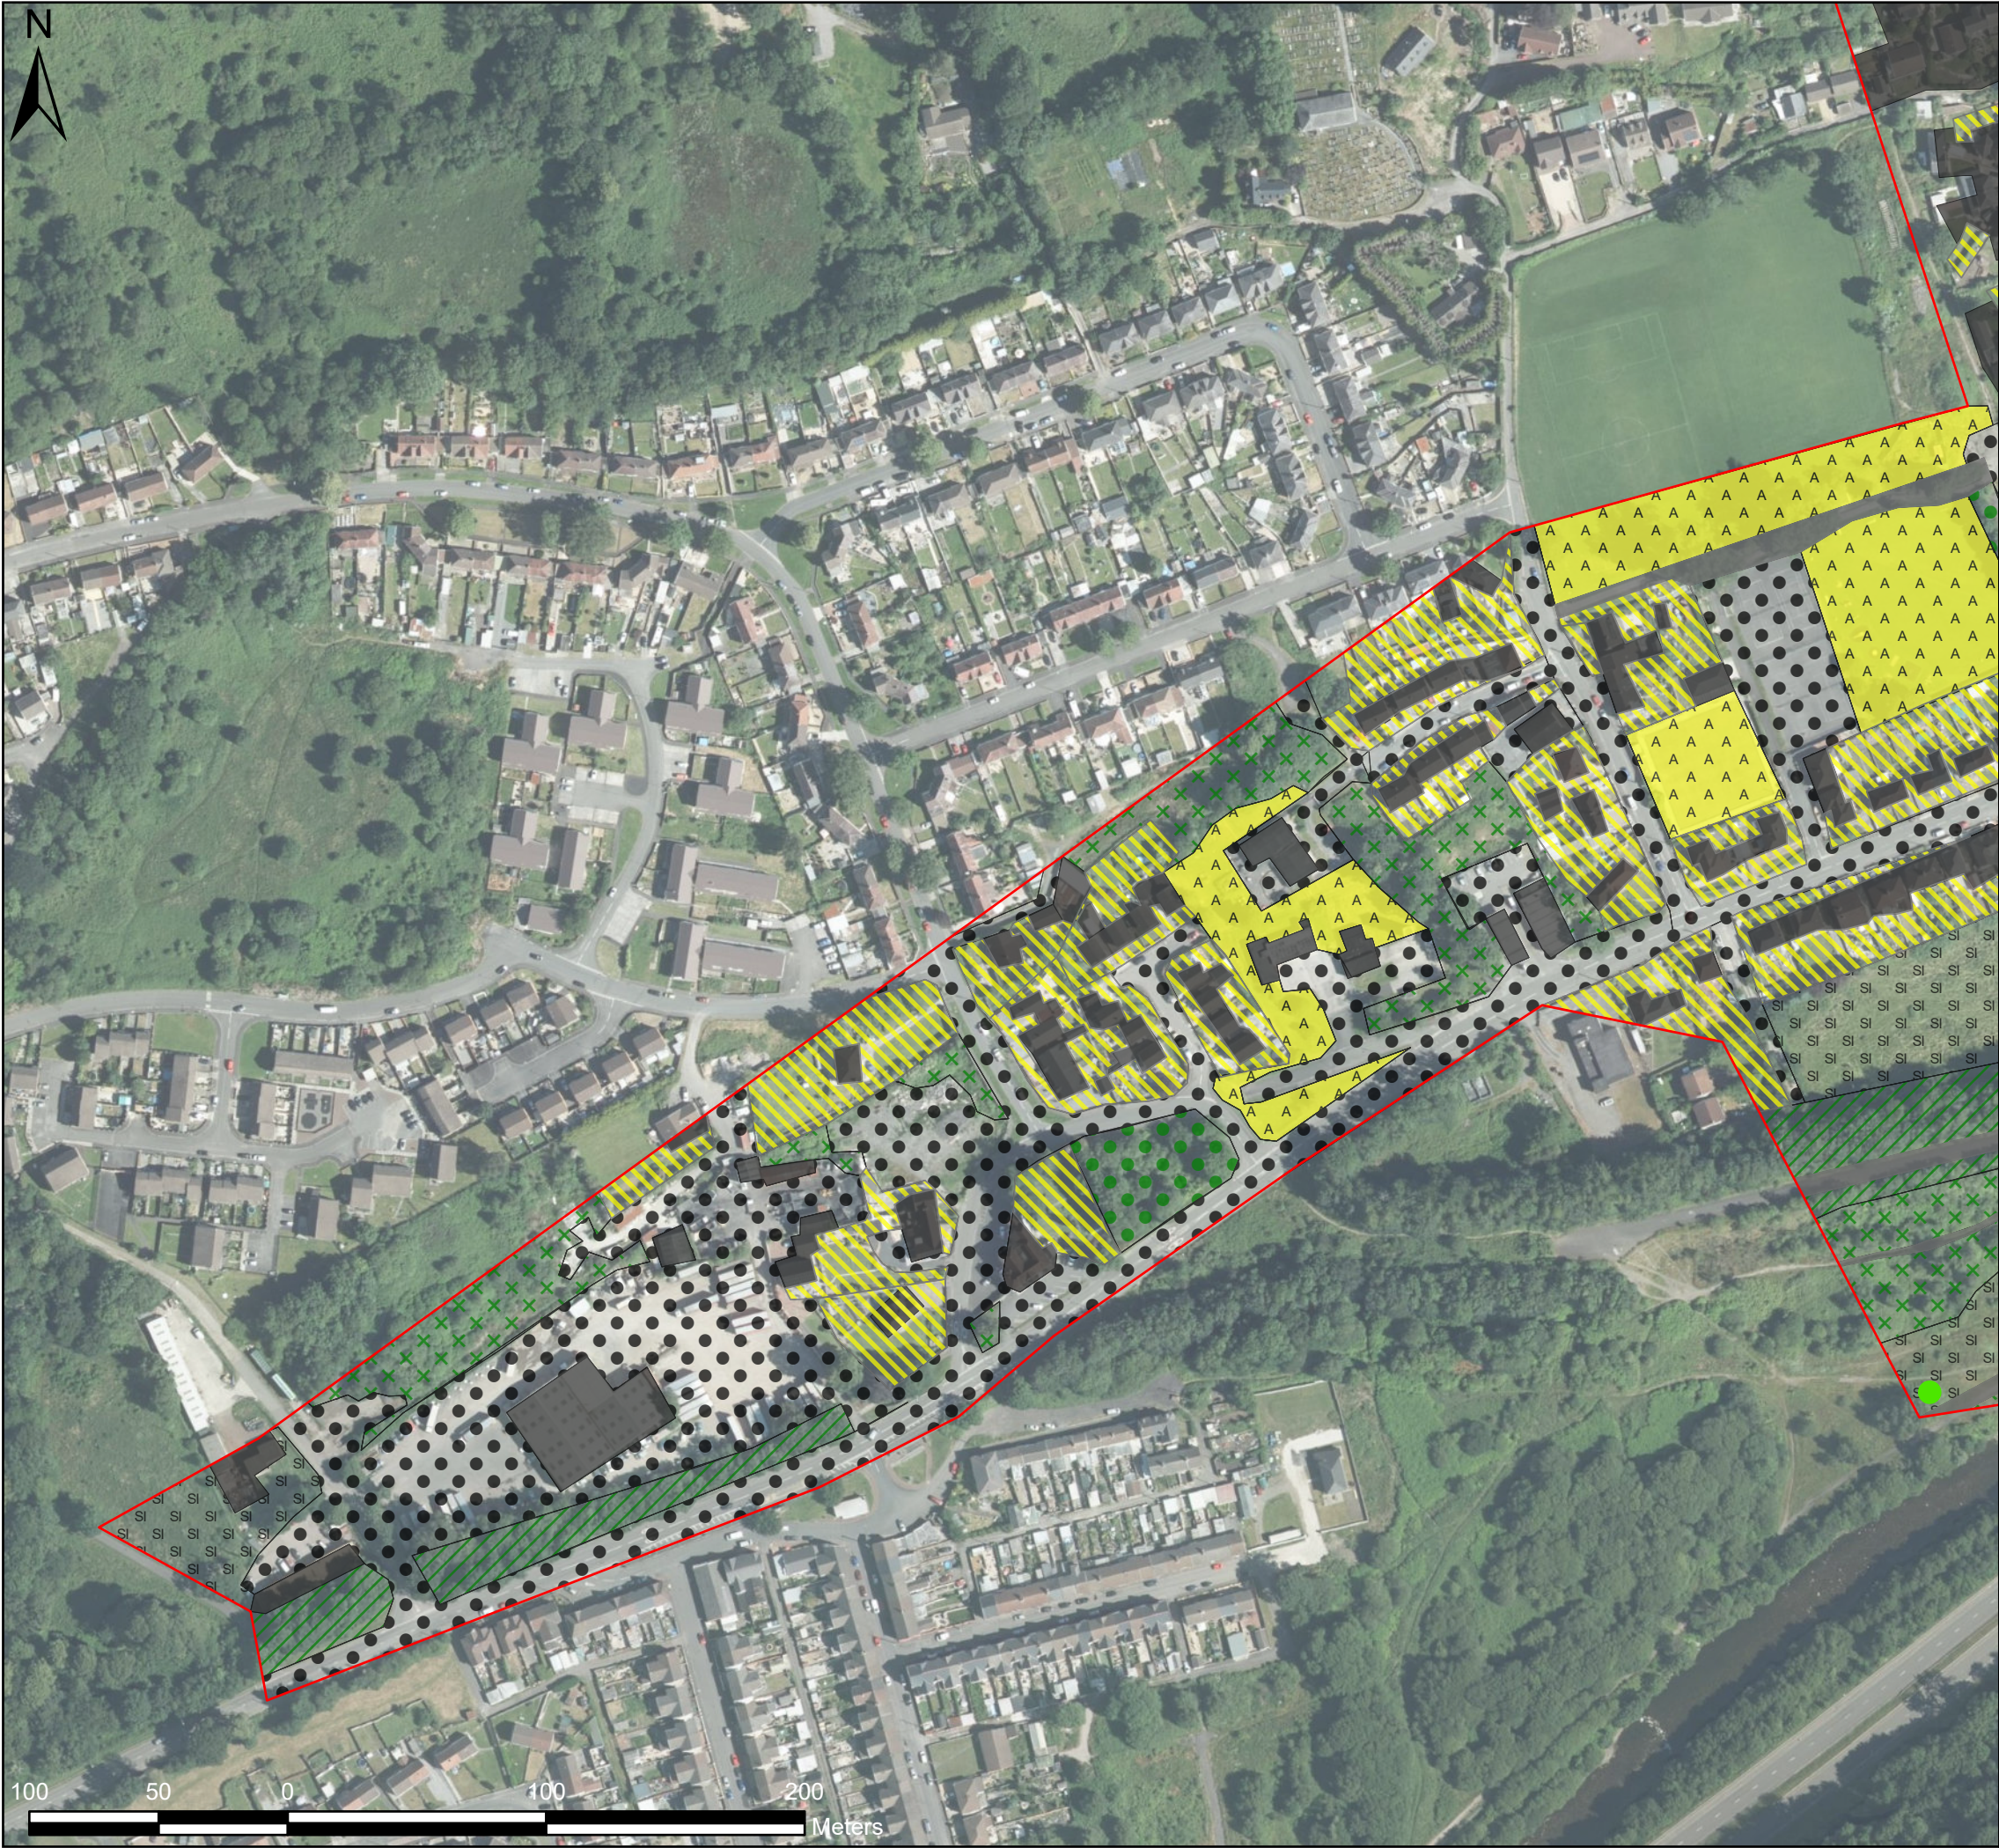
- Survey Boundary
- Proposed Drainage Culvert
- Trees
- Habitat**
- A1.1.2 - Broadleaved woodland - plantation
  - A2.2 - Scrub - scattered
  - A3.1 - Broadleaved Parkland/scattered trees
  - B6 - Poor semi-improved grassland
  - J1.2 - Cultivated/disturbed land - amenity grassland
  - J3.6 - Buildings
  - J4 - Bare ground
  - J1.5 (Gardens)
  - J3.7 (Track)
