**174 NEW ROAD, SKEWEN**

**ROADSIDE DIGITAL ADVERTISING BOARD**

**Stage 1 Road Safety Audit**

**RDW-DC-21-3557-RSA1**

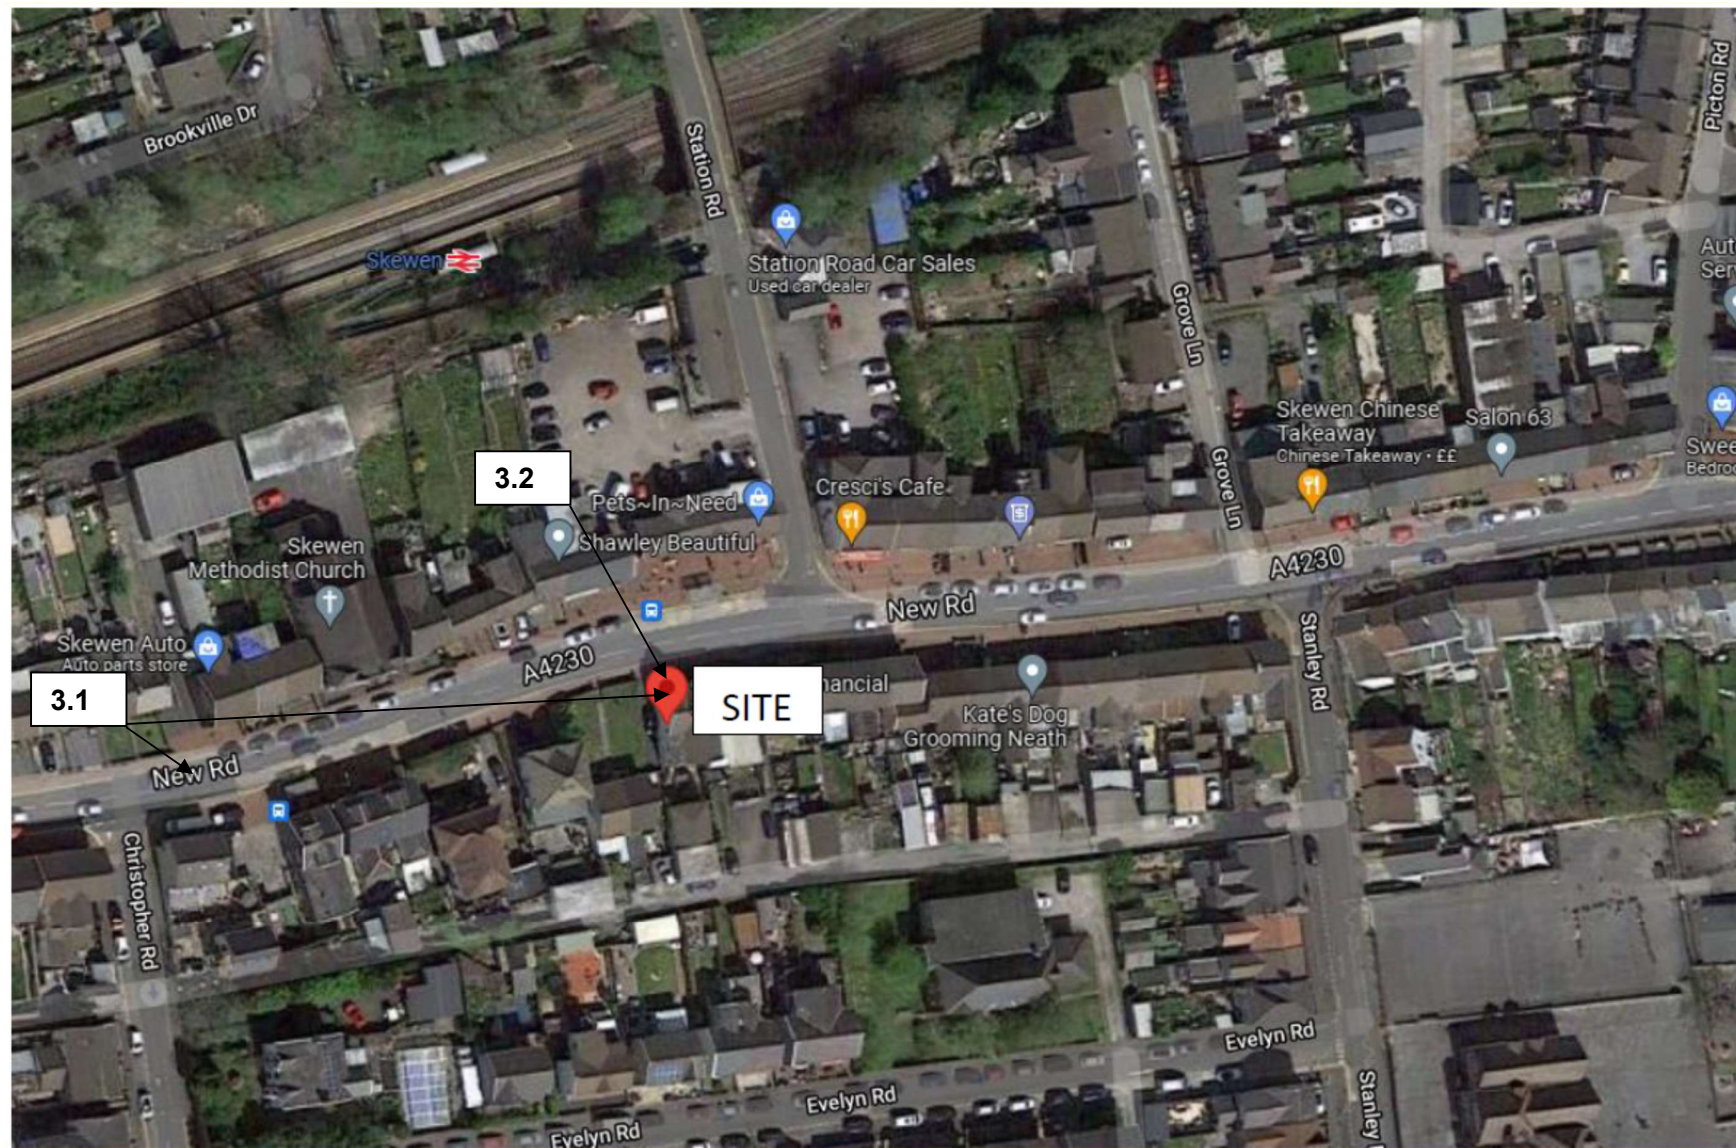
## APPENDIX A: LOCATION PLAN

1.14 All problems identified in this Road Safety Audit Report are indicated on a location plan in Appendix A
