PROJECT:  
PROPOSED ADVENTURE PARK,  
AFAN VALLEY RESORT

FIGURE 8b:  
GEOMORPHOLOGICAL MAPPING  
PHOTOGRAPH LOCATIONS

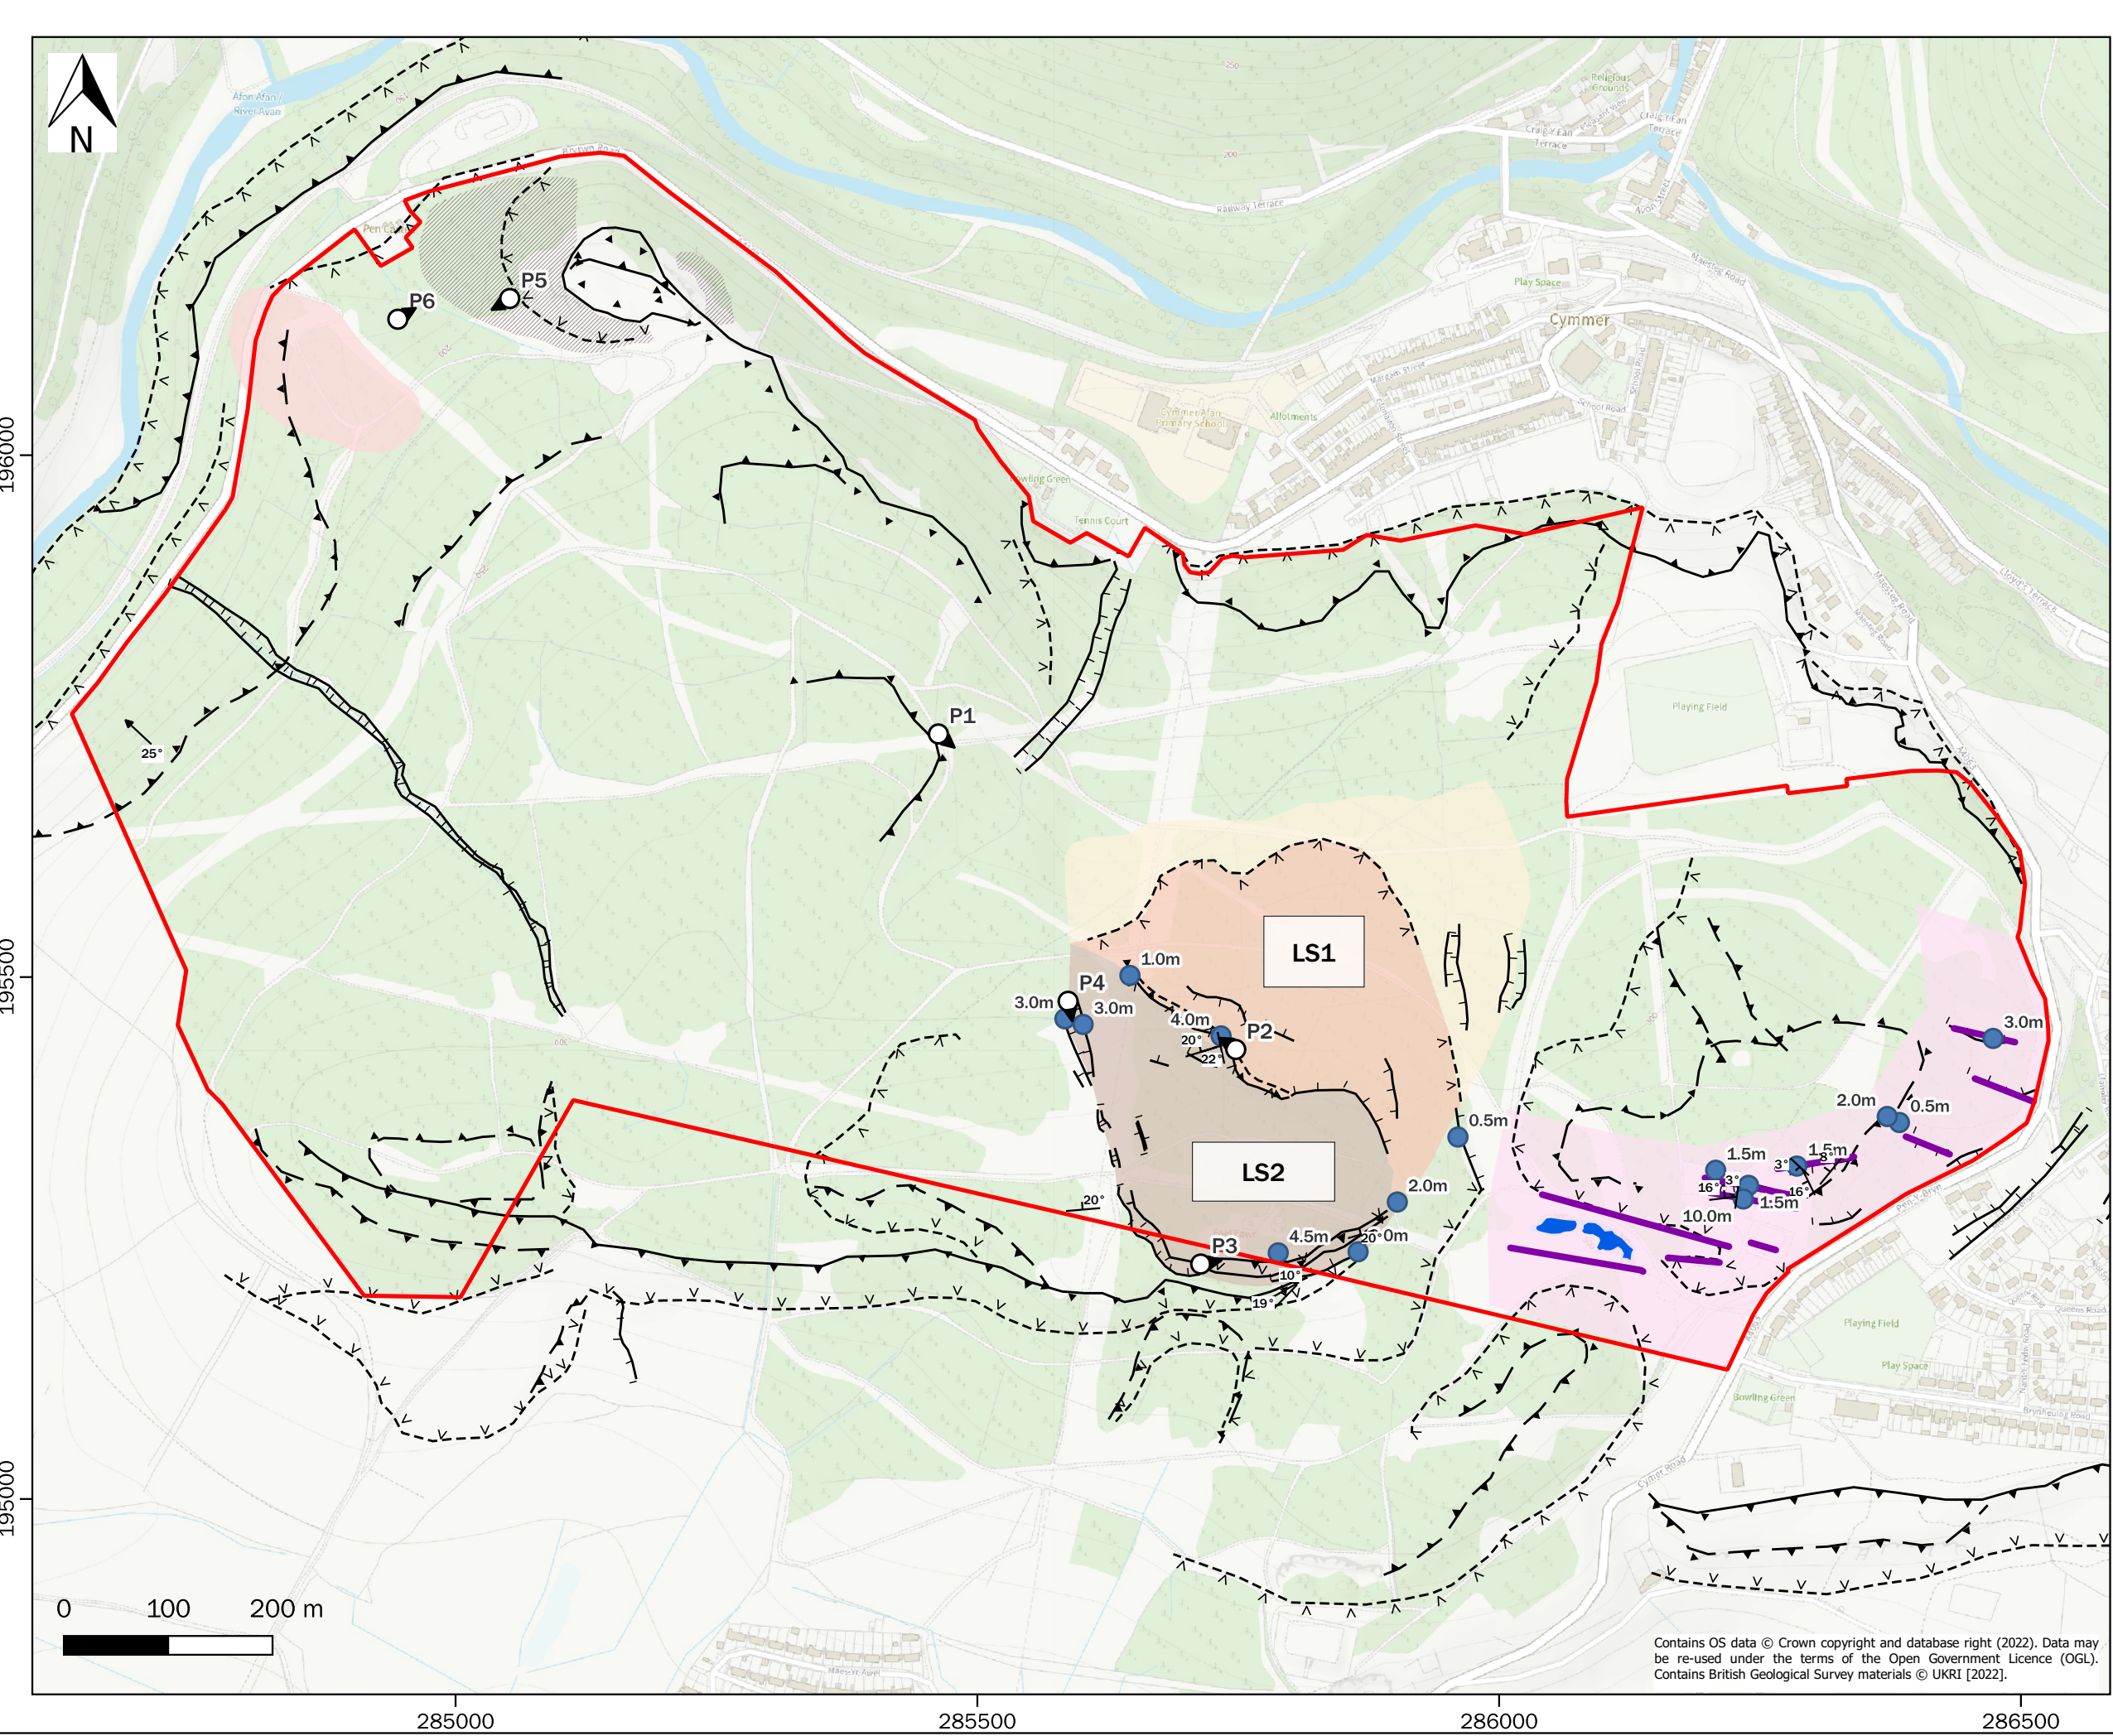
Geomorphology

- Break in Slope
- Convex change in slope
- Convex break in slope
- Concave break in slope
- Concave change in slope

- Graben Zone
- Grabens / Fissures
- Possible Sag Pond

Landslides

- Landslide 1 (LS1)
- Landslide 2 (LS2)
- Possible maximum extent of landslide 1
- Possible Debris Slide
- Earth Flow
- Possible Rockfall

- Tension Crack Height
- Photograph Locations (arrow indicates direction of photograph)
- Outcrop strike and dip
- Slope angle
