# Summary of Findings in Relation to Peat Survey

Afan Valley Adventure Resort

17 May 2018

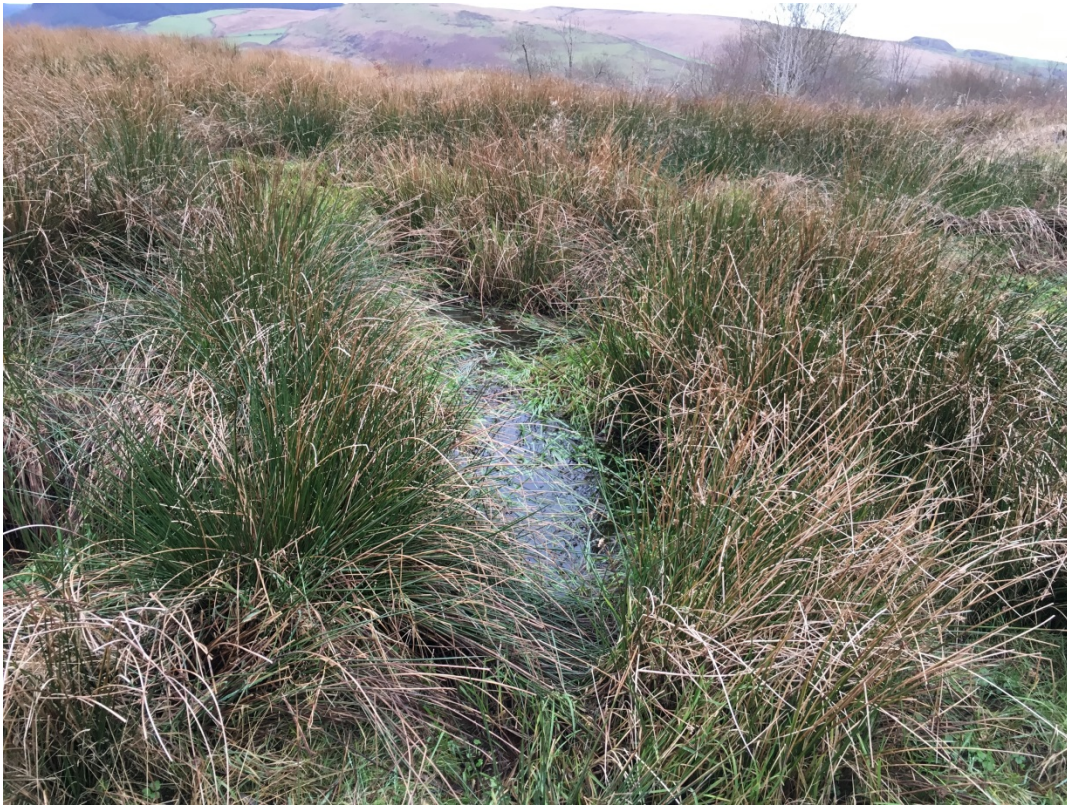
L13 facing north – north east

| Table 01. Summary of Findings | | | |
|---|---|---|---|
| 13 | 0.00 – 0.18 Very soft, black, slightly sandy clayey PEAT | SPS | 0.18 – 0.30 Brown slightly gravelly, sandy SILT/CLAY |

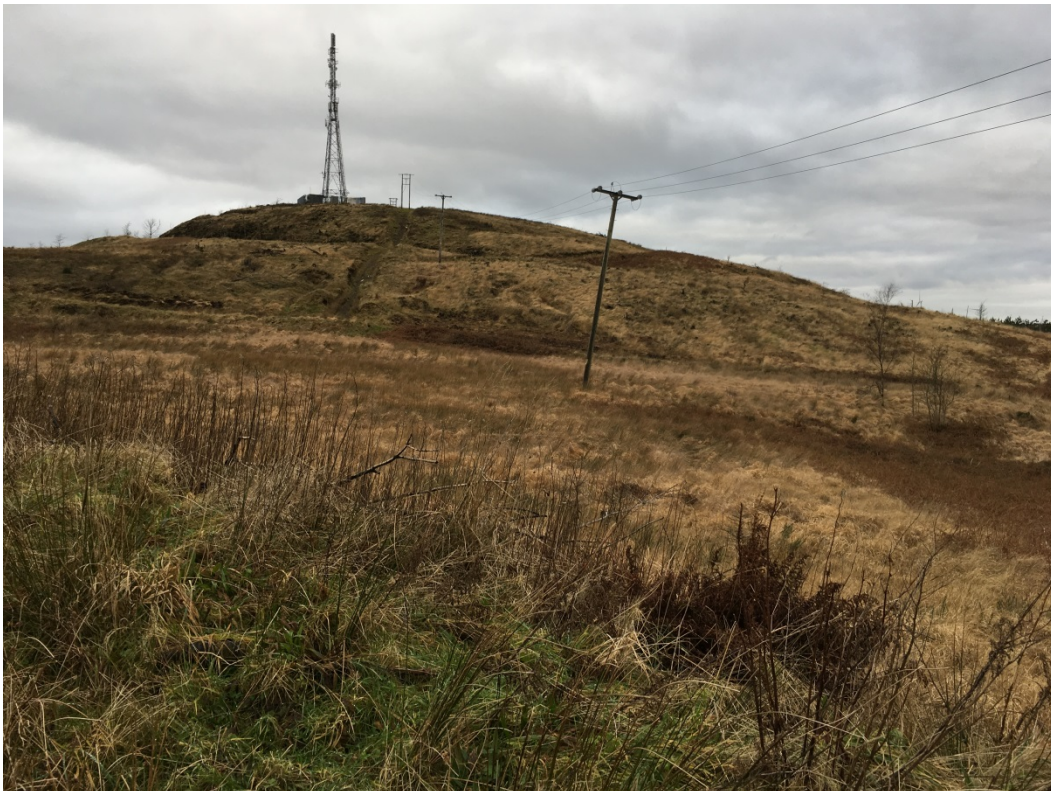
L13 facing west towards the mast

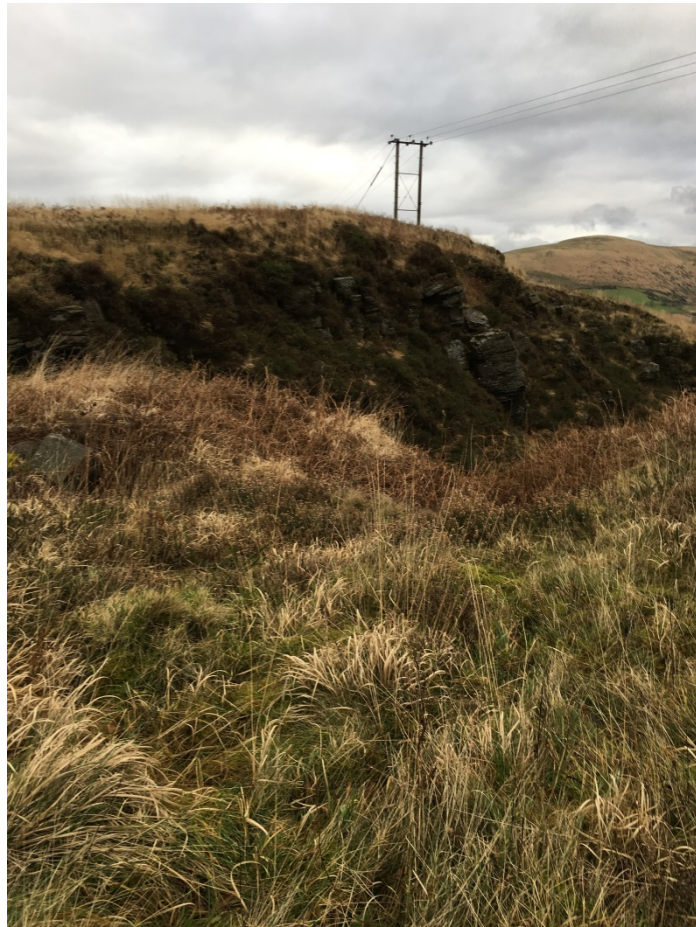
L14 facing north -west

| Table 01. Summary of Findings | | | |
|---|---|---|---|
| 14 | 0.00 - 0.10 Soft, black, organic SILT/CLAY | SPS | 0.10 – 0.60 Grey, occasionally gravelly, very sandy SILT/CLAY |

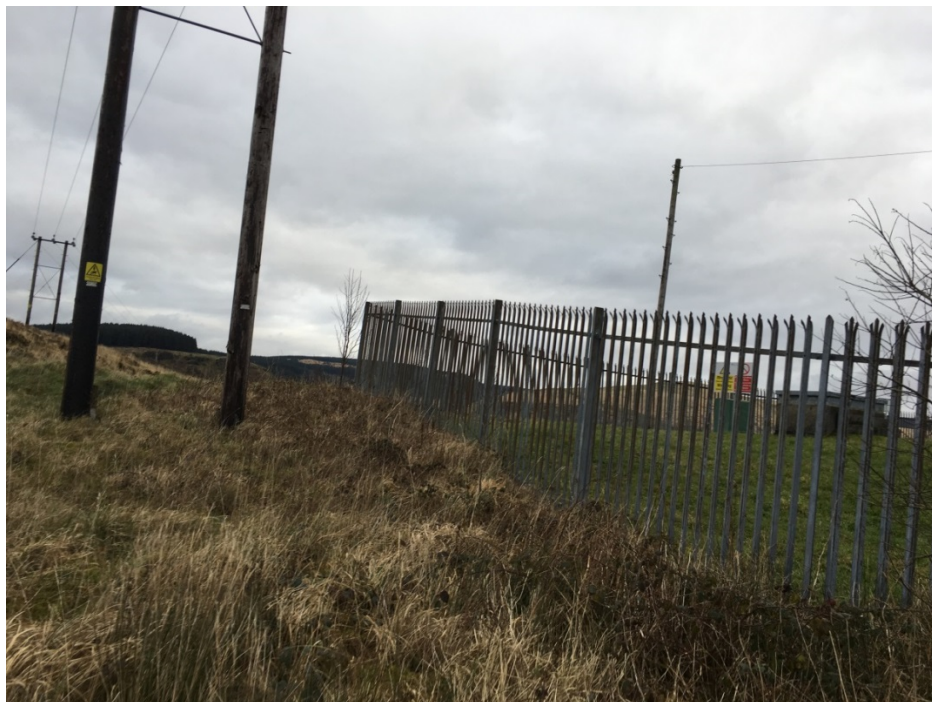
L19 Water resevoir

| Table 01. Summary of Findings | | | |
|---|---|---|---|
| 19 | 0.00 – 0.17 Dark-brown to black, sandy organic SILT/CLAY | SPS | 0.17 – 0.25 Light orange-brown, very sandy CLAY with occasional gravel to cobble |

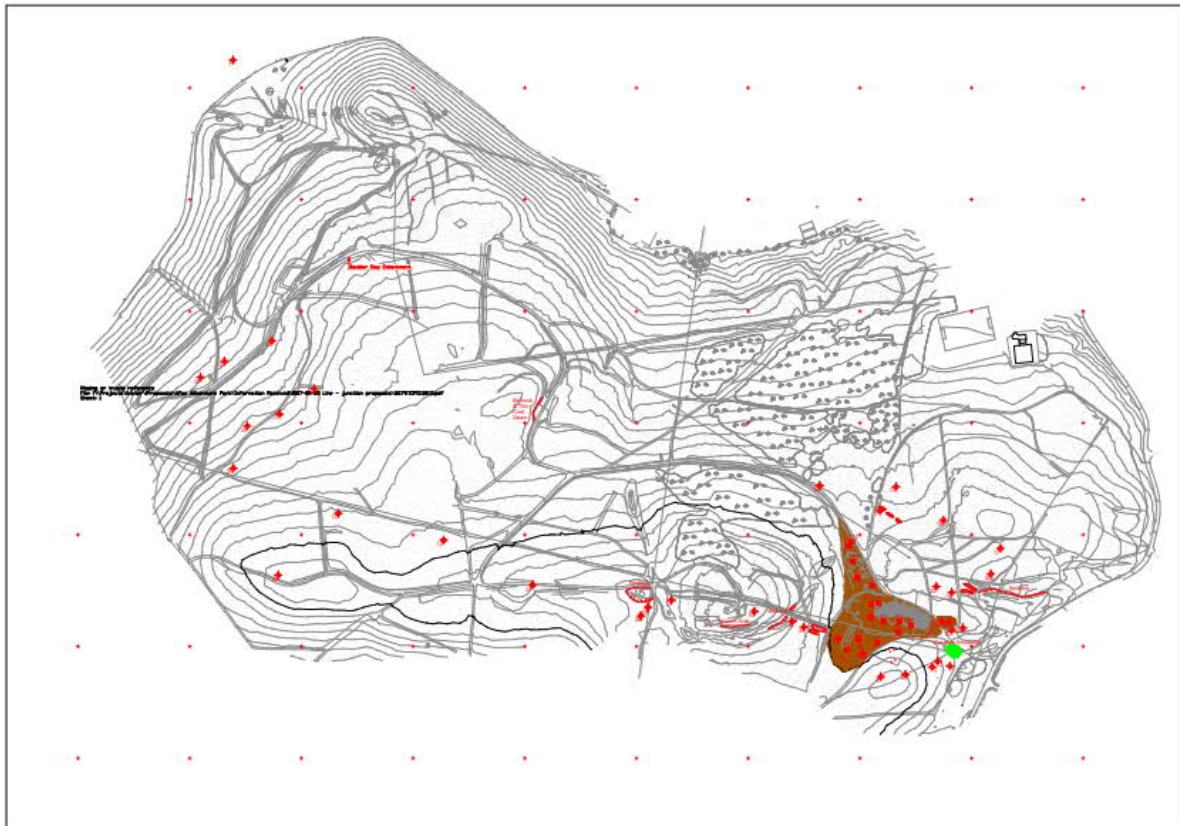
Fig. 1 Locations of trial pits and probing and area containing deep peaty soils

The results of this site based review have now been received and indicate that of the whole site an isolated area of deep peaty soils has been identified around the existing water course to the South East of the site, as shown on the site plan below.

The locations of the trial pits and probing are set out in Fig. 1 above and in more detail in Fig 5 below. Whilst there is evidence of peat in the area shaded brown on the site plan, In summary, the only deep peaty soil was encountered in these four locations highlighted below. These locations are shown on the extract below in Fig. 2.

In line with the current master plan, and whilst the area of peat identified is a very small percentage of the overall site, the intention will be to preserve the areas of deep peaty soils where possible and minimise disruption to this area of peat. This has to be seen in the context of the wider site development and the economic benefits of the scheme and where disruption is unavoidable we will liaise with NPTC/NRW prior to any works being carried out. Below in Table 01 the soils have been classed based on the minimum thickness of Peat/Topsoil/Organic Soil. Anything less than 0.1m thick is considered a mineral soil (**MS**). We have assumed that soils <0.4m are considered Shallow Peaty Soil in accordance with English / Welsh classification.

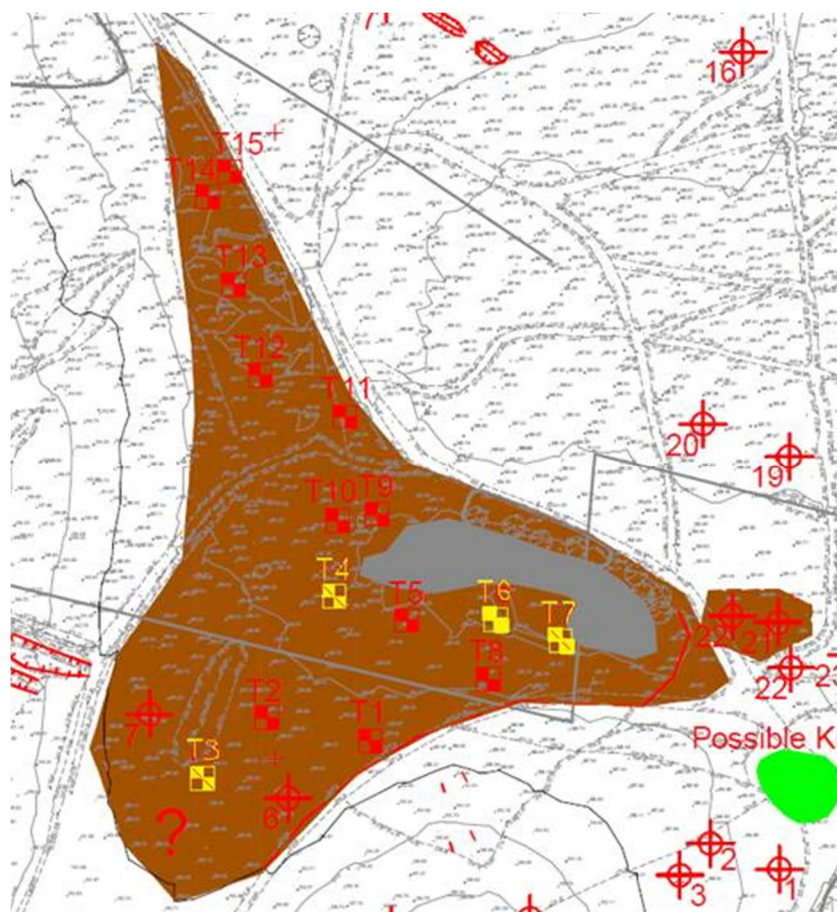
Fig. 2 Location indicating deep peaty soils (yellow)

The remainder of probes and trial pits across the site did not indicate the presence of deep peaty soils greater than 0.4m deep.
