| | | <b>EXPLORATORY HOLE PHOTOGRAPHS</b> | | <b>Remarks</b><br>Machine excavated trial pit from GL to 1.60m. No groundwater encountered. 3 soakaway testing cycles in accordance with BRE365 was completed. Backfilled with arisings. | | <b>Exploratory Hole</b> |
| <b>Project</b> | Afan Valley Adventure Resort | <b>Easting</b> | 286268.57 | <b>Equipment</b> | 13 tonne tracked excavator | Sheet 2 of 2 |

| <div></div> | | TRIAL PIT EXPLORATORY HOLE LOG | | | | | | Exploratory Hole Progress by Time | | | Exploratory Hole | | |
| Project | Afan Valley Adventure Resort | | | Equipment | 13 tonne tracked excavator | | | | | Sheet 1 of 1 | | | |

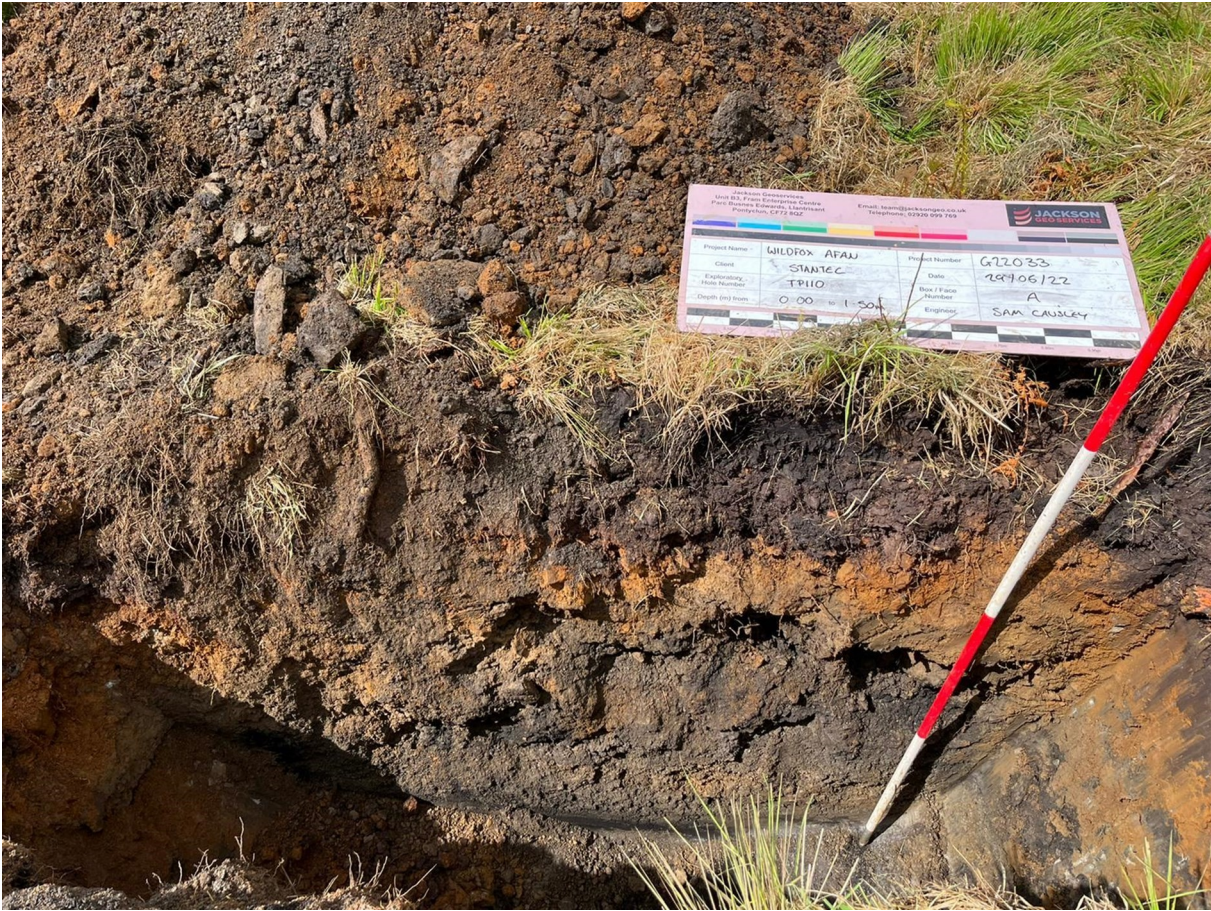
TP110 Face A

| | | <b>EXPLORATORY HOLE PHOTOGRAPHS</b> | | | <b>Remarks</b><br>Machine excavated trial pit from GL to 1.50m. No groundwater encountered. 1 soakaway testing cycle in accordance with BRE365 was completed. Backfilled with arisings. | | <b>Exploratory Hole</b> |

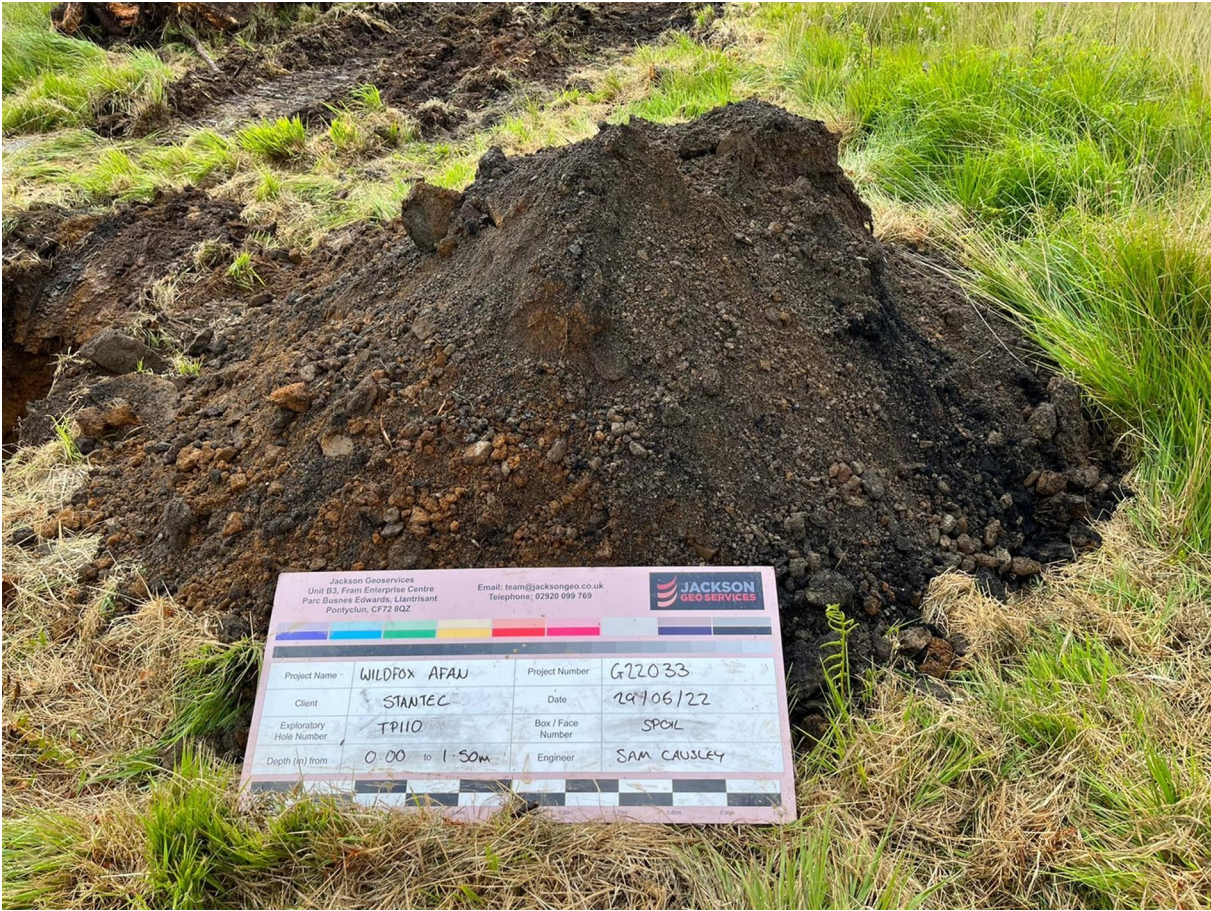
TP110 Spoil

| | | <b>EXPLORATORY HOLE PHOTOGRAPHS</b> | | <b>Remarks</b><br>Machine excavated trial pit from GL to 1.50m. No groundwater encountered. 1 soakaway testing cycle in accordance with BRE365 was completed. Backfilled with arisings. | | <b>Exploratory Hole</b> |
