| Project | <b>EAGLE HOUSE, PORT TALBOT – PHASE 1 REPORT</b> |
| Client | <b>Castell Group</b> |

Spectrum Geo Services (SGS) were requested by Castell Group, to undertake a Phase 1 Desk Study of a site at Eagle House, Port Talbot.

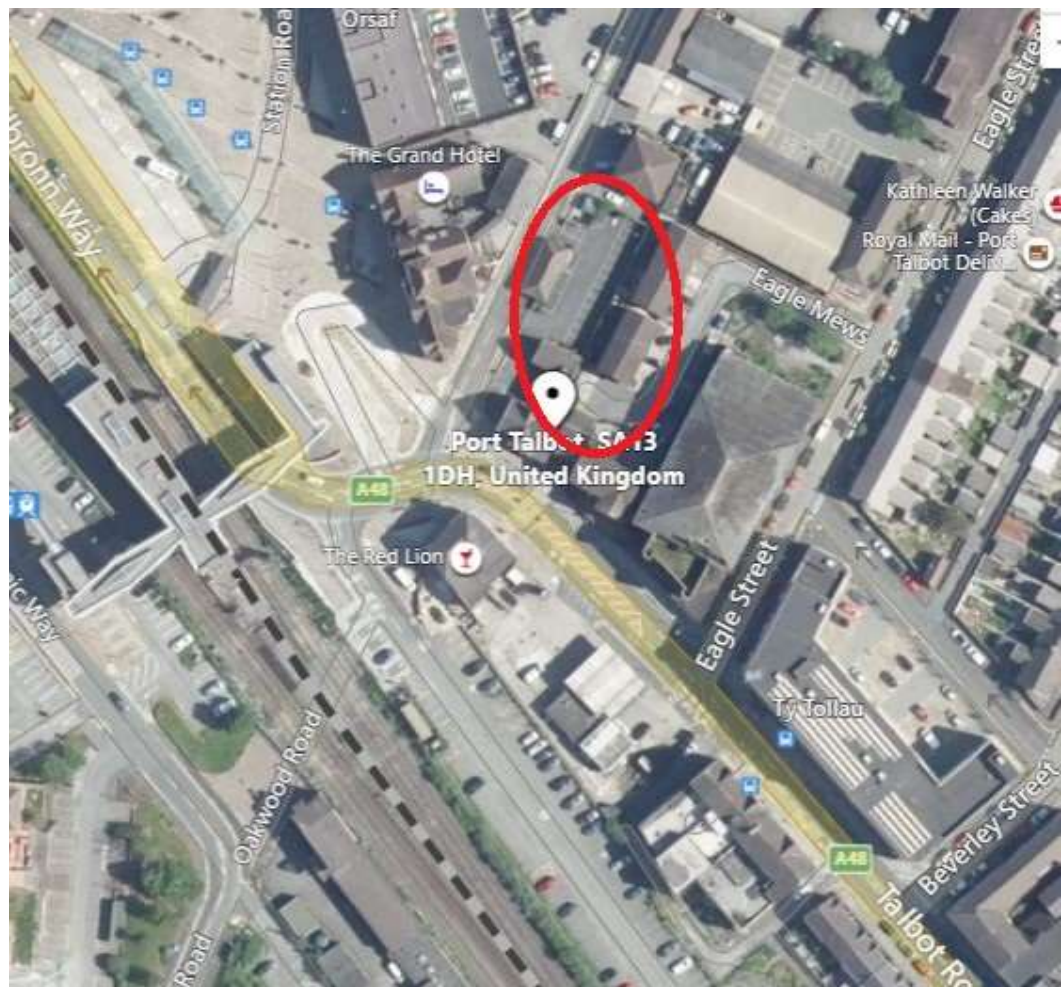
**Figure 21035\_01**

The development site is at Eagle House, Port Talbot, SA13 1DH. The site location plan shown as Figure 21035/01.
