Project: Internal & External Alterations to Moose Hall, Neath  
Client: Mr & Mrs Hill  
Address: Moose Hall, Castle Street, Neath, Neath Port Talbot, SA11 3LU

Drawing Title: Site Plan & Location Plan as Existing  
Project No: 21/1011  
Drawing No: 100  
Revision: A  
Scale: 1:100 at A3  
Status: Planning

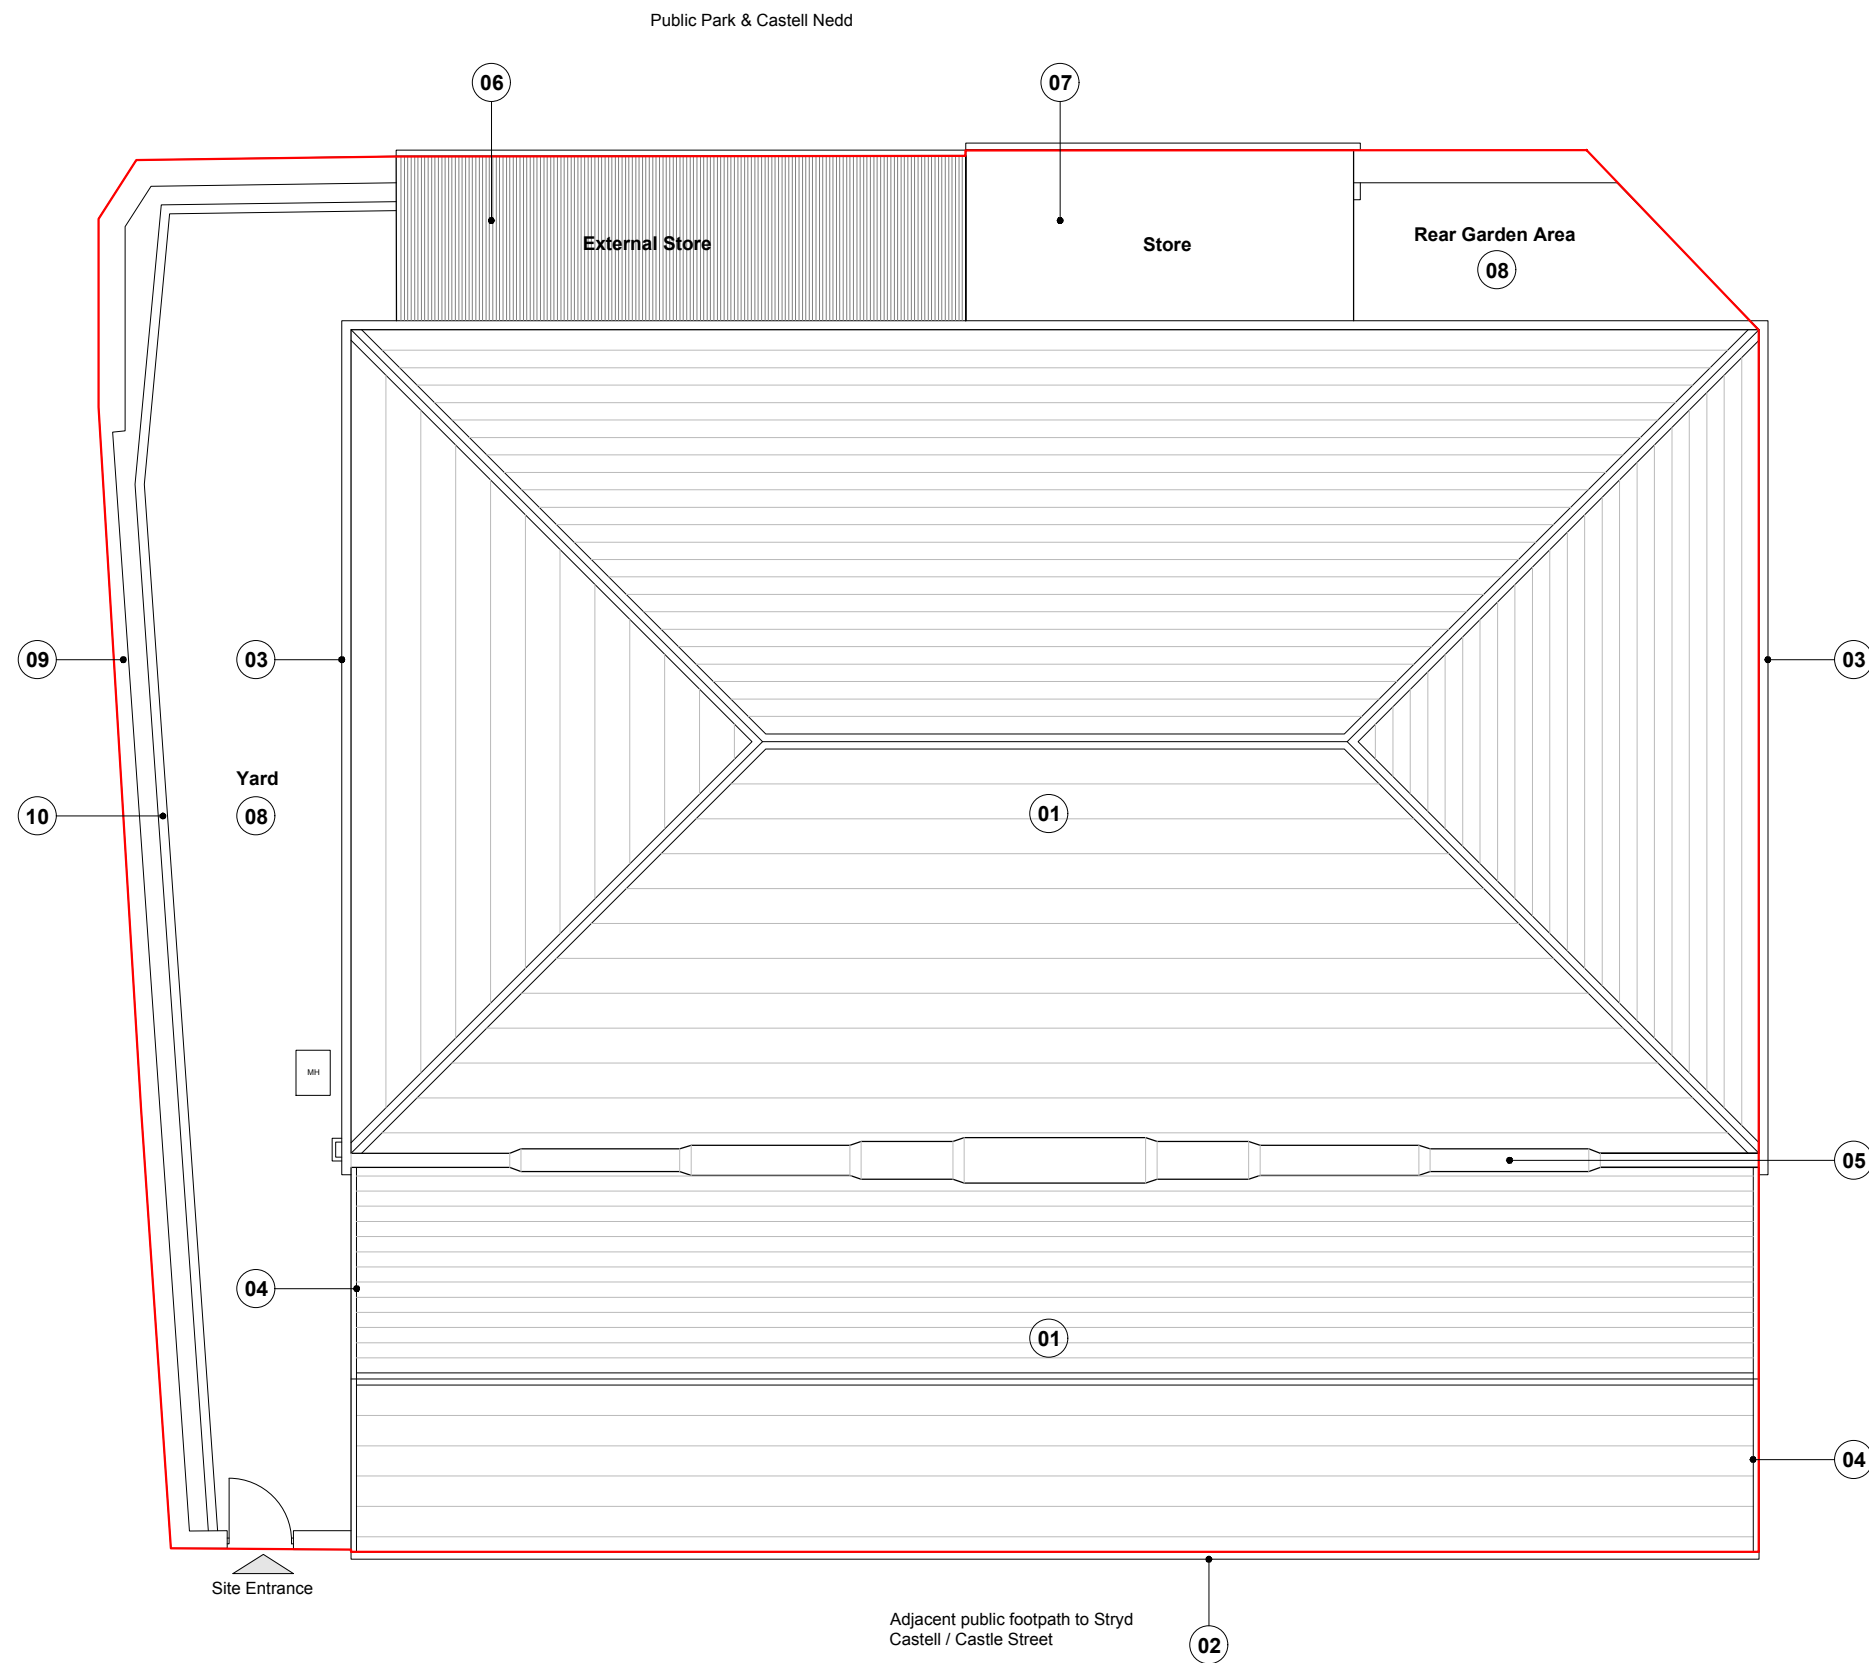
1 Site / Roof Plan as Existing  
1:100

1. Slate roof with concrete ridge and hip tiles
2. Metal half-round gutters, colour black, fixed to timber fascia, colour green
3. Combination of metal and UPVC ogee gutter, colour black, fixed to timber fascia, colour green
4. Timber bargeboard and trim, colour green
5. Staged lead valley between pitched slate roofs
6. Corrugated metal sheet roof
7. Single ply/GRP roof
8. Concrete hardstanding
9. Boundary formed of fair-faced blockwork to internal face. To external face of boundary, wall finished in combination of exposed coursed stone and smooth (fined down) render to low level, rough-cast render to upper section
10. Contemporary concrete drainage channel
