Gnoll Park Estate

Repairs:

Ground Floor

Pond Cottage

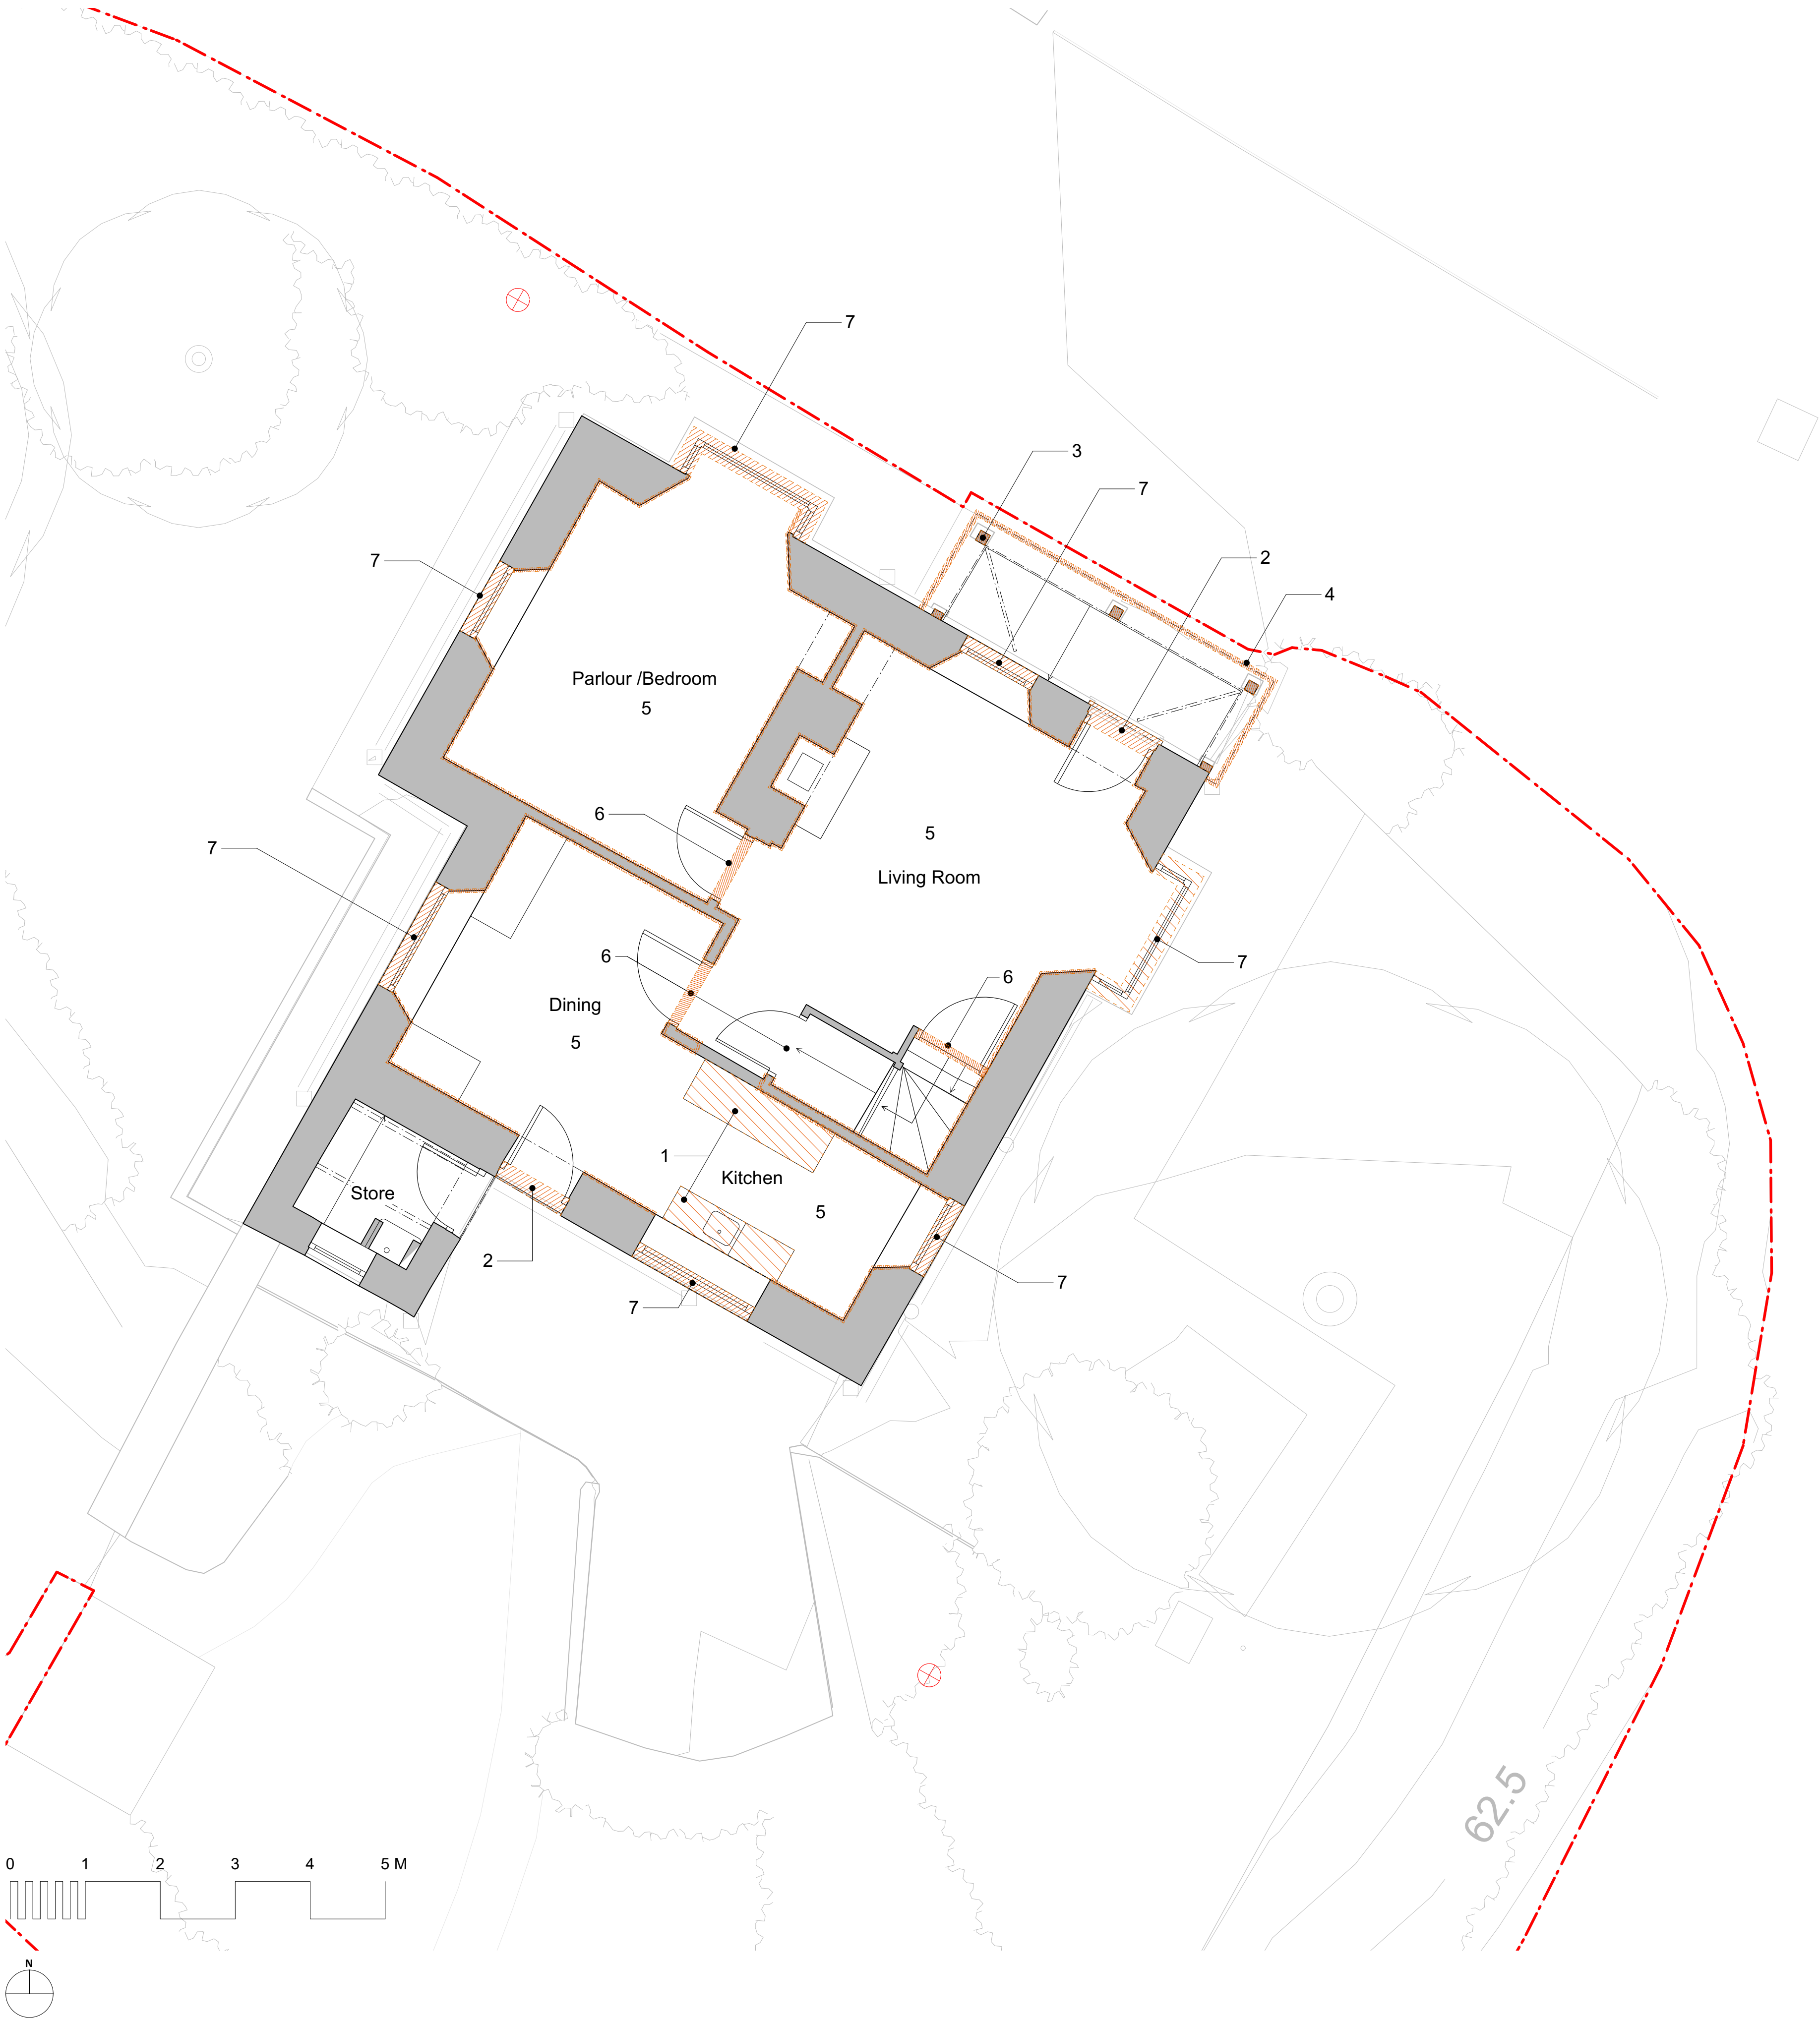
GROUND FLOOR KEY NOTES

1. Carefully remove existing Kitchen fixtures and fittings and cart away
2. Existing timber door to be overhauled and redecorated.

- Door is to be carefully stripped of all surface decoration.

- Rotten sections of timber are to be cut back to sound material with new sections of timber to be cut in to match existing. The profiles of decayed sections should be copied exactly and precisely married in to the existing. Timber used in the repair is to be of the same species and of the same moisture content of that of the existing to avoid differential movement between the old and the new.

- Ventrolla perimeter sealing system (or similar approved) to be fitted to the existing door.

- Redecorate door on completion
3. Existing porch structure to be repaired and redecorated including cutting back rotten sections of timber to sound material with new sections of timber to be cut in to match existing. The profile of the decayed sections is to be copied exactly and precisely married in to the existing. Timber used in the repair should be of the same species and of the same moisture content of that of the existing to avoid differential movement between the old and the new.

4. Previously painted metal railings to be thoroughly degreased. Remove any weak paint and rust back to bare metal, leaving a firm edge to any sound paintwork. Provide a key in any retained paintwork for subsequent coats. All corrosion and loose scale to be taken back to bare metal, with any residual rust treated with a proprietary removal solution

- Apply 2 coats metal primer and 3 coats of exterior eggshell paint. Colour to be confirmed.
5. Prior to redecoration of walls and ceiling undertake lead testing and stratigraphical analysis of decorative finish. Undertake trial area for removal of modern plaster skim to all internal faces of walls and ceilings to ascertain whether the plaster skim can be removed and a suitable finish achieved to the underlying lime based plaster. Allow for all existing plaster to be hacked off wall, back to stonework. Include removal of all concealed mechanical and electrical services and conduits

- Following plaster removal, include for maximum period possible to allow walls to dry out. Subsequently reinstate with three coat lime based plaster. Lime based plaster to be finished with mineral based paint, with exact colour to be confirmed.

6. Carefully remove existing modern door and cart away. All architraves and timber skirtings to be retained
7. Existing timber window to be overhauled and redecorated.

- Windows are to be carefully stripped of all surface decoration.

- Cracked window panes are to be carefully removed and replaced with glazing to match existing.

- Deteriorated putty to all windows should be removed manually, taking care not to damage the wood along the rebate. If the glass is to be removed, the glazing points, which hold the glass in place, can be extracted and the panes numbered and removed for cleaning and reuse in the same openings. The remaining putty can be removed. Hardened putty in the rabbets may be softened by heating with a soldering iron at the point of removal. Any putty remaining on the glass may be softened by soaking the panes in linseed oil.

- Ventrolla perimeter sealing system (or similar approved) to be fitted to the existing timber window.

- Redecorate window on completion
