# School House Gwaun-Cae-Gurwen

BS5837:2012 Tree Survey 13<sup>th</sup> October 2023

| Site Location: School House Gwaun-Cae-Gurwen | Report Reference: 10.23/SCH/V3 |

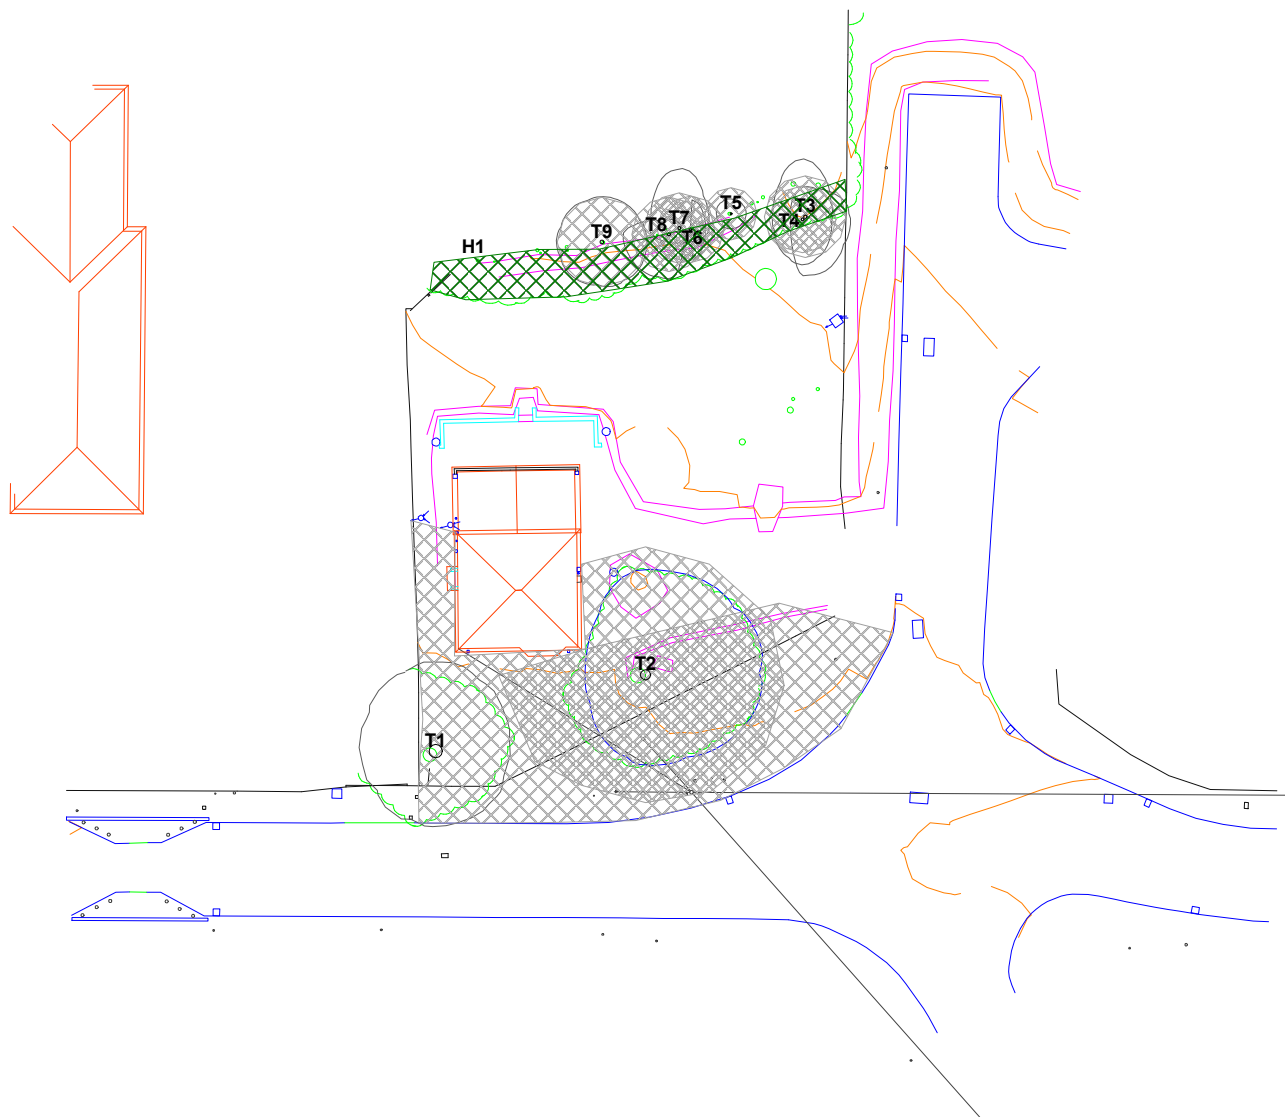
3.1.2 Above Ground Constraints - current crown spread is marked on the Tree Constraints Plan (TCP). This does not indicate the ultimate crown spread of the individual trees.

3.1.3 Below Ground Constraints – the root protection area (RPA) is a circle of radius 12 x the diameter of the stem of the tree measured at 1.5 metres above ground level. For a multi-stemmed tree, the RPA is calculated using the following formula:

3.1.4 The RPA is usually depicted as a complete circle; however, this area can be altered in shape to reflect compromised growing conditions such as the presence of buildings, watercourses, etc. In this case, only the RPAs of T1 and T2 been amended to reflect the existing site layout.

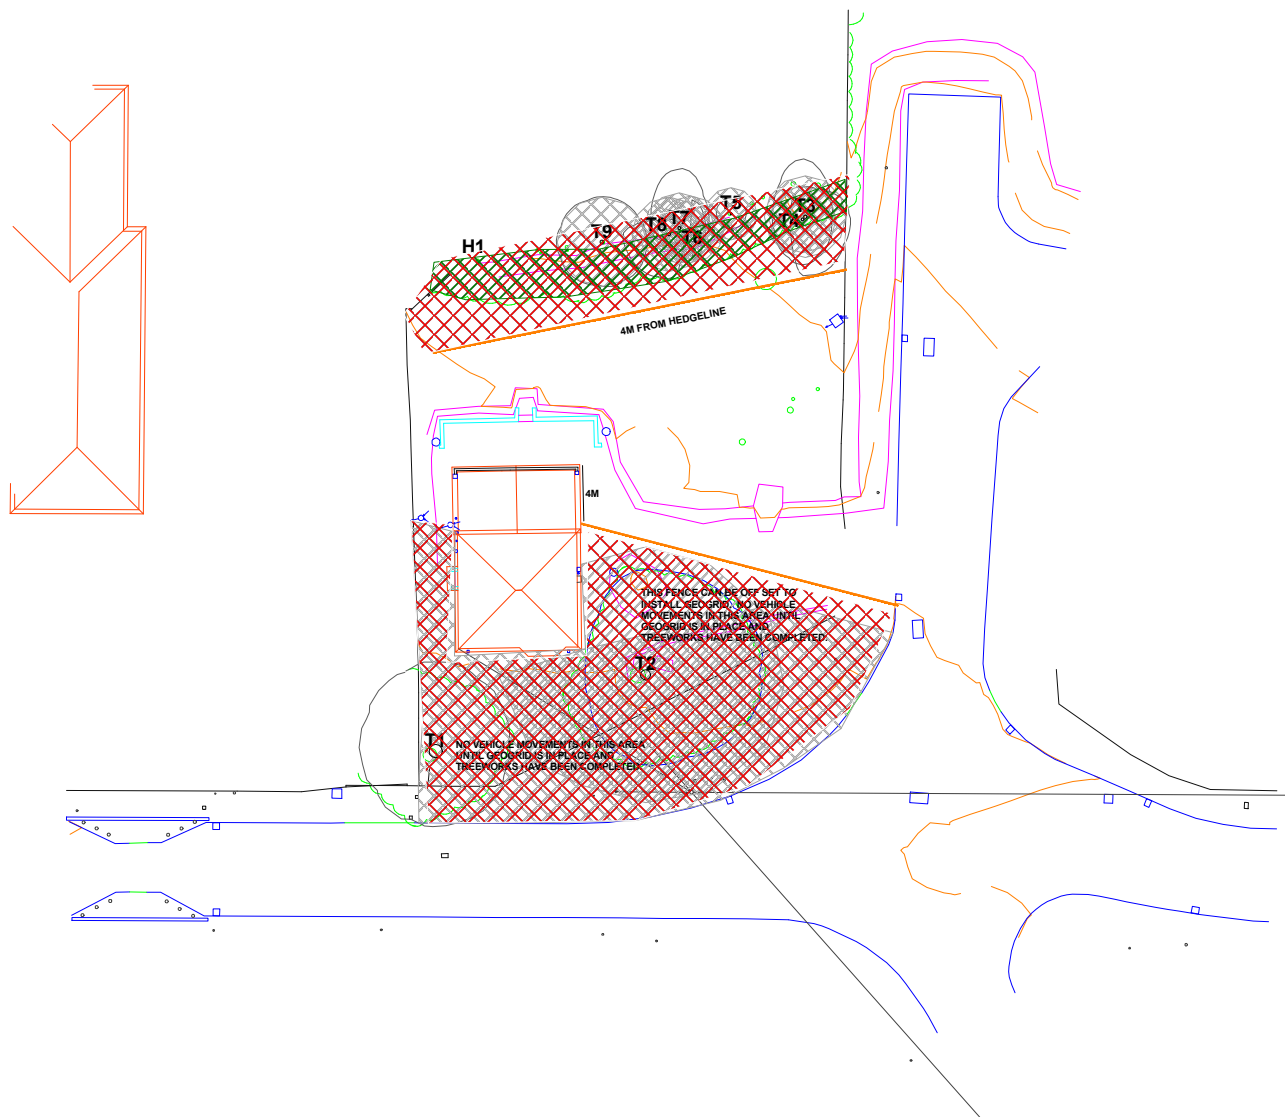
HERAS FENCE

3.3.1 The Tree Protection Plan is in Appendix II.

3.3.3 Heras fencing as shown below will be erected in the location marked on the Tree Protection Plan.

3.3.4 The fenced off area will be designated as the construction exclusion zone (CEZ). All fencing must be in place before construction works begin and must not be moved or removed until all construction works have finished. Signage as shown below must be attached to the fencing.

3.3.5 Works within the CEZ are restricted as follows:

- No excavations to be carried out unless agreed as part of the planning permission.
- No vehicle access.
- No fires to be lit within the CEZ or within 10 metres of the crown of a tree to be retained.
- No storage of construction materials or spoil within the CEZ.
- No mixing of cement or discharge of contaminants such as fuel within the CEZ.
- Soil levels within the CEZ must not be altered unless agreed as part of the planning permission.
- No signs or lighting to be attached to trees to be retained.

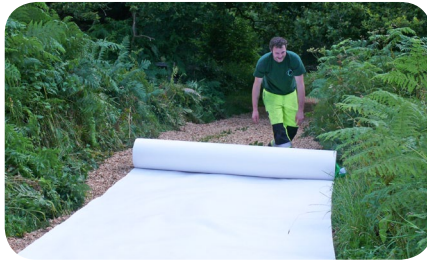
*Step 2: Lay out Treetex™*

2. **Geotextile:** We recommend the installation of a Treetex™ under the Cellweb® TRP, or under the sub-base, if installed. The overlapping between adjacent rolls of Geotextile should be: CBR > 3%: 300mm minimum, CBR between 1% and 3%: 500mm minimum. CBR ≤ 1%: 750mm minimum.

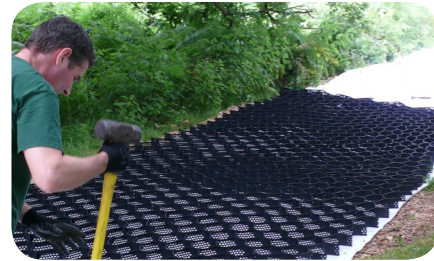
*Step 3: Lay out Cellweb® TRP*

- Cellweb® TRP is a NO DIG tree root protection measure and it is recommended that no excavation be performed without prior approval and guidance from the Local Authority Arboricultural Officer.
- Soil compaction from vehicles, machinery and materials is to be strictly prohibited during construction within Root Protection Areas (RPAs).
- Approval must be obtained from the Local Authority that the design and the method of construction is acceptable.
- Further information is available from the following two documents;
  - British Standard BS5837: 'Trees in Relation to Design, Demolition and Construction' (2012).
  - Arboricultural Advisory and Information Service: Practice note 12 – 'Through the Trees to Development' (APN12).

- Lay out the collapsed Cellweb® TRP on-top of the Treetex™.
- Place one of the supplied J pins into the centre cell at the end of the panel and secure into the ground.

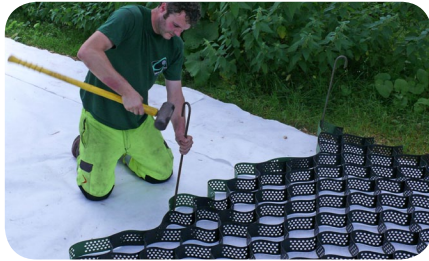
*Step 3: Pinning Cellweb® TRP*

- Pull out the Cellweb® TRP to its full 8.1m length and secure its length with another J pin.

- Now measure its width to 2.56m and secure in each of the corners with the J pins.
- Use 10 pins per panel to create a panel measuring 8.1m x 2.56m.

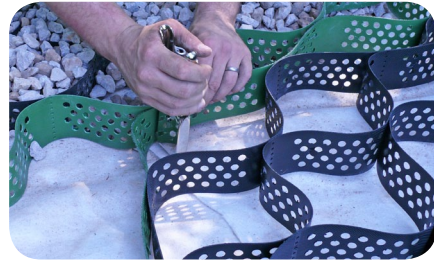
*Step 3: Stapling Cellweb® TRP*

- This will produce a cell size of 259mm x 224mm which is the required cell diameter. Each cell must be fully extended and under tension.
- Staple adjacent panels together at each cell (see Note 3).
- If a curved path or shape is required, this should be cut when the Cellweb® TRP panel is pinned out to 8.1 x 2.56m, ensuring complete cells remain. Do not try to curve or bend the Cellweb® TRP panels into place.
- All cells must be fully opened to the required diameter.

3. **Staples:** Number of staples per join: 200mm: 5 staples. 150mm: 4 staples. 100mm: 3 staples. 75mm: 3 staples.
4. **Granular Fill:** Open graded sub-base, clean angular stone Type 4/20 or Type 20/40. Please refer to BS7533-13:2009 and to the Design Manual for Roads and Bridges (DMRB), Volume 4 Geotechnics and Drainage, Section 1 Earthworks, HA44/91, Volume 7 – IAN 73/06 Design Guidance for road pavement foundations and Manual of Contract Documents for Highway Works (MCHW), Volume 1 Specification for Highway Works for the construction and maintenance of the fill material.

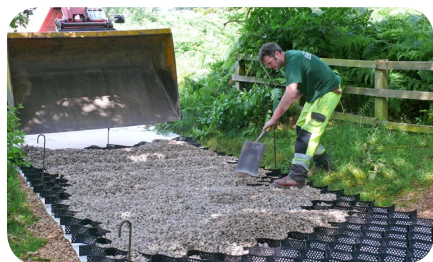
*Step 4: Clean Angular Stone*

## 4. Infill the Clean Angular Stone

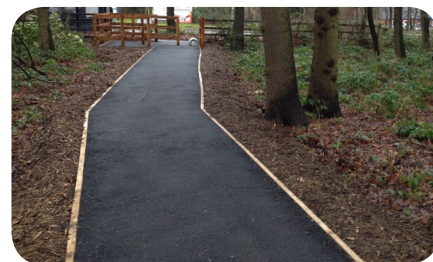
*Step 6: Surface Options*

- All surfaces in Root Protection Areas must be porous. Surfaces can include block paving, asphalt, loose gravel, grass and gravel retention systems (e.g Golpla), resin bound gravel, concrete etc.

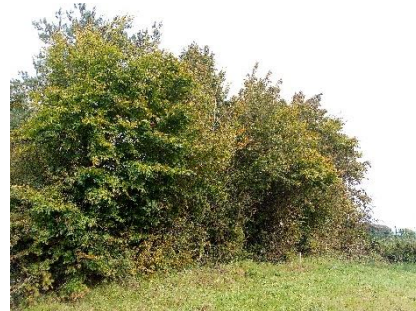
Outgrown hedgerow on north boundary
