## CARDONNEL COURT CARE FACILITY

**CARDONNEL COURT NURSING HOME, CARDONNEL ROAD,  
NEATH**

**BAT SURVEY**

### Cardonnel Court, Cardonnel Road, Skewen, NEATH

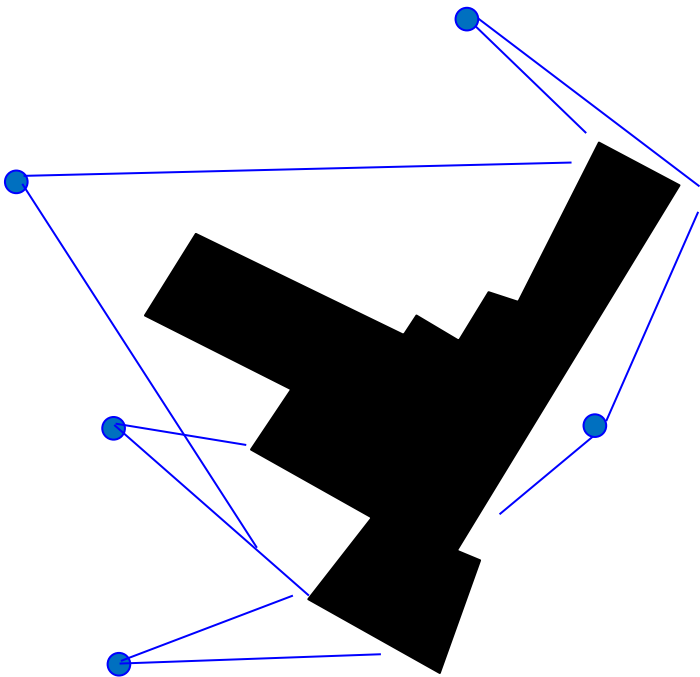
A dusk survey was carried out on 3<sup>rd</sup> May 2023 using surveyors, positioned in such a way that as much of the building was visible to surveyors as possible. Surveyors and cameras were equipped with Batlogger M detectors.

Approximate surveyor location

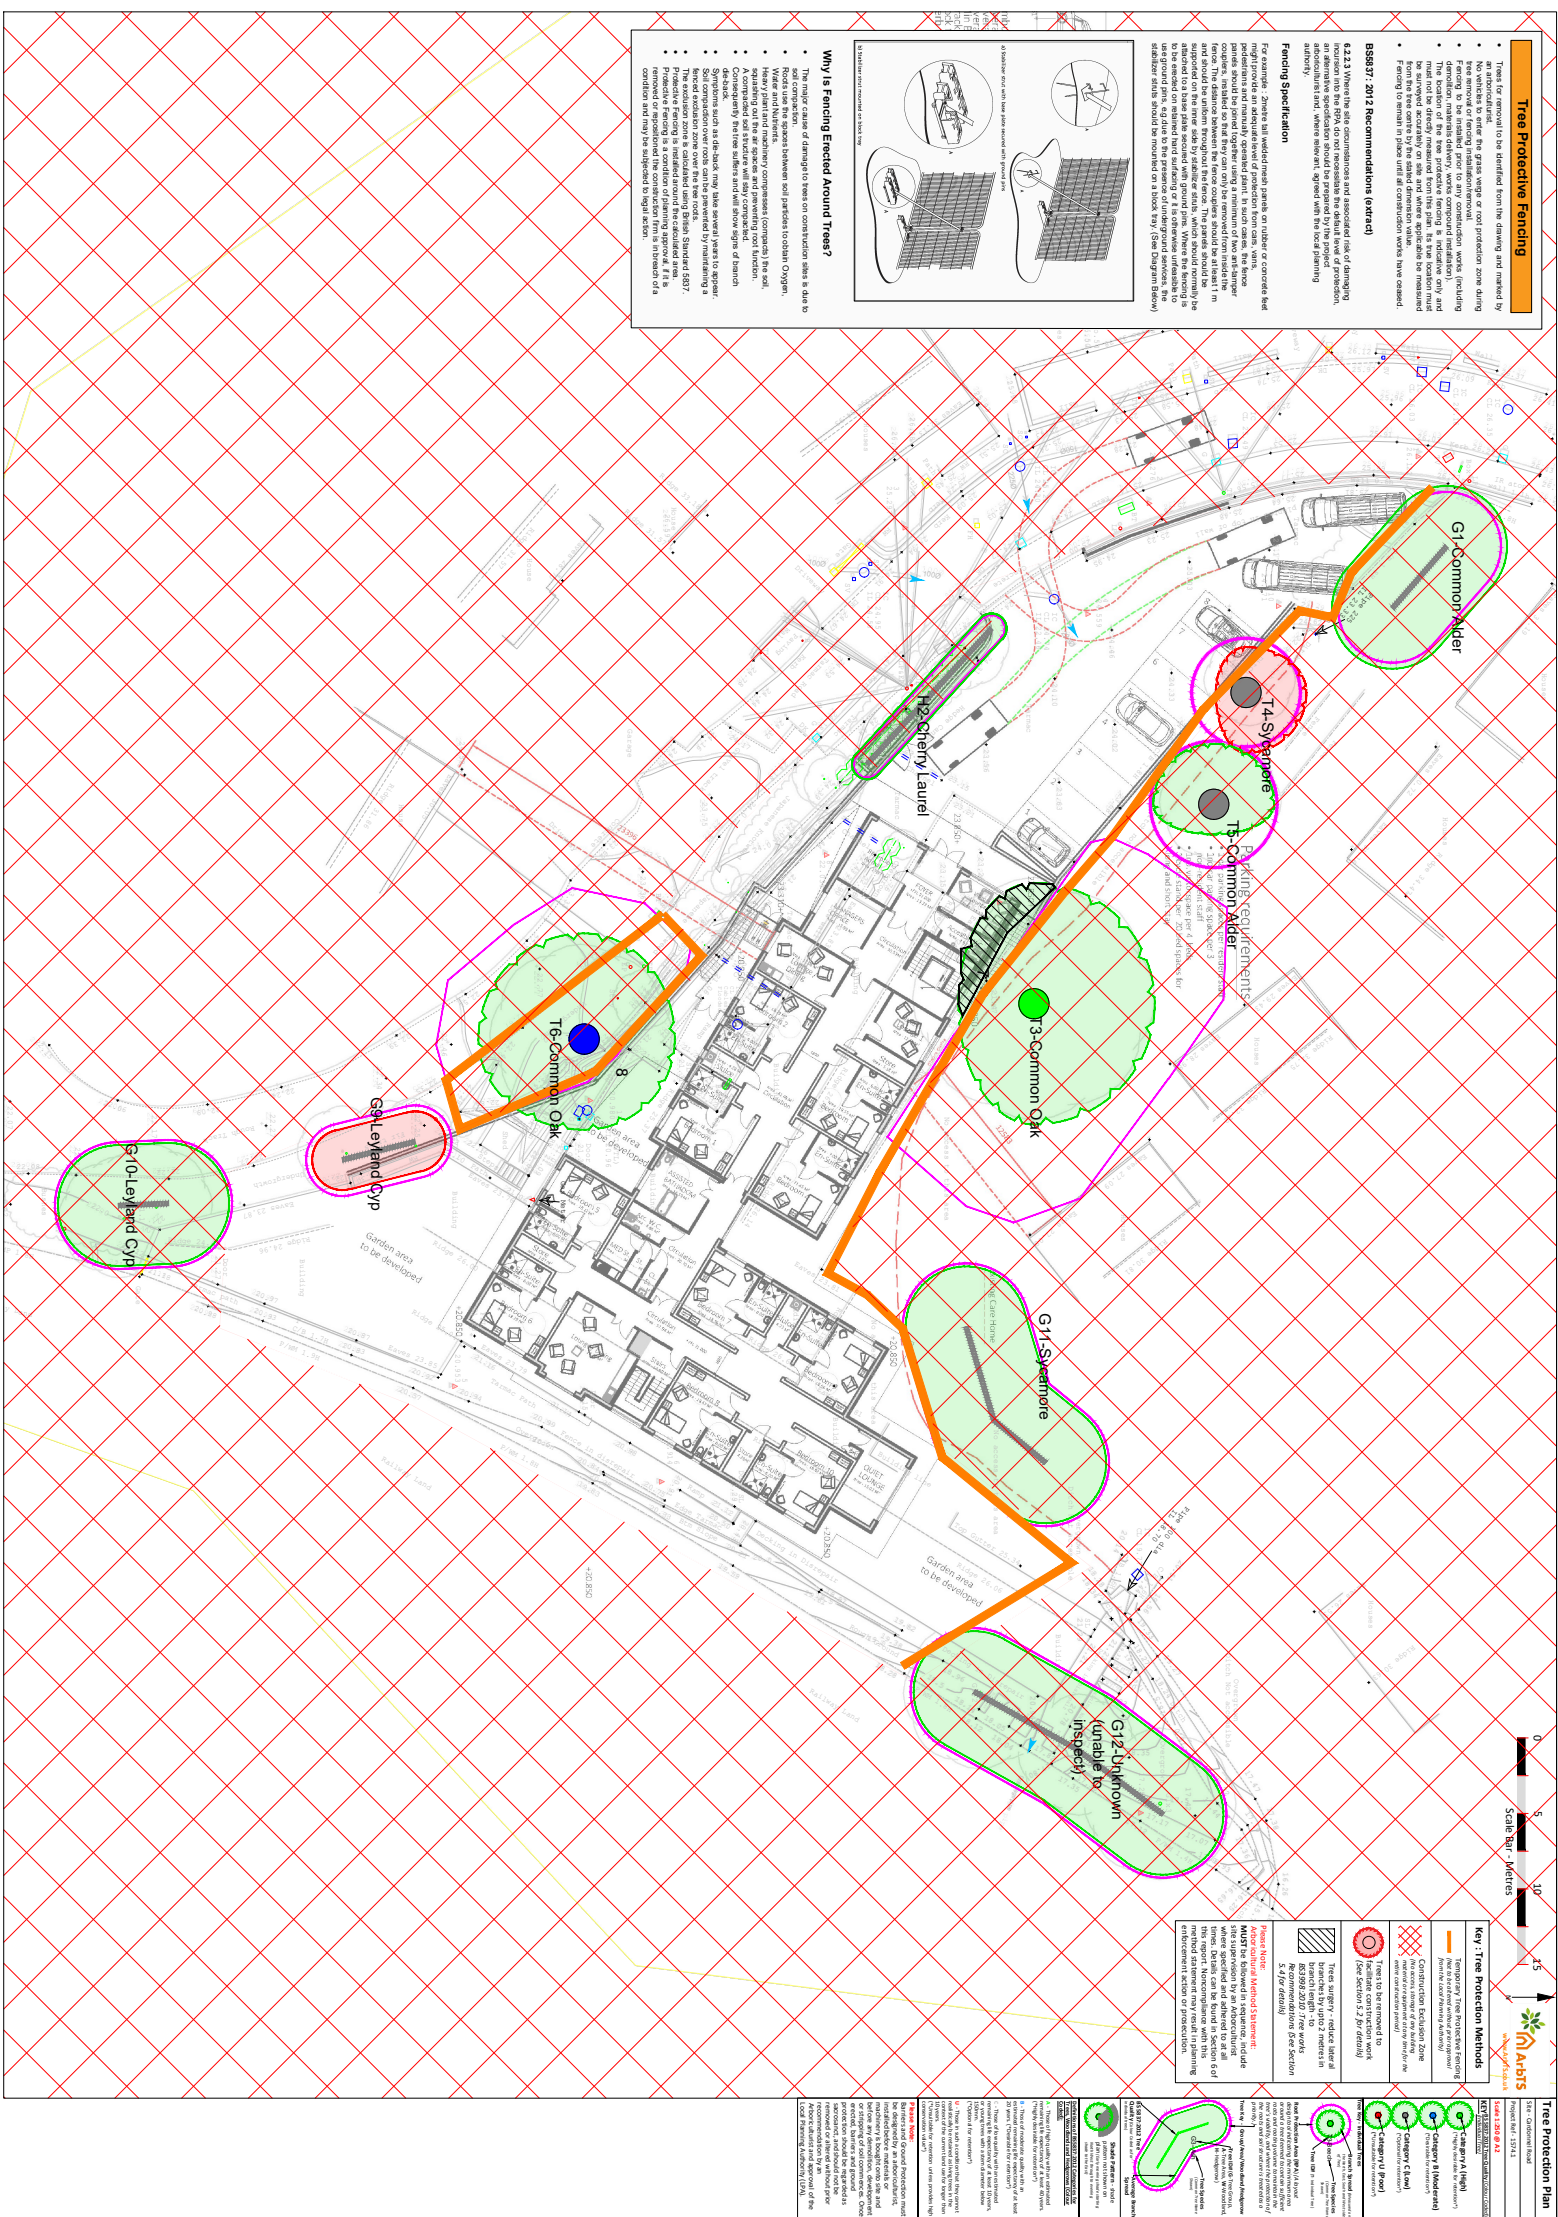
## 10.0 Appendix 4 – Tree Protection Plan

- 6.1 The Tree Protection Plan to facilitate the construction of the development design can be found in Appendix 4 of this report. The Tree Protection Plan must comply with all of the following:
- Be regarded as sacrosanct and follow the sequence of events as detailed in the table below
  - Be installed before commencement of any demolishing or construction works on site
  - Must not be removed or altered without prior approval of the local planning authority
- 6.2 The following table below provides a detailed sequence of events that must occur to protect the retained trees during all stages of the construction process. These methods must be communicated to the entire construction team before any work on site.

5.4 Tree surgery work – AIA – LOW- Some minor branch reduction/branch lifting pruning work will be required to facilitate this proposed scheme, as detailed in the tree protection plan (Appendix 4). This work will be carried out to the *British Standard 3998:2010 tree work recommendations*. Adhering to this standard will ensure no adverse impact on these trees' long-term health or visual amenity.

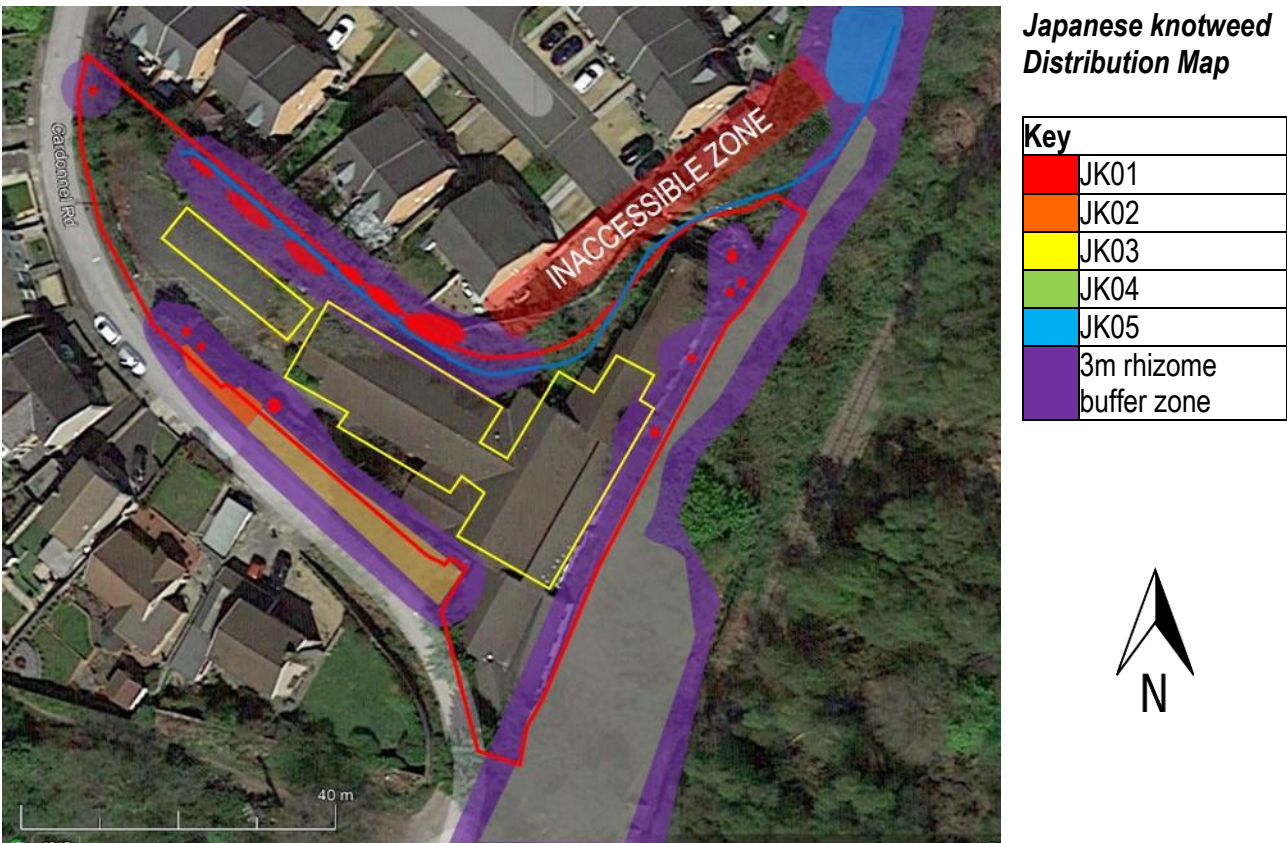
#### 3.2. Japanese knotweed Distribution Map

- The Japanese knotweed was observed in several locations around the site but all on the boundary perimeter.
- Japanese knotweed areas are as followings;
  - JK01, within the site boundary. subdivided into 4 different locations (JK01a, b, c & d)
  - JK02; along the boundary with Cardonnel Road
  - JK03; along the boundary with Cardonnel Road showing evidence of herbicide treatment
  - JK04; along the railway track showing evidence of herbicide treatment
  - JK05; to the north east of the site other side of the stream

- In the **3.2. Japanese knotweed Distribution Map** the purple area is the theoretical 3m buffer zone potential underground rhizome growth around all visible areas of Japanese knotweed.

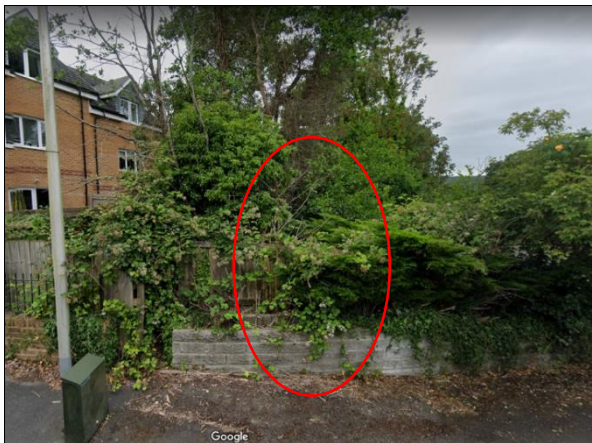
Google Street View photos showing no live Japanese knotweed growth in June 2022 in area JK01a

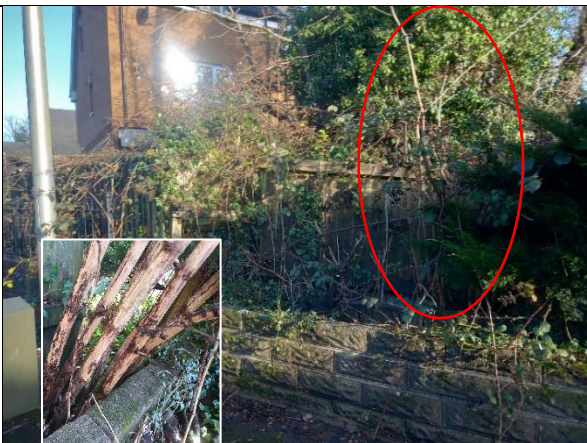
During the site visit on 19 Jan 2022, faded brittle standing canes assumed to be from 2021 season

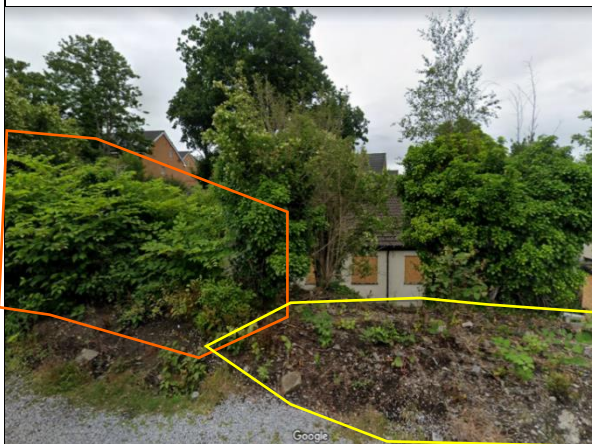
Google Street View photos from June 2022; JK03 yellow showing evidence of herbicide treatment

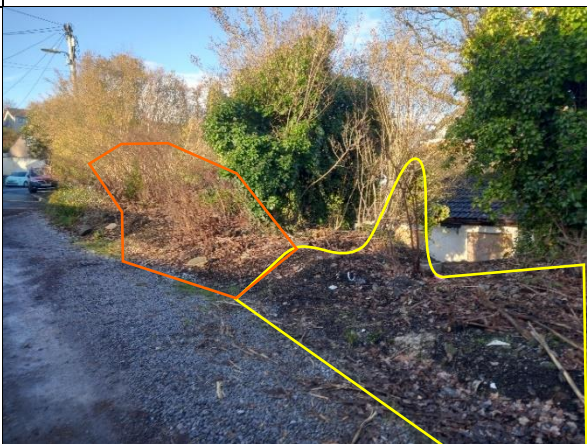
Site visit 19 January 2022; JK03 yellow showing bare ground, short thin sporadic regrowth

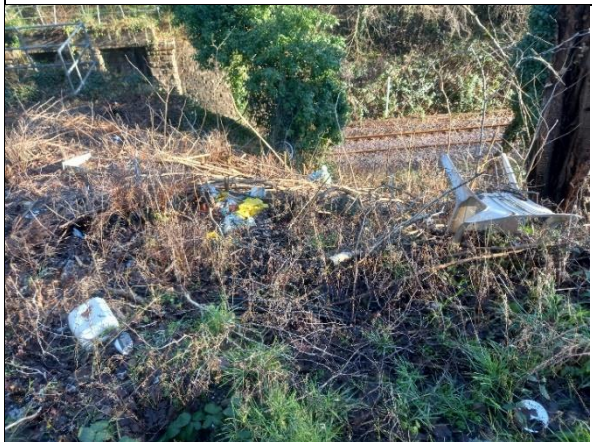
JK04 on railway embankment showing old large knotweed crowns (dark brown lumps in photo on the right), bare ground and short thin sporadic regrowth and some sub lethal bonsai growth

- The Japanese knotweed area JK04 along the railway embankment looking at Google Earth images shows it was a large mature and established area of knotweed from appeared from at least 1999 (large knotweed crowns still in evidence on site) but the aerial images appear to show treatment from 2016. During the site visit on 19 January 2022 the evidence supports this in area JK04 with remaining short thin sporadic regrowth and sub lethal bonsai growth typical of glyphosate based herbicide treatment.

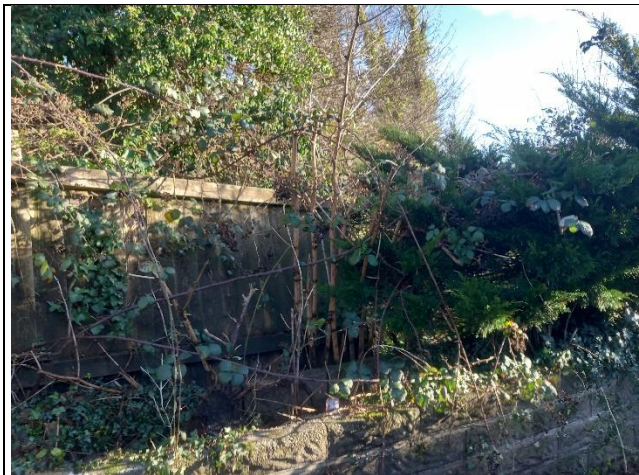
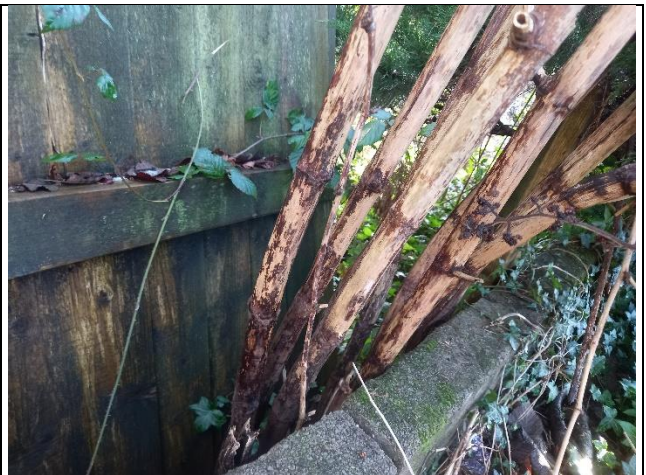
4.1.a. JK01a

During the site visit on 19 Jan 2022, faded brittle standing canes assumed to be from 2021 growing season

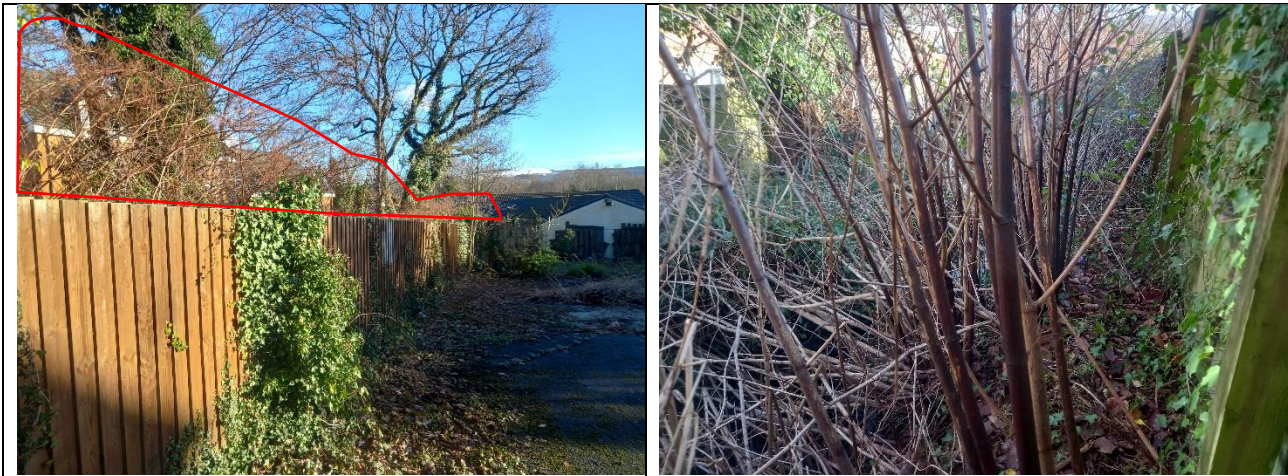
General area of JK01a behind the fencing with tall stems from 2022 growing season still standing with brown orangey seed stalks still in place

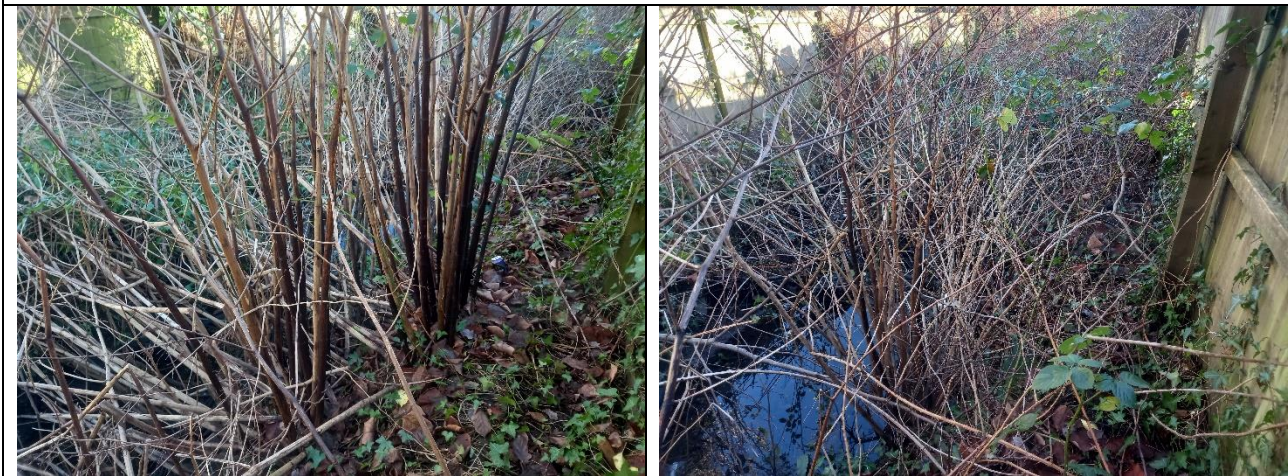
JK01b: Tall thick dark black brown robust canes from the 2022 growing season and tall thick faded and fragile canes from the 2021 growing season all along the southern stream bank

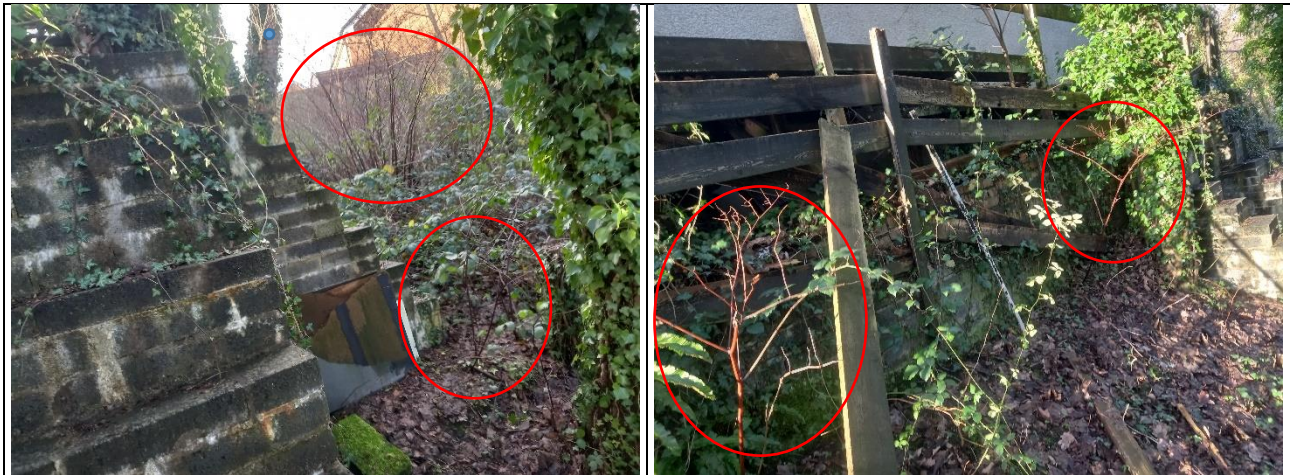
Several individuals stems with one larger area with multiple canes

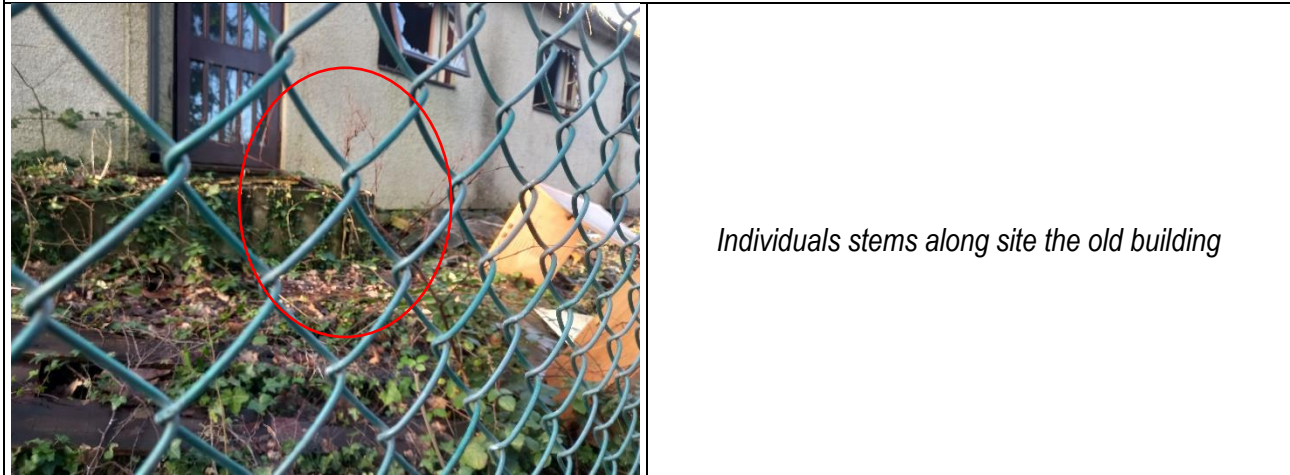
Individuals stems along site the old building

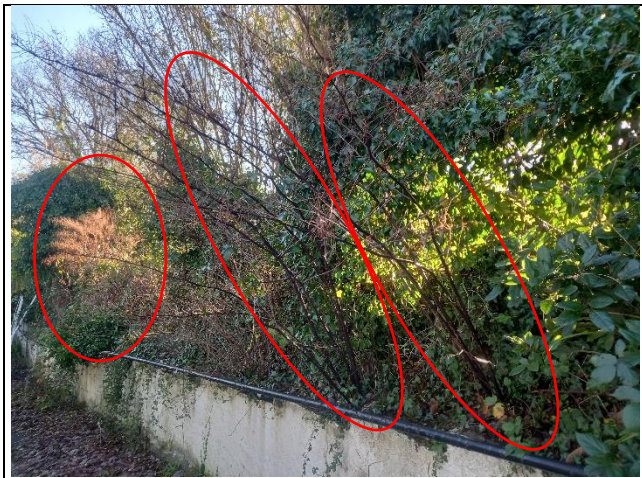
3 small area of mature established knotweed in the bank next to the entrance to the old building

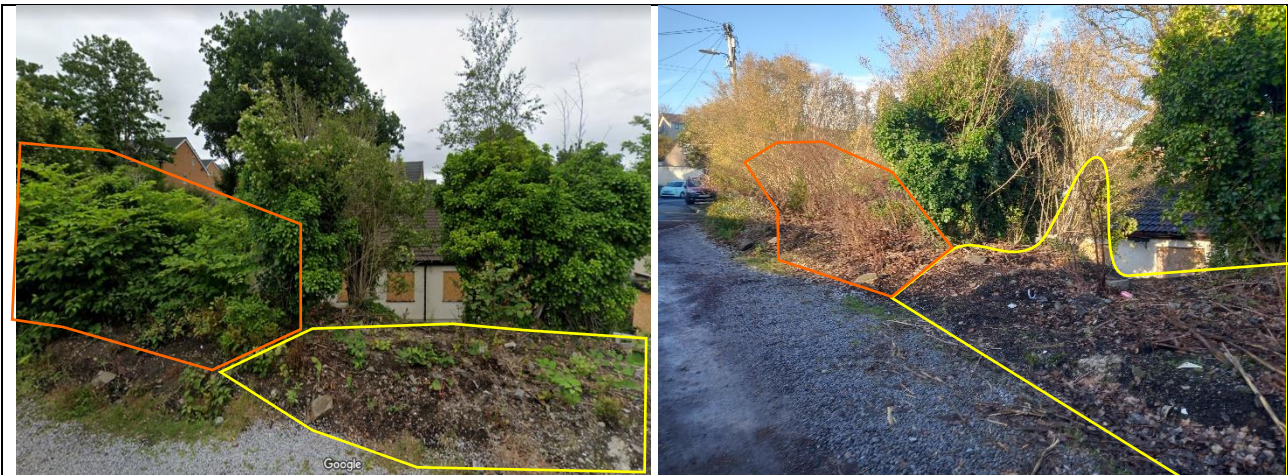
Google Street View photos from June 2022; JK03  
JK02 orange untreated area

Site visit 19 January 2022; JK03 yellow showing  
JK02 orange untreated area

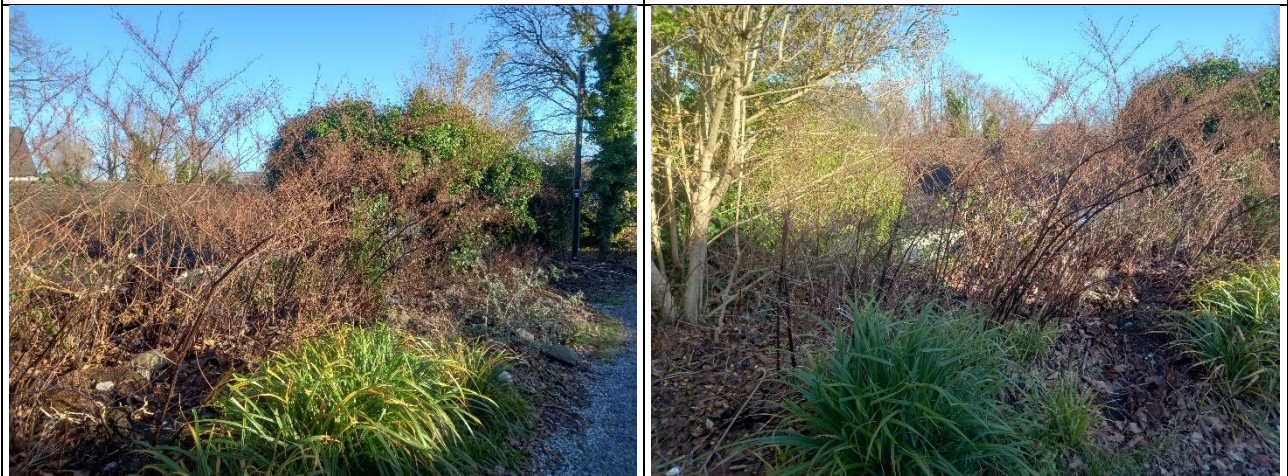
JK02 Tall thick dark black brown robust canes standing with brown orangey seed stalks still in place

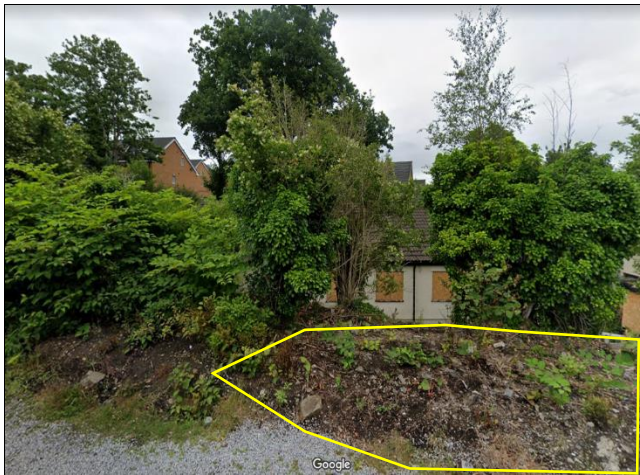
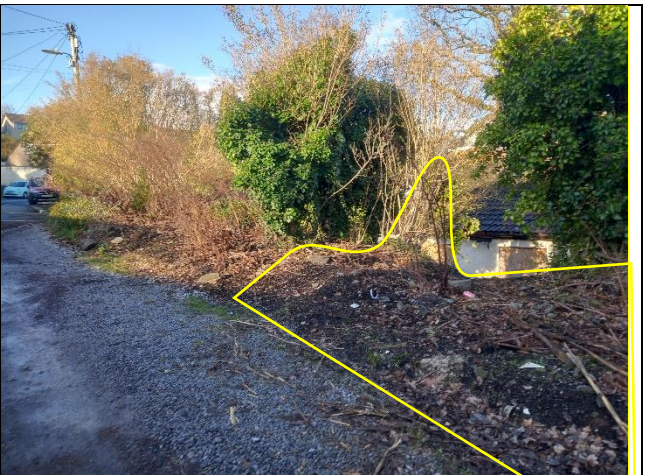
| Google Street View photos June 2022; JK03 yellow showing bare ground & short thin sporadic regrowth | Site visit 19 January 2022; JK03 yellow showing bare ground & short thin sporadic regrowth |

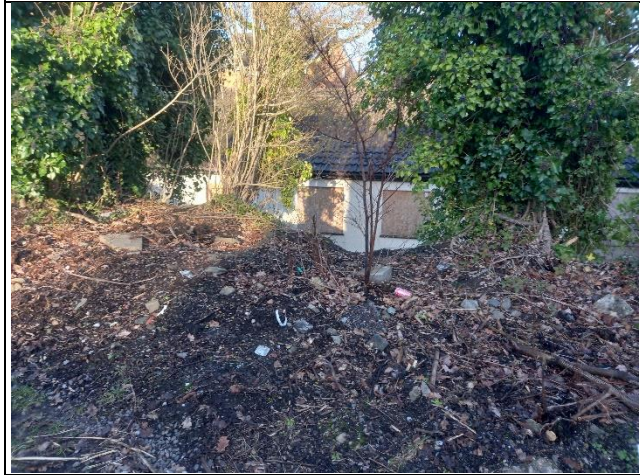
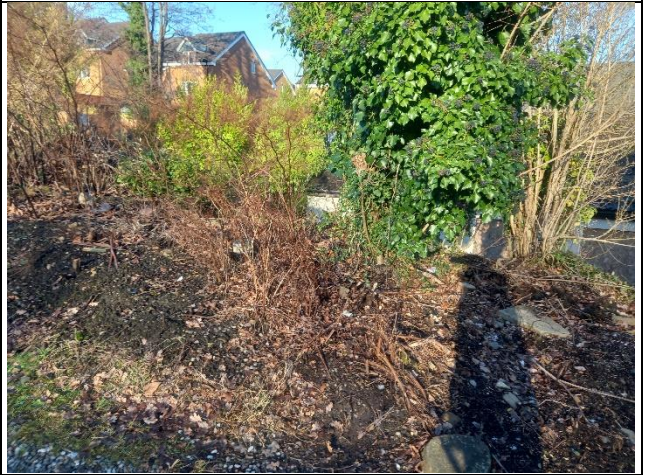
| Bare ground and short thin sporadic regrowth all evidence of herbicide treatment | |

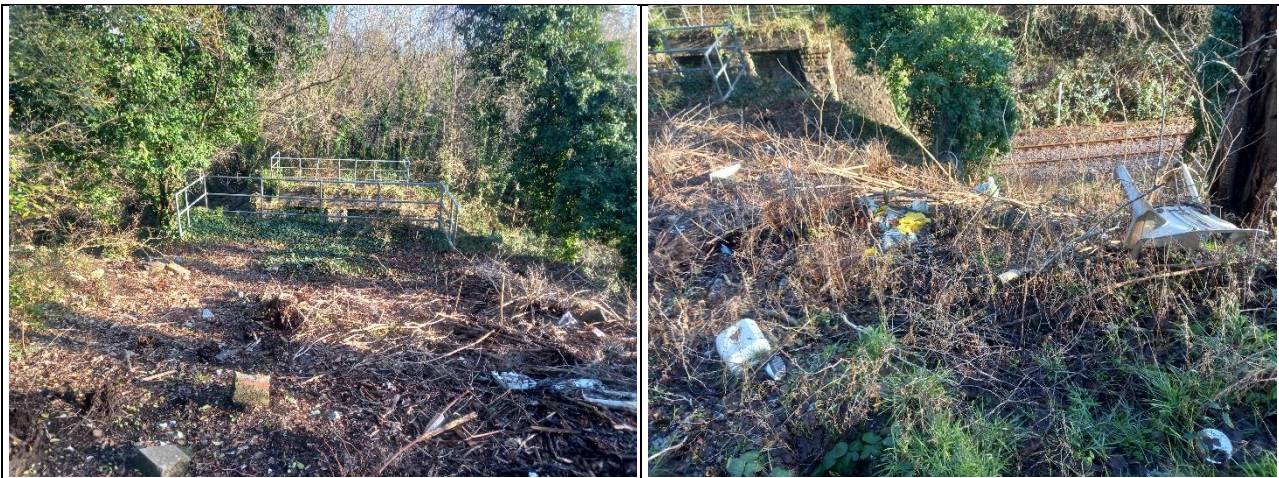
Winter remains of short thin sporadic growth & some stems with stunted deformed regrowth called sub lethal bonsai growth but mainly bare earth with limited revegetation

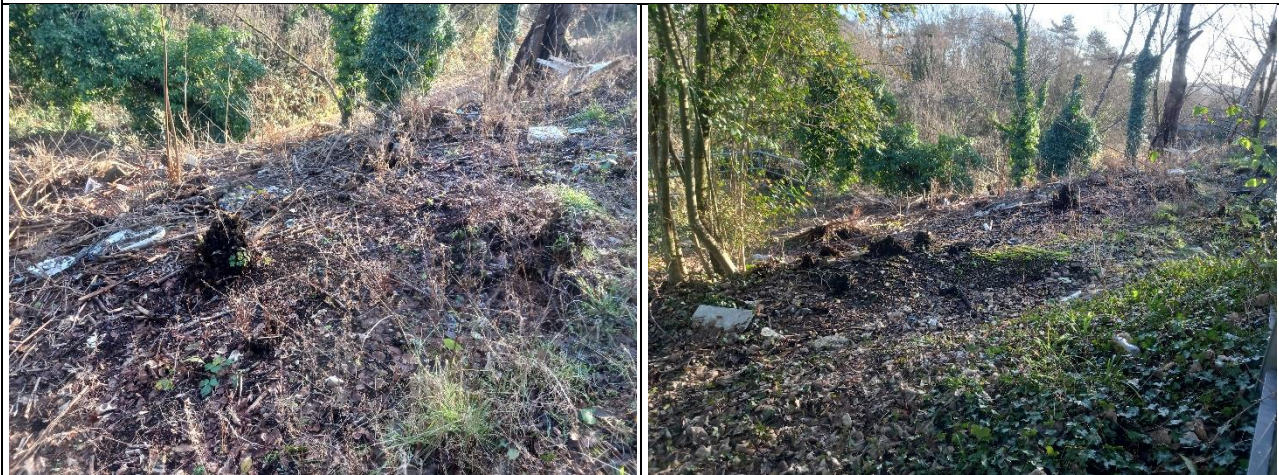
Large old crown old established mature knotweed (brown lumps)

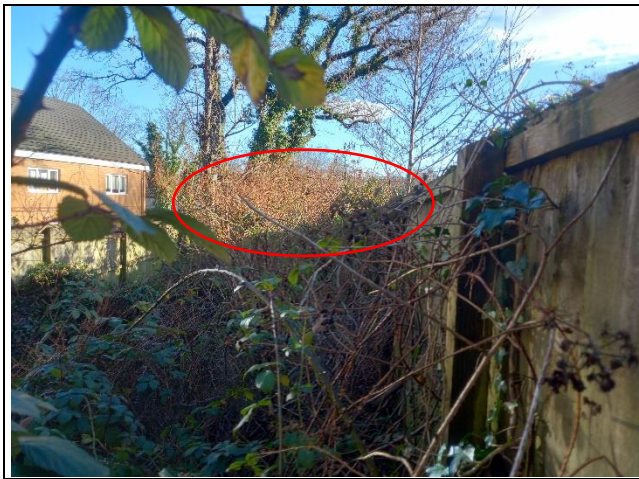
| | <p><i>In an inaccessible zone but appears to be tall thick dark black brown robust canes with brown orangey standing and seed stalks still in place</i></p> |

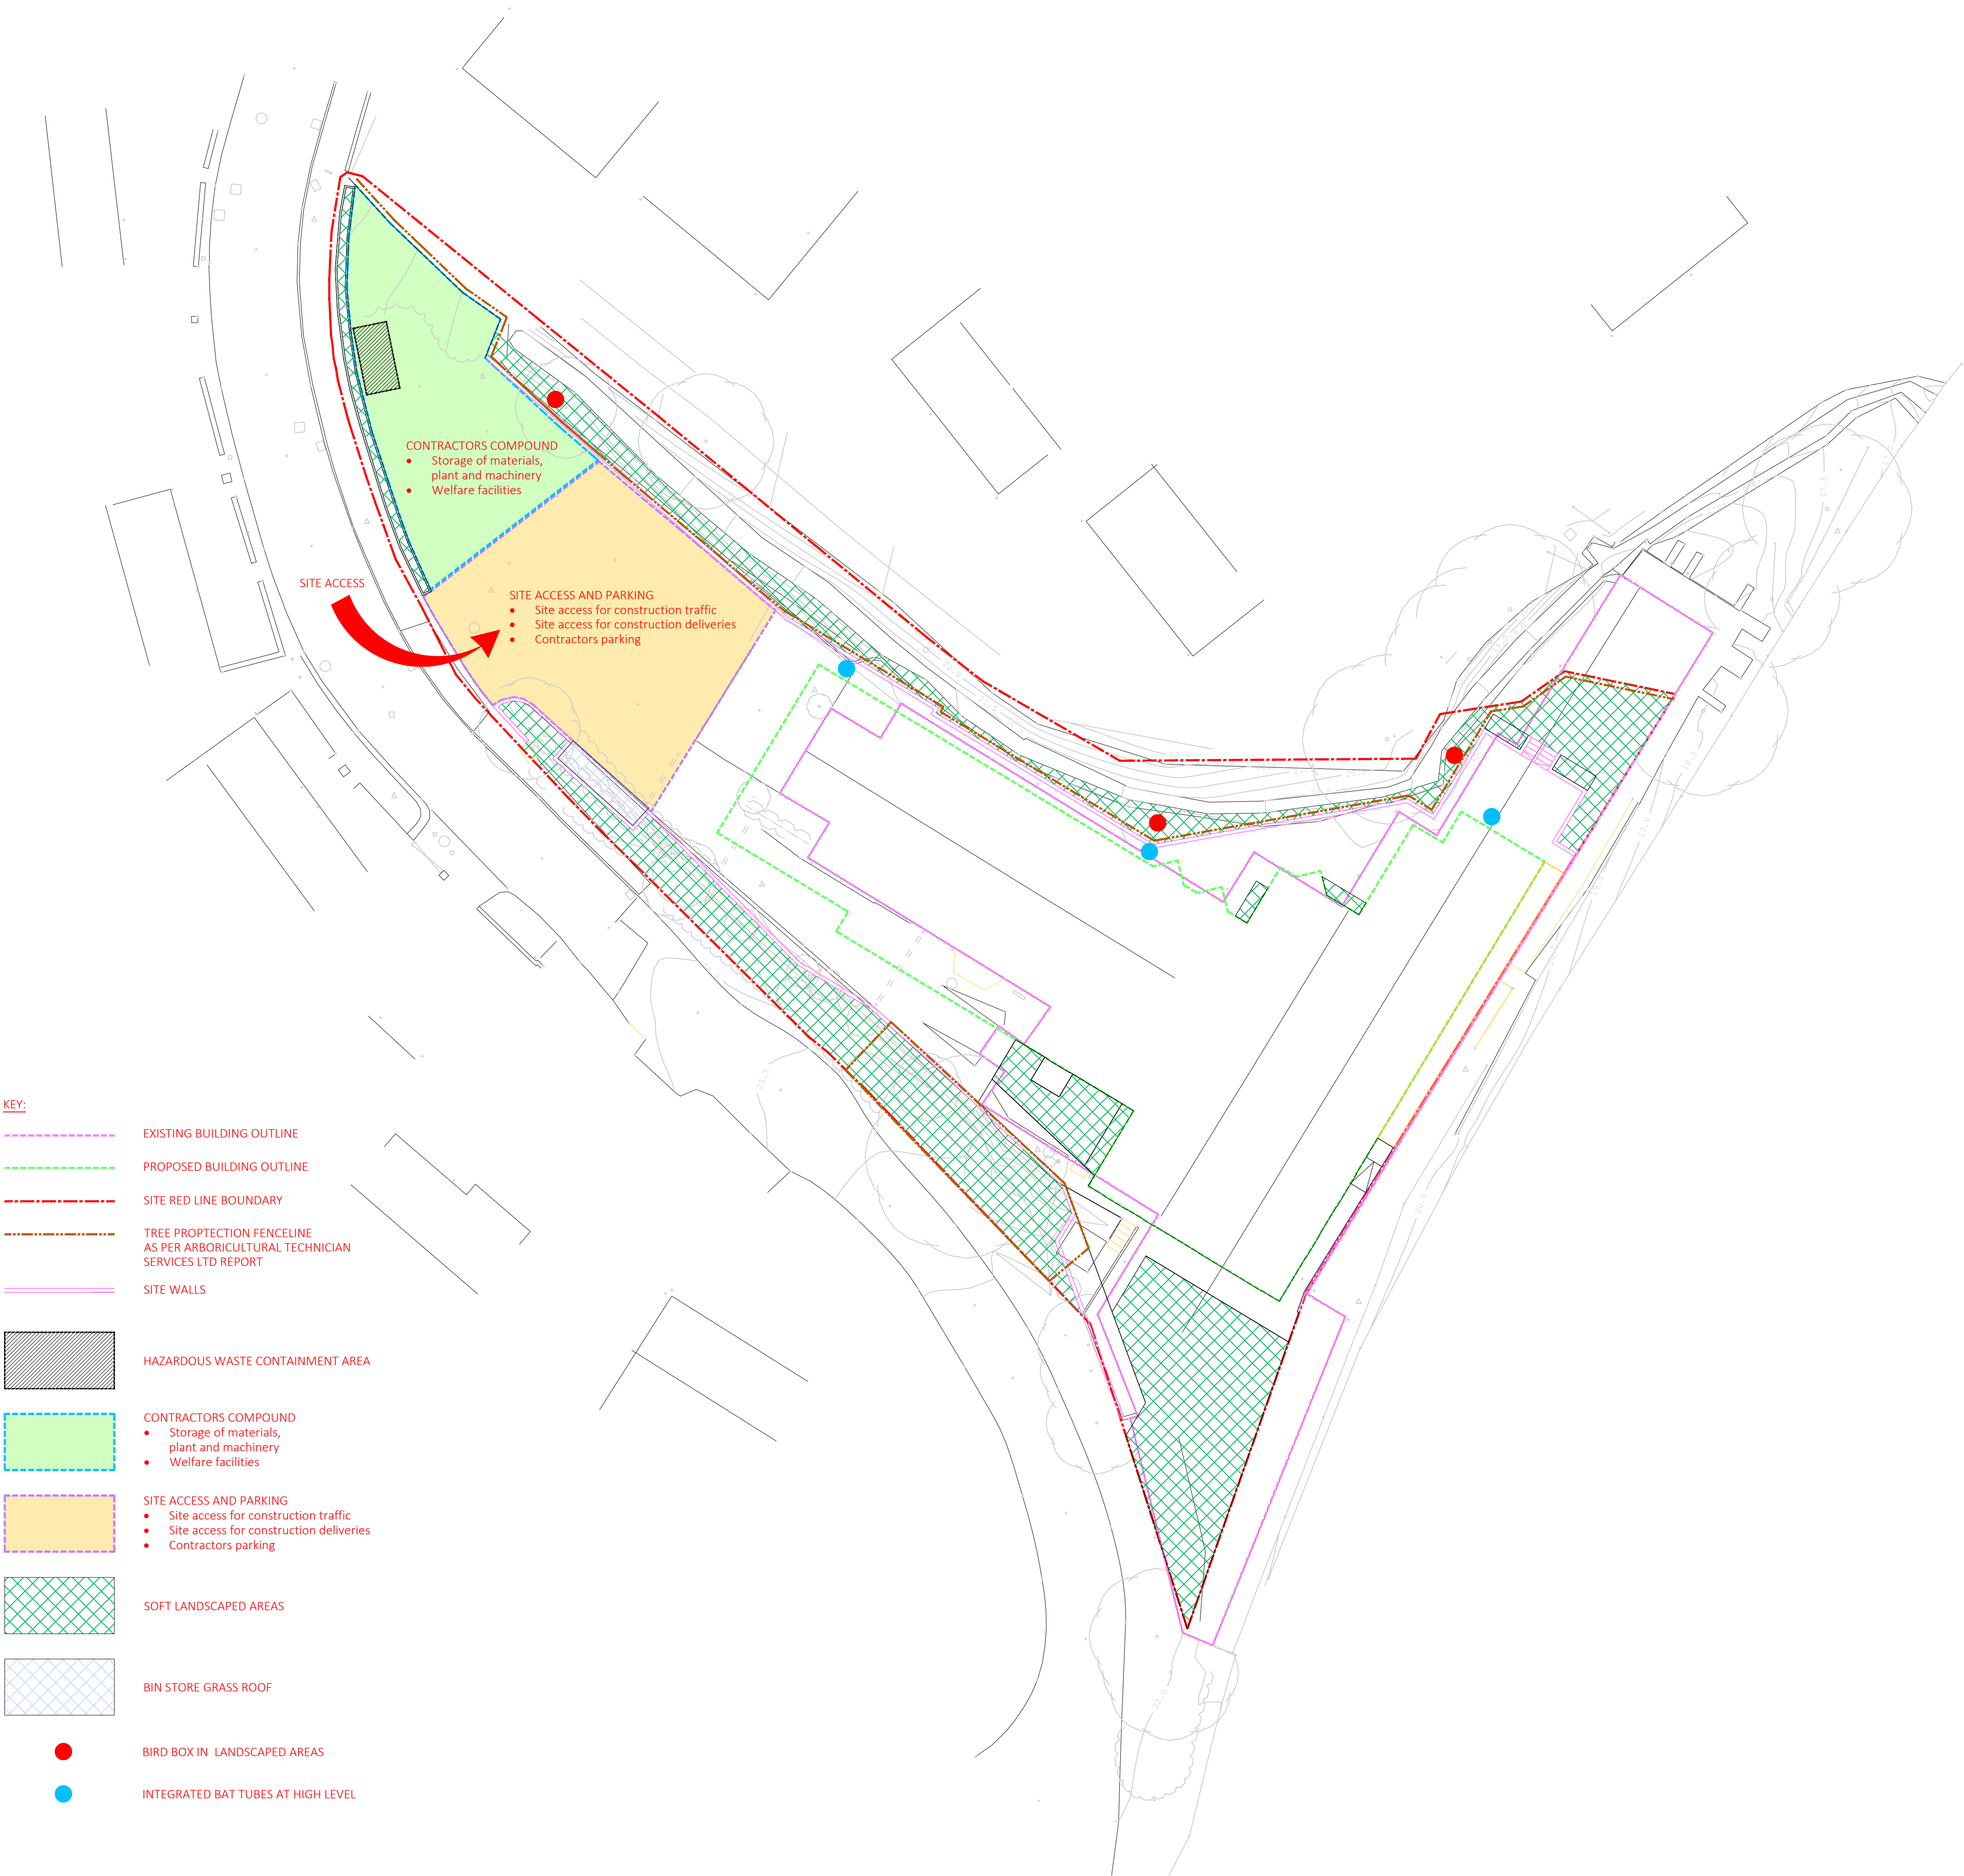
**APPENDIX 6 – CEMP MASTERPLAN**

- KEY:**
- EXISTING BUILDING OUTLINE
  - PROPOSED BUILDING OUTLINE
  - SITE RED LINE BOUNDARY
  - TREE PROTECTION FENCELINE  
AS PER ARBORICULTURAL TECHNICIAN  
SERVICES LTD REPORT
  - SITE WALLS

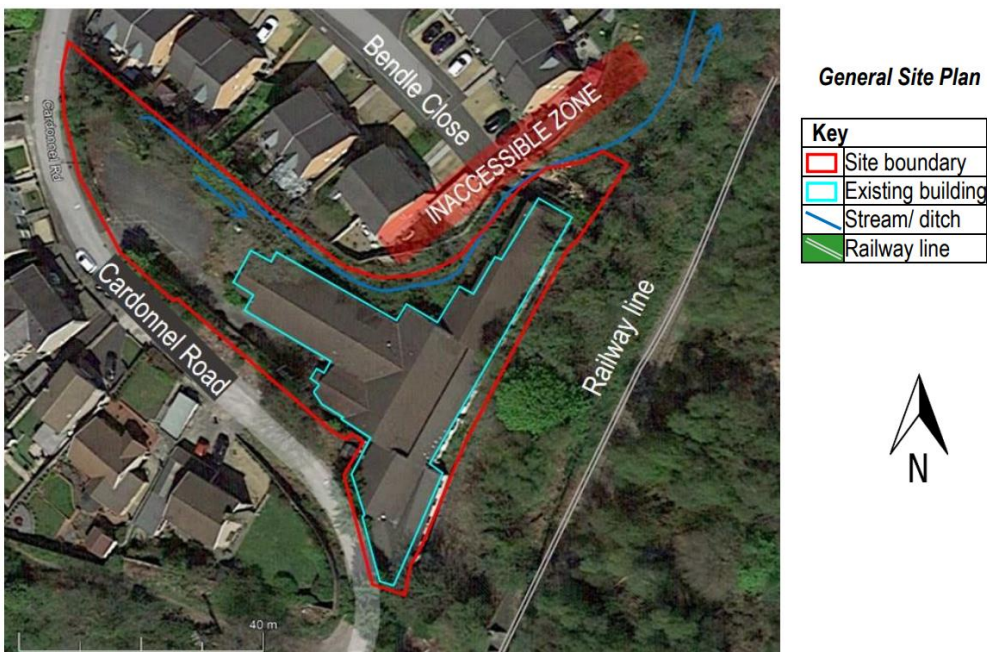
The boundary of site and agreed areas of works have been established by the client and Allclear Demolition. Additional 2.0m high Heras fencing will be utilised within the site as segregation, waste skip compounds and drop zone areas. Warning signs will be displayed at appropriate points of segregation throughout the site.

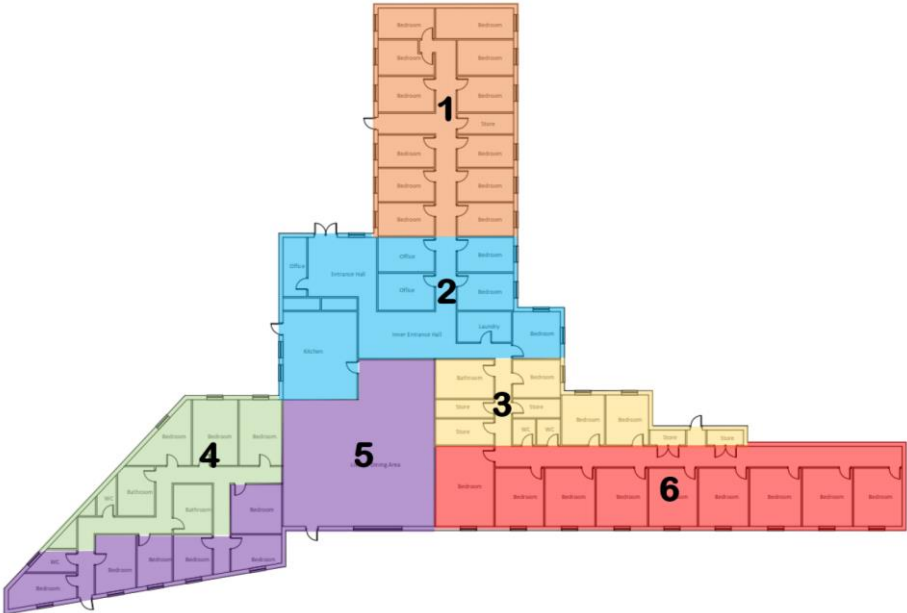
**Proposed Demolition Sequence**

*Following the internal soft strip, removing all materials not structural or integral to the building, the sequenced structural demolition down to existing slab level of the former nursing home building will commence. Consisting of brickwork façade, internal blockwork partitions, timber roof trusses with supporting timber beams, with a hipped tile covered roof. Roof structures are to be removed initially, followed by the external brick and internal blockwork partitions are to be raised to slab level, processing and removing all arisings from site.*

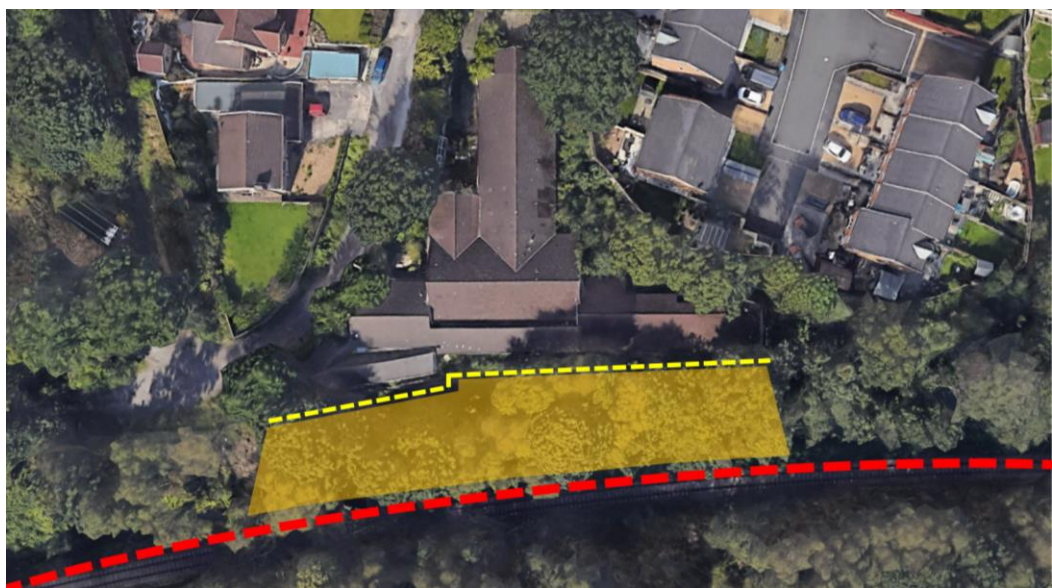
**Demarcation line – Yellow dash      Out of Bounds – Yellow      Live Railway Line – Red dash**

- 7.24 Manual Demolition will be considered when reducing the structural wall nearest to the NWR boundary fence utilising hand tools with access gained with the use of a tower scaffold, allowing arisings to fall within the building footprint.
- 7.25 On the attached plan below, hatched in yellow, this will be demarcated on site using the existing fencing. Operatives and plant shall not be positioned beyond this area. Highlighted in Yellow is a complete out of bounds area. At no time shall any plant, MEWP or the like work in this area. All excavators to be used are standard 360 excavators, no cranes, no long/ high reaches required for these works.
