# **ABP Port Centric Survey Report**

**APLS-1174 Harbourside Port Talbot  
Survey Control & Topographic Survey**

**APLS-1174 Harbourside Port Talbot  
Survey Control & Topographic Survey  
Survey Report**

**Report of Survey**

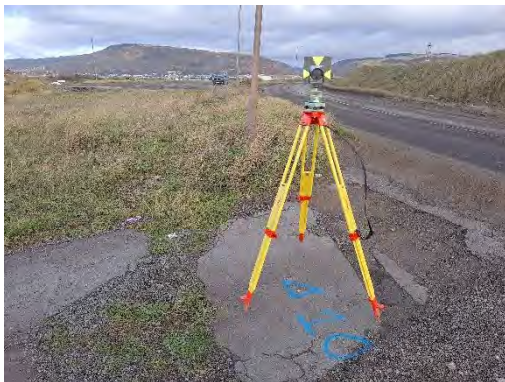
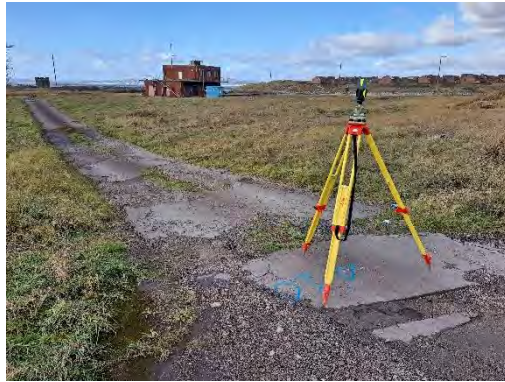
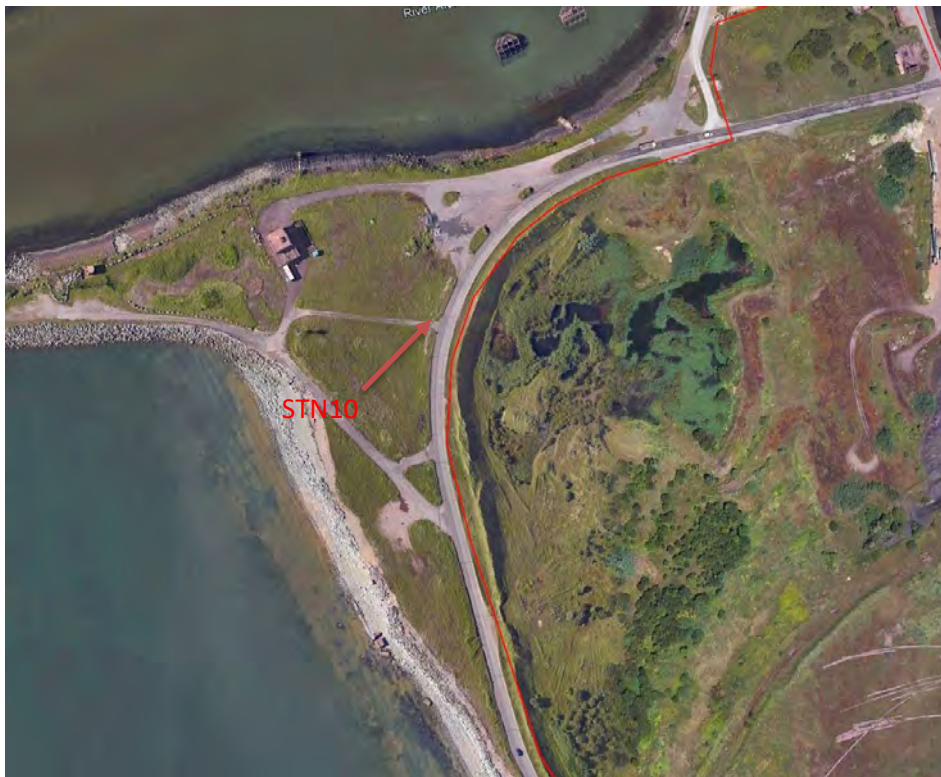
**Station ID :** STN10  
**Easting :** 275344.430  
**Northing :** 188557.341  
**Elevation :** 9.124mAOD  
**Description :** MAG nail & washer installed in tarmac access road.  
**Photos:**

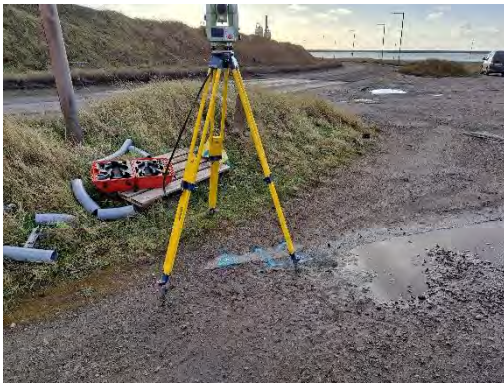
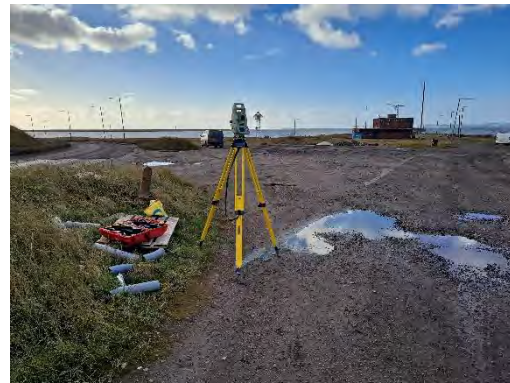
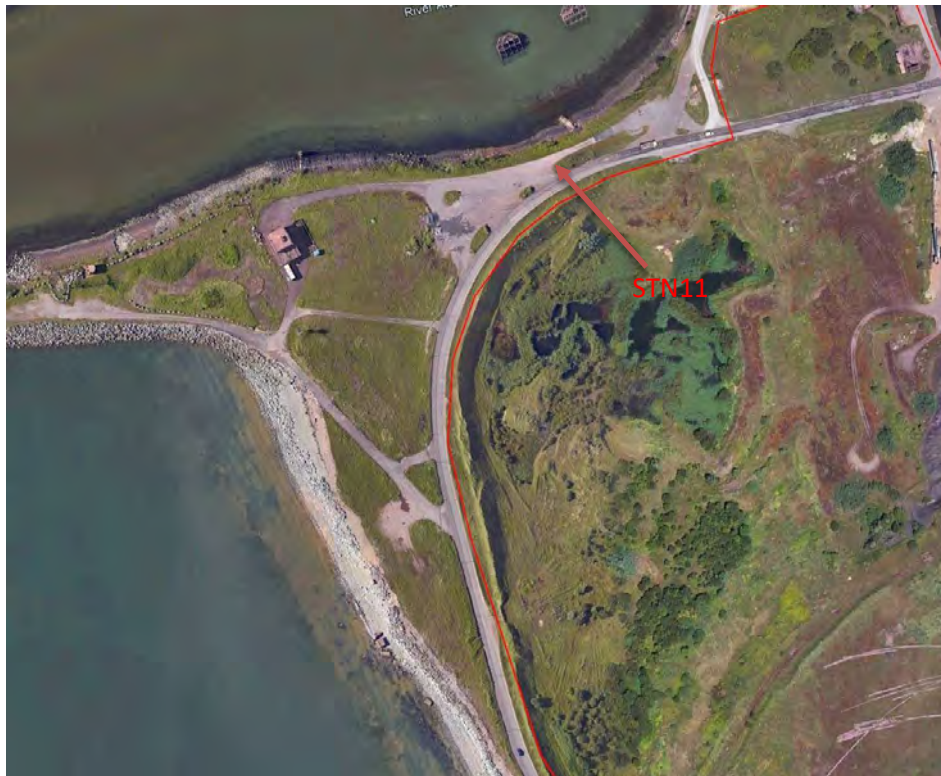
**Station ID :** STN11

**Easting :** 275398.920

**Northing :** 188635.081

**Elevation :** 10.647mAOD

**Description :** MAG nail & washer installed in tarmac access road
