## Car Park Extension & New Service Yard Area Ecological Assessment Gnoll Country Park

The project has been subdivided up into multiple planning applications and the focus of this report is the New Service Yard & Car Park Extension.

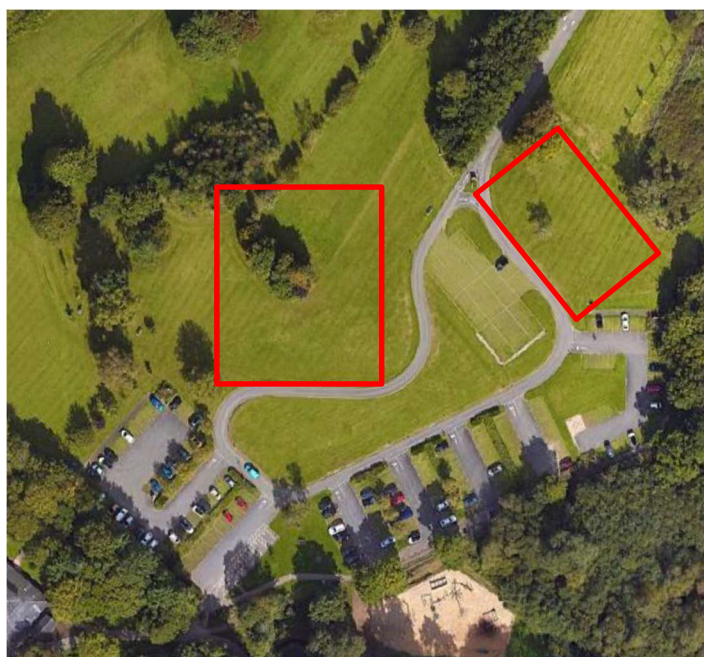
Figure 1- Car Park Extension locations

The Proposed Car Park Extension is located on species poor amenity grassland to the North east and the West of the existing car park. One tree is being removed as part of the works, however this tree (Grey Alder – *Aldus incana*) is dead and dying so would have to be removed as part of the normal tree works in the Country Park.

The car park extension will be built close to existing trees however appropriate tree protection

measures will be put in place to ensure there is no damage to these trees from the works (See the BS5837:2012 Tree Survey and Arboriculture Constraints Report produced July 2023 – Nick Thomas).

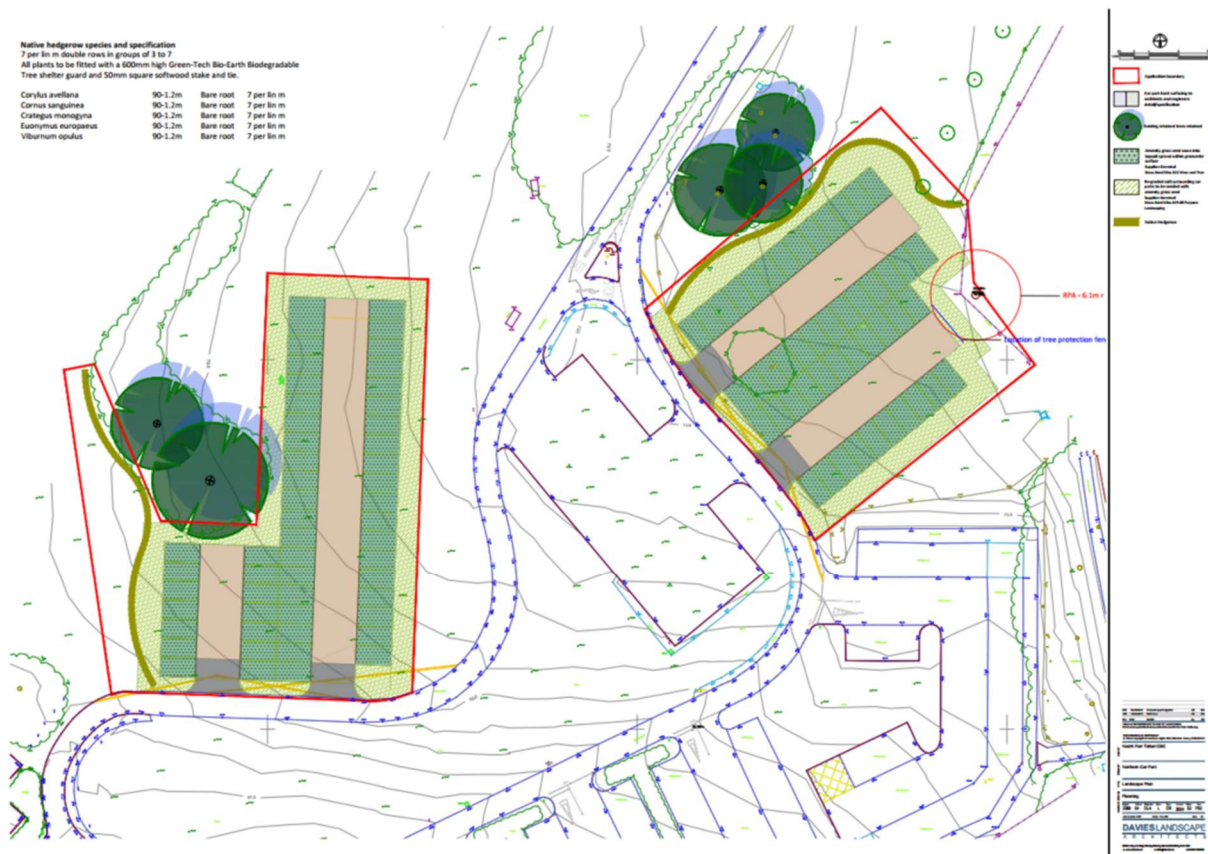
*Figure 2 - Car Park Extension Landscaping Proposals*

To ensure there is an overall biodiversity enhancement provided as part of this scheme, Figure 1 below shows the landscape proposals. 2 lines of native hedgerow will be planted adjacent to the car park extension areas.

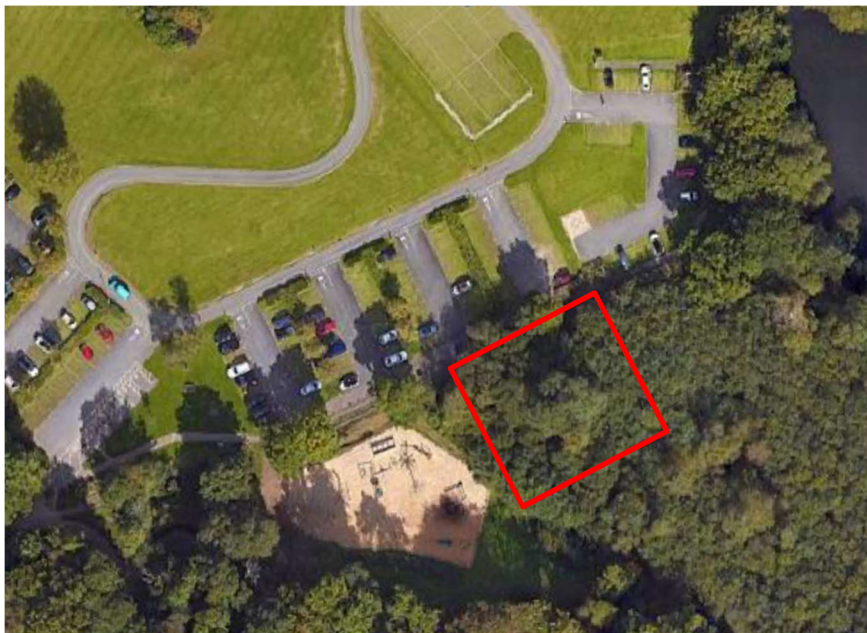
*Figure 3- Location of new service yard*

The new service yard area is located to the west of the existing car park in an area of Alder and Goat Willow scrub. There is a large oak tree to the north of the area however this tree will be protected with appropriate measures (See the BS5837:2012 Tree Survey and Arboriculture Constraints Report produced August 2023 – Nick Thomas).

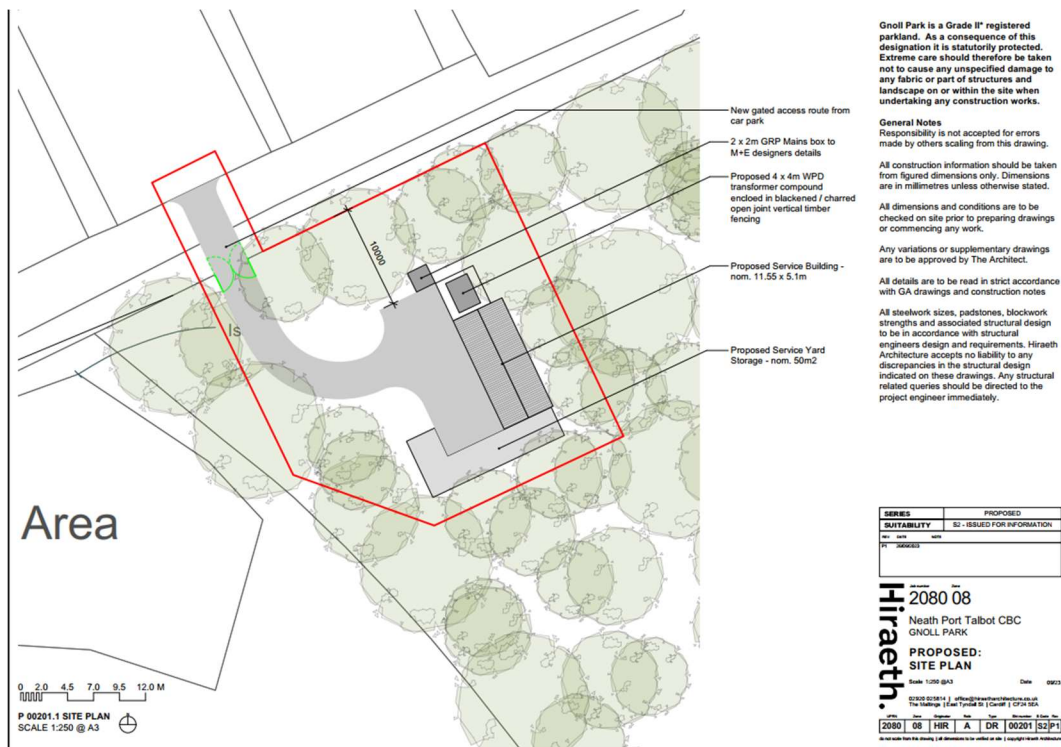
Approximately 700m<sup>2</sup> of scrub woodland will be cleared to allow for the proposed service yard (Figure 3 below shows the proposed plan). All the trees are semi mature and small in size with a dense growth that makes entry into the area very difficult. No ecological constraints are associated with the clearance of this scrub to allow the service yard to be constructed.

To compensate and enhance for the loss of this scrub woodland, the adjacent scrub woodland areas will be entered into a woodland management plan, currently the area to be managed has not been decided however it will be at least 3 times the size of the area cleared to allow works to proceed. The management of the adjacent woodland will promote good ground flora and allow the tree canopy to develop properly. Resulting in more biodiverse woodland for the future.
