## Arboricultural Report

To the British Standard 5837:2012  
*(Trees in relation to design, demolition  
and construction. Recommendations)*

Site – 16 St Davids Park, Margam, Port Talbot, SA13 2PU

Project Reference – ArbTS\_1861.1\_16 St Davids Park

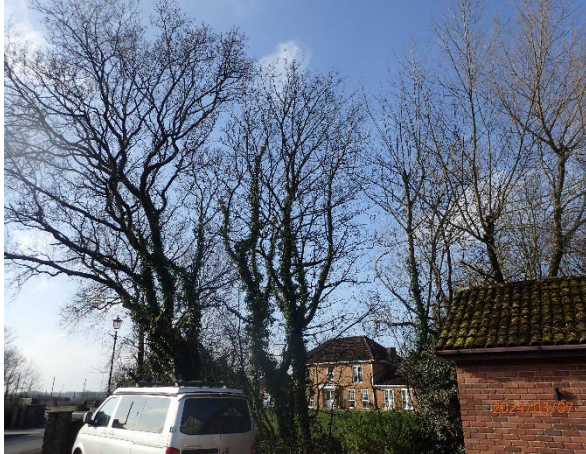
Tree ID#T1, G1 , T3

| Tree ID # | Tree Species | Age | Stems | Stem Diam (mm) | Cat | Height + (Lower Branch Height) | Nrth | Est | Sth | Wst | Phys Cond | Struc Cond | Est. Remain Contrib | Comments | Preliminary Management Recommendations | Work Priority | RPR (m) | RPA (m2) |
|---|---|---|---|---|---|---|---|---|---|---|---|---|---|---|---|---|---|---|
| G1 | Acer pseudoplatanus (Sycamore) | EM | 1 | 350 | C2 | 12(5) | 5 | 5 | 3 | 4 | G/F | F | 20+ | group of sycamore stems forming a rough whole, ivy cover on trunks | | | 4.2 | 55.42 |
| T1 | Quercus robur (Common Oak) | M | 1 | 600 | B2 | 12(5) | 8 | 9 | 7 | 6 | G/F | F | 20+ | large end tree, of fair form, slightly unbalanced in crown form, longer over extend eastern lateral branches noted, some lower branches pruned poorly | | | 7.2 | 162.9 |

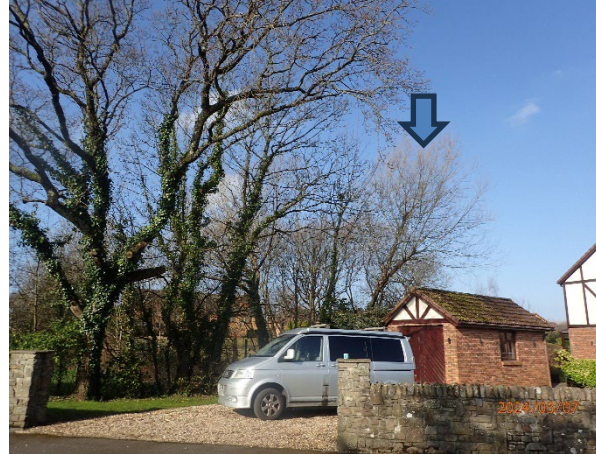
Tree ID#T3 – arrow below

| Tree ID # | Tree Species | Age | Stems | Stem Diam (mm) | Cat | Height + (Lower Branch Height) | Nrth | Est | Sth | Wst | Phys Cond | Struc Cond | Est. Remain Contrib | Comments | Preliminary Management Recommendations | Work Priority | RPR (m) | RPA (m2) |
|---|---|---|---|---|---|---|---|---|---|---|---|---|---|---|---|---|---|---|
| T3 | Salix caprea (Goat Willow) | M | 1 | 250 | C2 | 8(4) | 5 | 5 | 0 | 0 | F | F | 10+ | leaning tree of fair to poor form | | | 3 | 28.28 |

- 5.4 Tree surgery work – AIA – LOW - Some heavy pruning work will be required to T3 (Low-quality Goat willow) due to its form and to facilitate this proposed scheme, as detailed in the tree protection plan (Appendix 4). This work will be carried out to the *British Standard 3998:2010 tree work recommendations*. Adhering to this standard will ensure no adverse impact on these trees' long-term health or visual amenity.

1.) Tree Surgery Work - T3 - Low quality Goat willow - Due to form and proximity to extension reduce to 3 metres in height to allow to regenerate

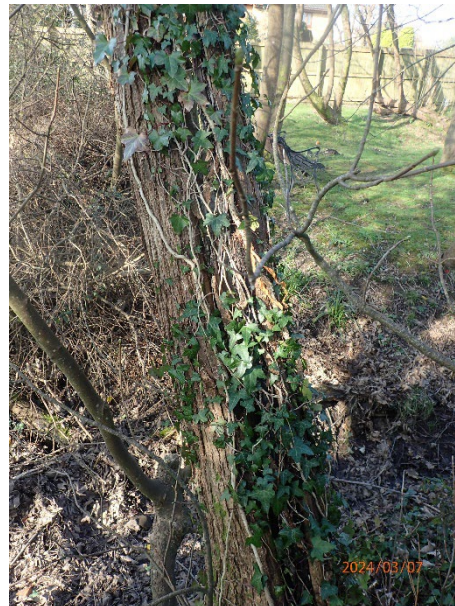
| Tree ID # | Tree Species | Age | Stems | Stem Diam (mm) | Cat | Height + (Lower Branch Height) | Nrth | Est | Sth | Wst | Phys Cond | Struc Cond | Est. Remain Contrib | Comments | Preliminary Management Recommendations | Work Priority | RPR (m) | RPA (m2) |
|---|---|---|---|---|---|---|---|---|---|---|---|---|---|---|---|---|---|---|
| T2 | Salix caprea (Goat Willow) | M | 1 | 350 | U | 11(4) | 4 | 0 | 5 | 7 | F | P | <10 | leaning tree with integral split in main trunk | fell | H | 4.2 | 55.42 |

Tree ID#T2 – split in trunk of goat willow

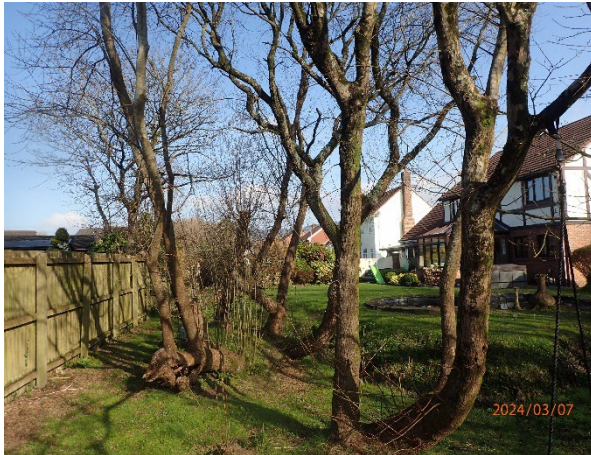
Tree ID#G3

| Tree ID # | Tree Species | Age | Stems | Stem Diam (mm) | Cat | Height + (Lower Branch Height) | Nrth | Est | Sth | Wst | Phys Cond | Struc Cond | Est. Remain Contrib | Comments | Preliminary Management Recommendations | Work Priority | RPR (m) | RPA (m2) |
|---|---|---|---|---|---|---|---|---|---|---|---|---|---|---|---|---|---|---|
| G3 | Acer pseudoplatanus (Sycamore), Salix caprea (Goat Willow) | M | 1 | 350 | C2 | 11(3) | 5 | 5 | 5 | 5 | G/F | F | 20+ | group of trees on other side of drainage ditch, some goat willow failures noted in group | recommended to reduce tree group of only goat willow species by 50% in height | M | 4.2 | 55.42 |
