GCRE

## **Appendix D. Site Walkover**

**Client Name: Global Centre of  
Rail Excellence**
**Site: GCRE (Onllywyn Washery)**
**Project No.  
5209796**

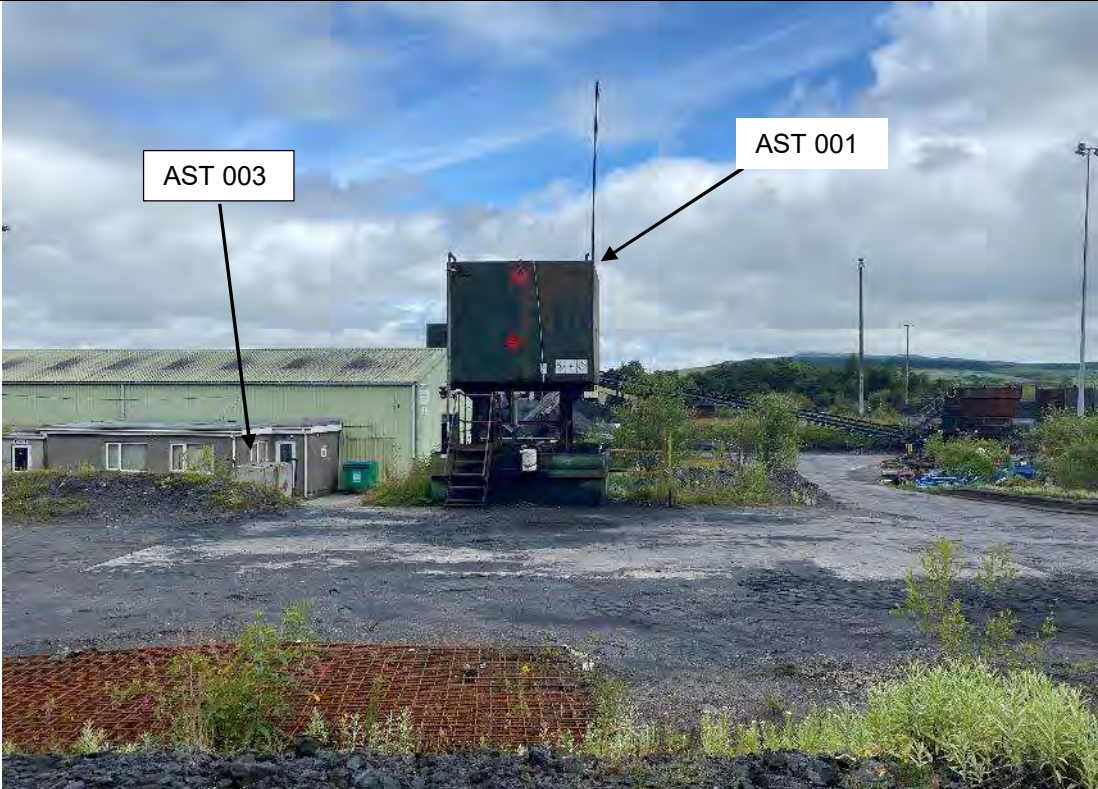
| <b>Photo No.</b><br>1 | <b>Date:</b><br>6 July 2022 | |

| <b>Fuel Storage (001 and 003)</b><br><br>View of ca. 4,000 litre diesel AST (001) in centre of picture, ca. 1,000 litre diesel AST (003) to left.<br><br>The photograph shows concrete access road in fore ground<br><br>The photograph aspect is north. | | |

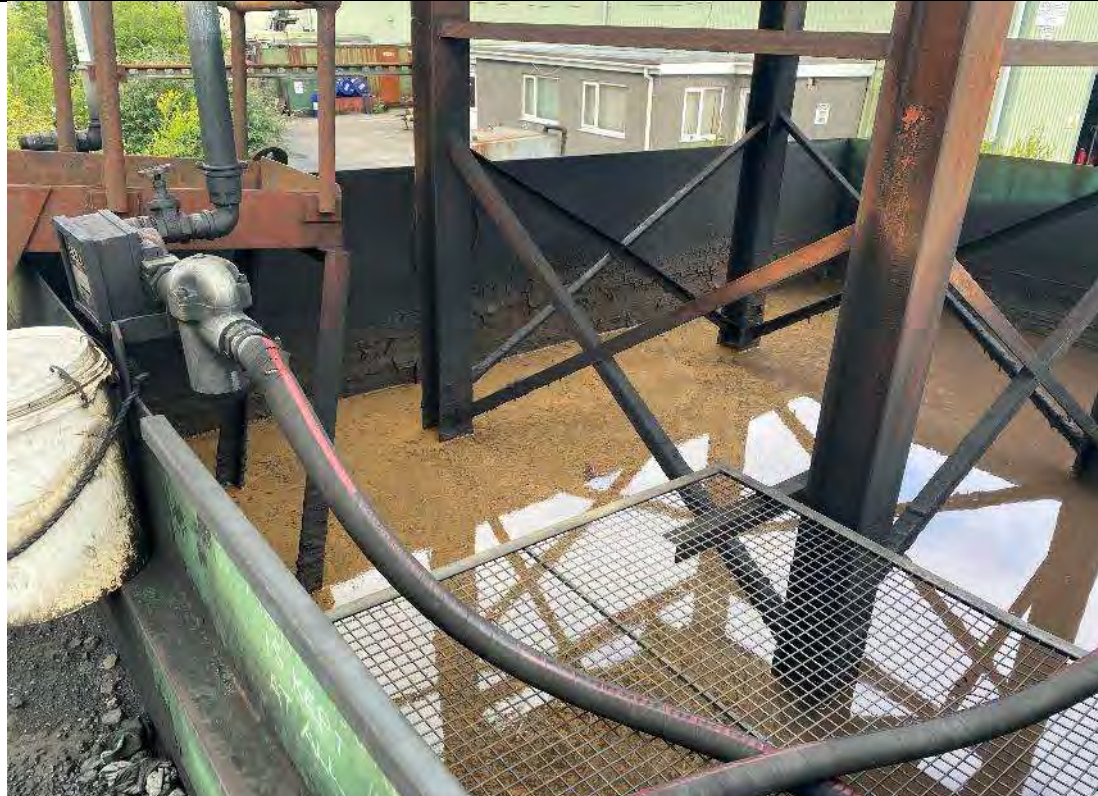
| <b>Photo No.</b><br>2 | <b>Date:</b><br>6 July 2022 | |

| <b>Fuel Storage (001)</b><br><br>View of AST bund<br><br>Bund holds mix of water and fuel. Light cracking of concrete surrounding tank base and light staining.<br><br>The photograph aspect is north-west. | | |

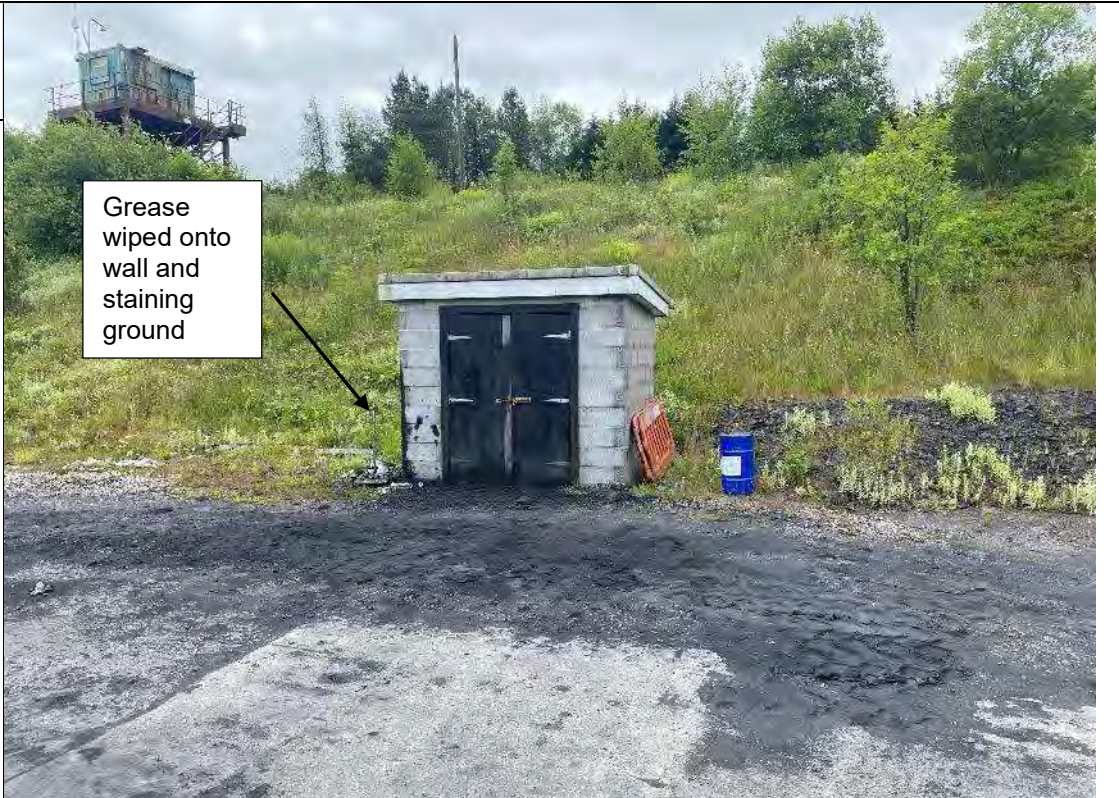
| <p><b>Photo No.</b><br/>3</p> | <p><b>Date:</b><br/>6 July 2022</p> | |

| <p><b>Grease Store (002)</b></p> <p>View of grease store (002).</p> <p>Concrete access road to foreground with colliery spoil heap/bund behind. Note oil staining on left of grease store and ground adjacent to it.</p> <p>The photograph aspect is south.</p> | | |

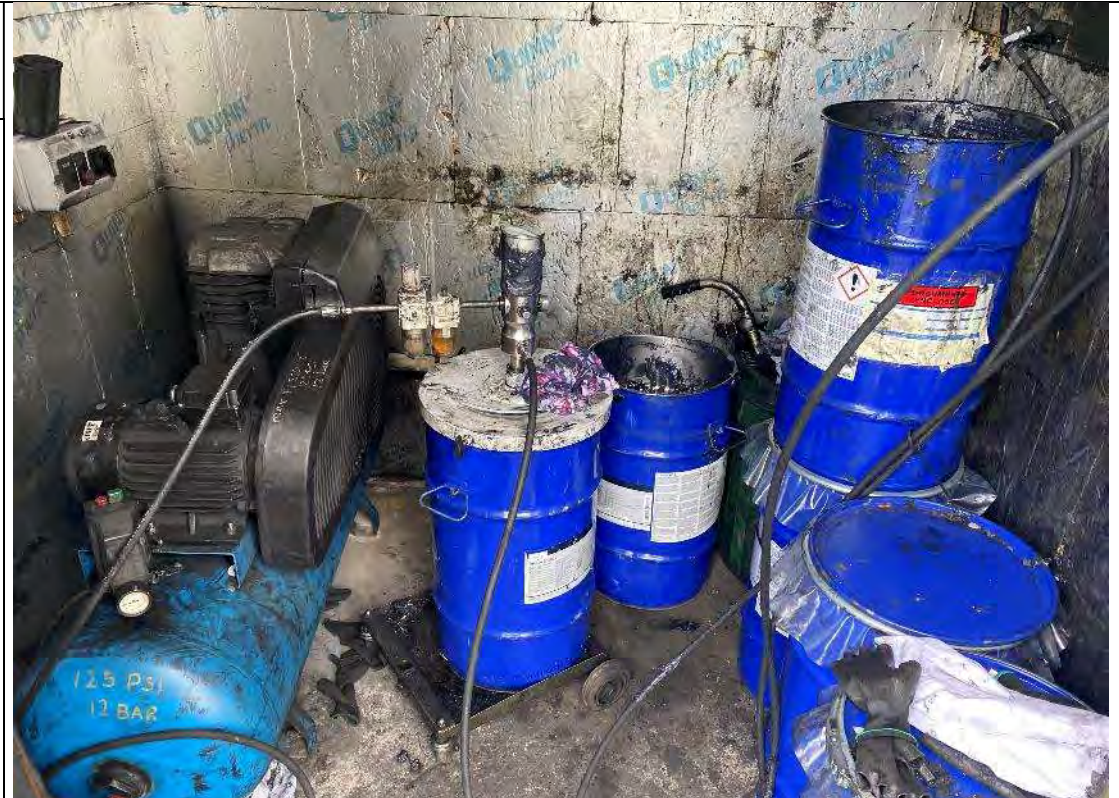
| <p><b>Photo No.</b><br/>4</p> | <p><b>Date:</b><br/>6 July 2022</p> | |

| <p><b>Interior of Grease Store (002)</b></p> <p>Drums of grease present with dispensing equipment.</p> <p>Floor slab in good condition with heavy staining.</p> | | |

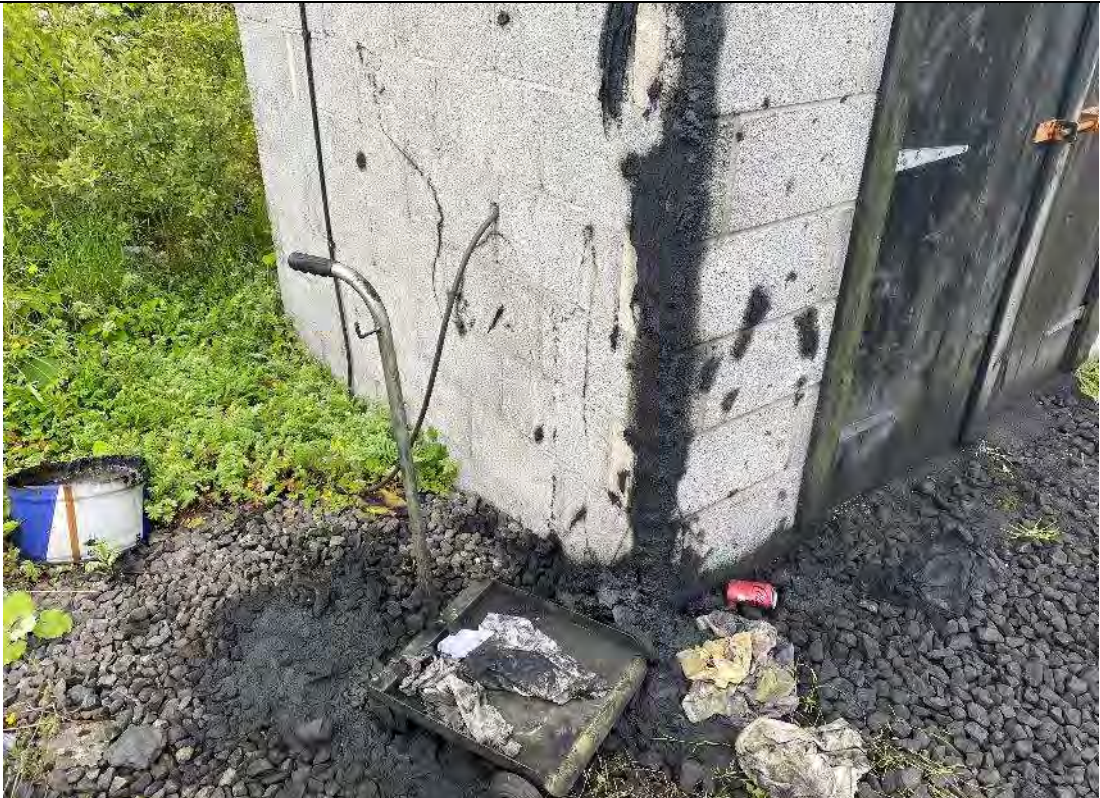
| <b>Photo No.</b><br>5 | <b>Date:</b><br>6 July 2022 | |

| <b>Grease Store exterior (002)</b><br><br>Heavy staining on surrounding soils with evidence that greased equipment is being wiped against corner of structure.<br><br>The surfacing is granular colliery spoil.<br><br>The photograph aspect is south-west. | | |

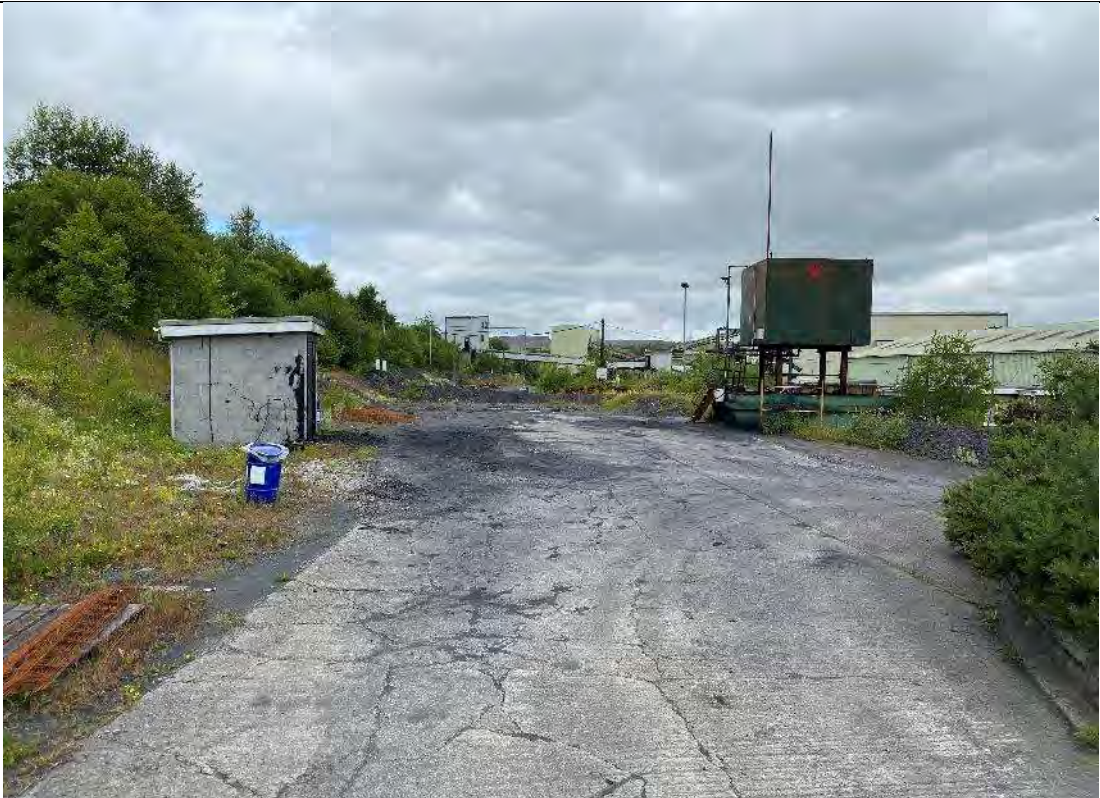
| <b>Grease Store (002) and AST (001)</b><br><br>View of the grease store (002) (left) and AST (001) (right) and access road foreground. Access road is concrete and heavily cracked and stained with grease adjacent to grease store and crushed coal in other areas.<br><br>Washery buildings to rear and repair shop to right.<br><br>The photograph aspect is west. | | |

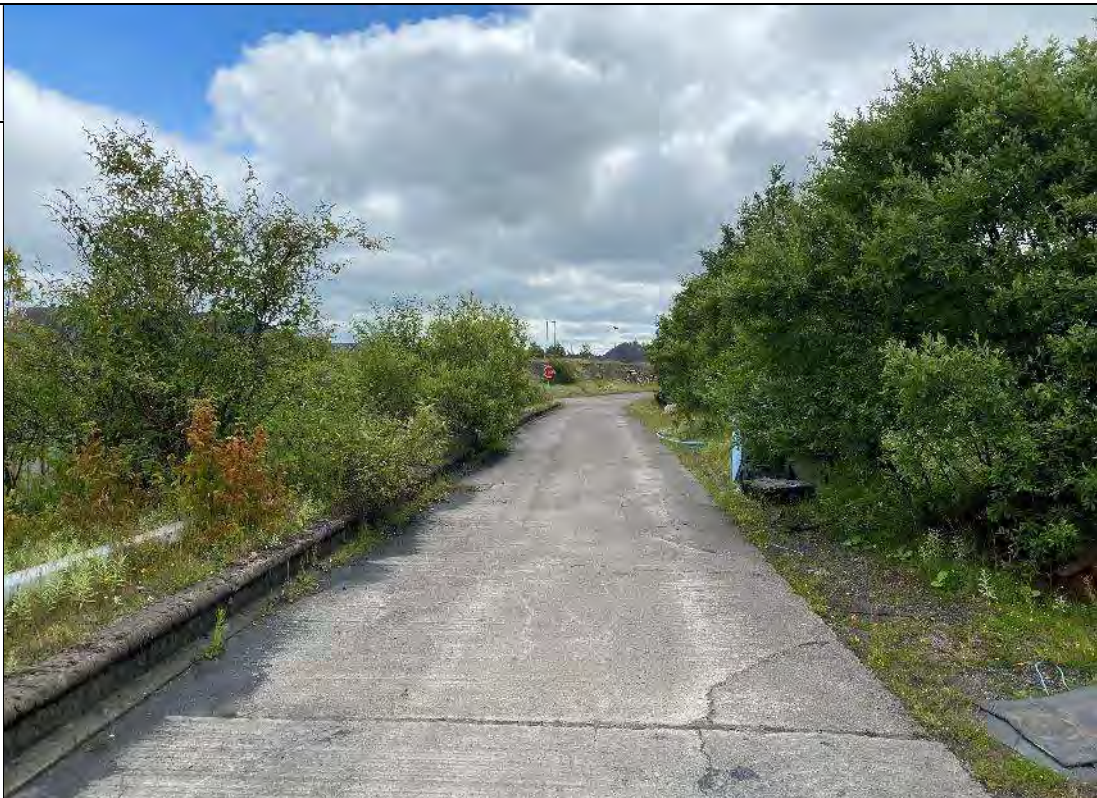
| <b>Photo No.</b><br>7 | <b>Date:</b><br>6 July 2022 | |

| <b>Access road and surrounds</b><br><br>The photograph aspect is east. | | |

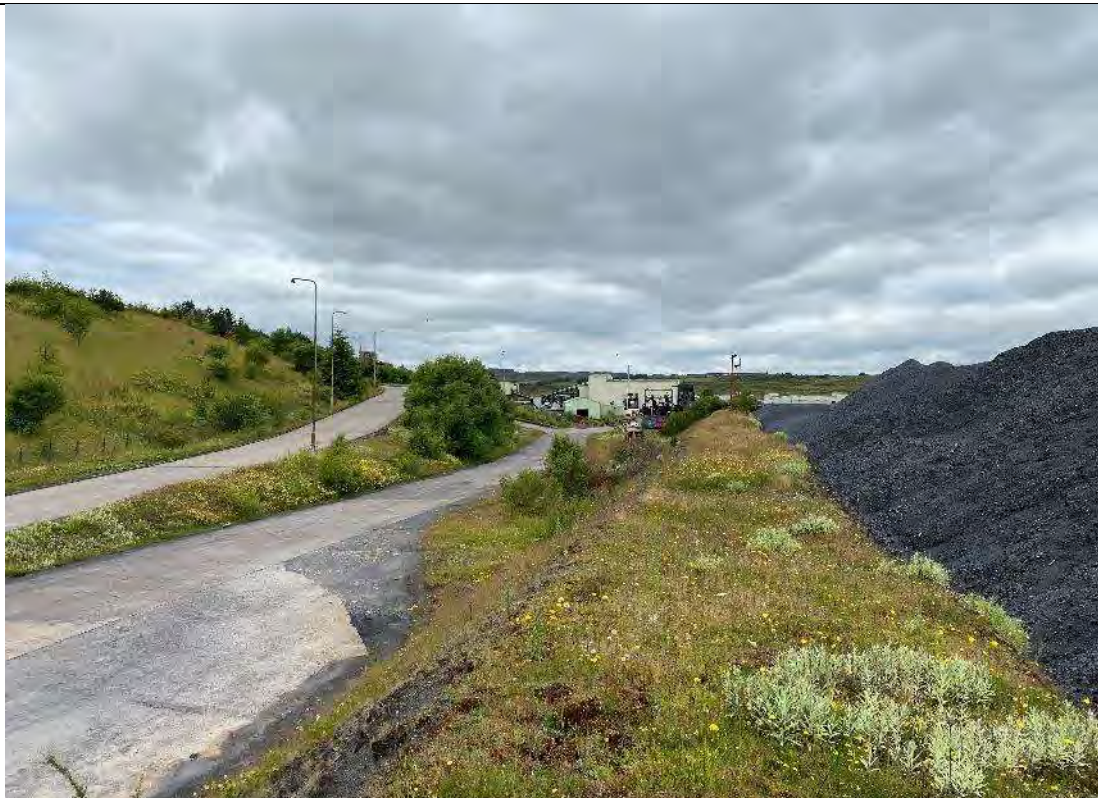
| <b>Photo No.</b><br>8 | <b>Date:</b><br>6 July 2022 | |

| <b>Coal stockpile (004)</b><br><br>View of retaining bund and stockpile of crushed and washed coal.<br><br>The photograph aspect is west. | | |

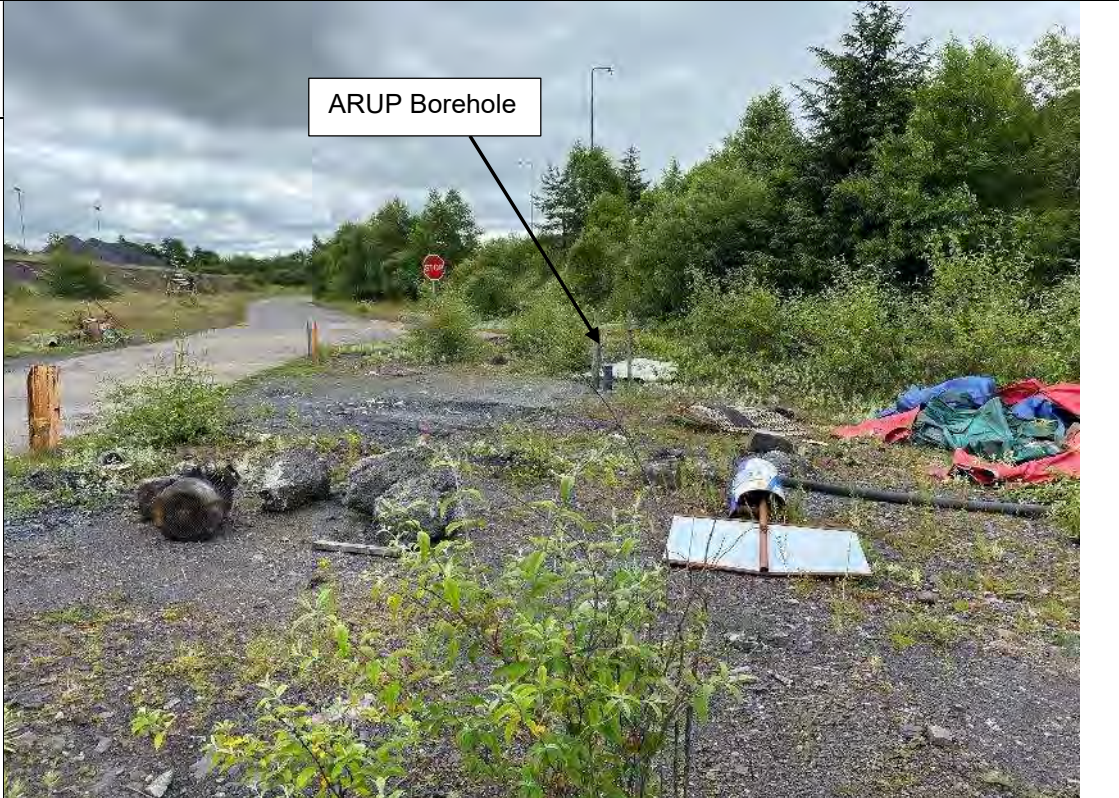
| <b>Photo No.</b><br>11 | <b>Date:</b><br>6 July 2022 | <p style="position: absolute; top: 200px; left: 465px; border: 1px solid black; padding: 2px;">ARUP Borehole</p> |

| <b>Machine Graveyard (005)</b><br><br>Materials dumped on surface, borehole to right.<br><br>The photograph aspect is east. | | |

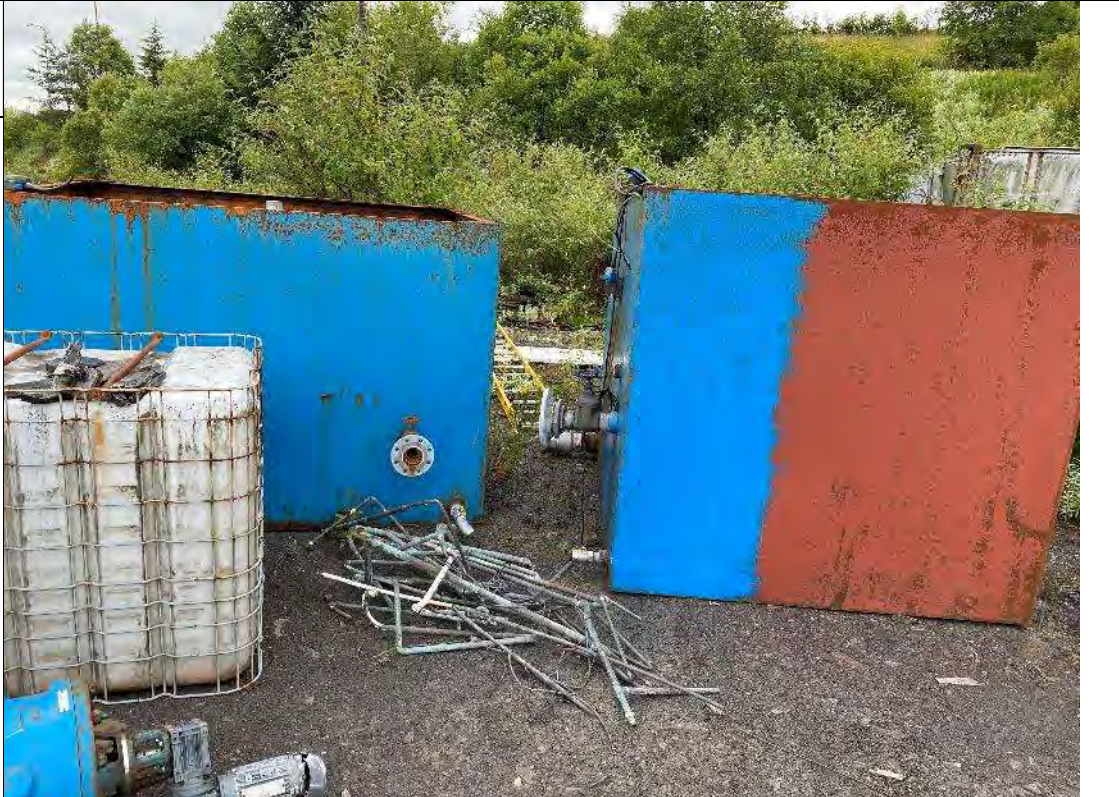
| <b>Photo No.</b><br>12 | <b>Date:</b><br>6 July 2022 | |

| <b>Machine Graveyard (005)</b><br><br>View of abandoned former tanks and IBC being used to drain them.<br><br>The photograph aspect is south. | | |

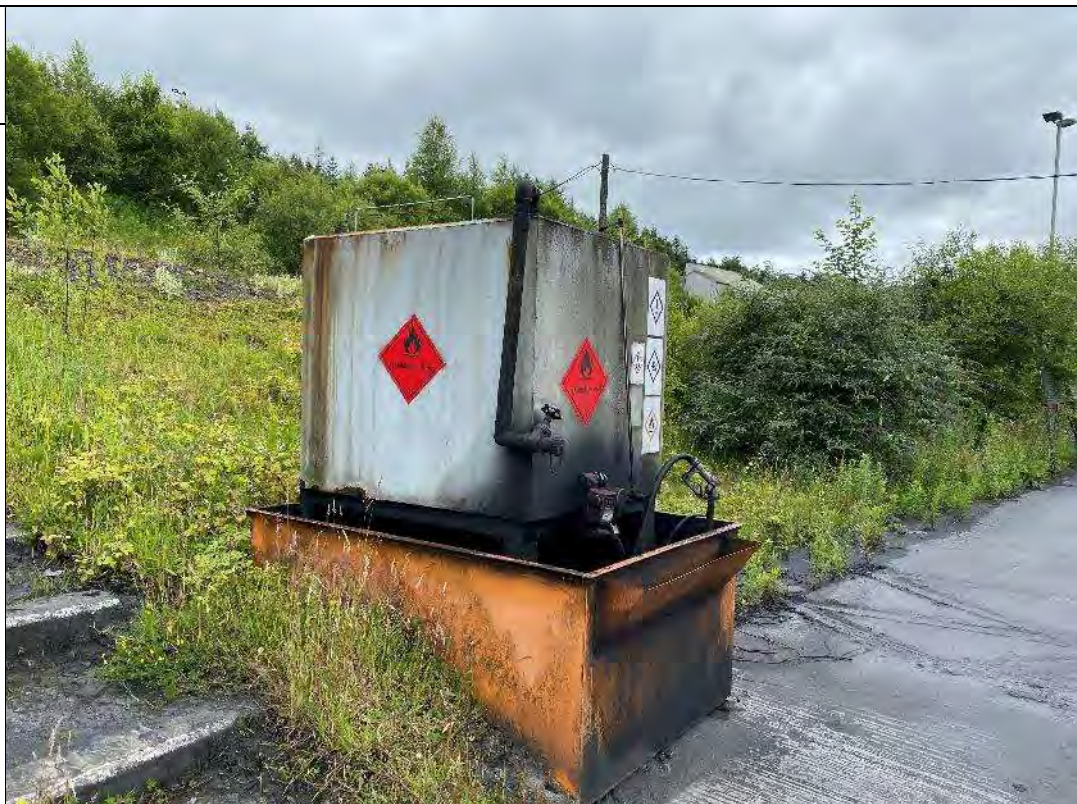
View of 1,000 litre diesel AST and bund. Surrounding concrete intact and not stained by fuel. Dark silt from coal dust present.

The photograph aspect is west-south-west.

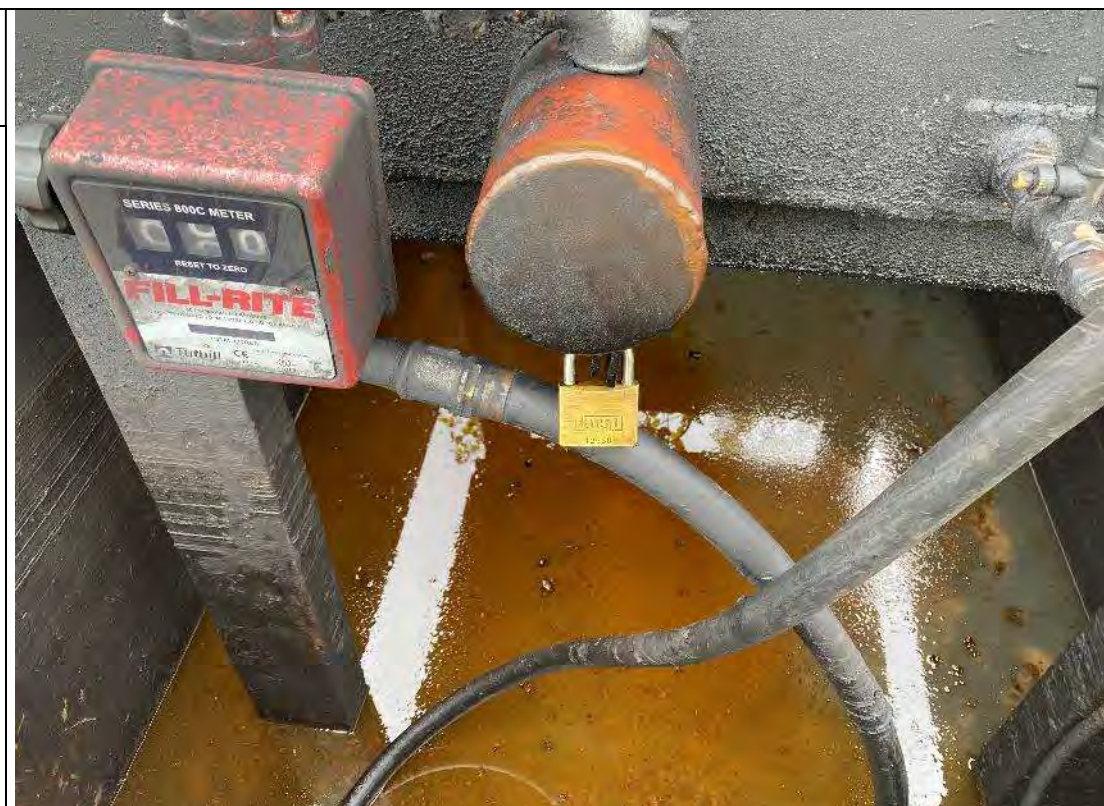
**Photo No.**  
14

**Diesel AST bund (003)**

View into bund, oil / diesel mixture present.

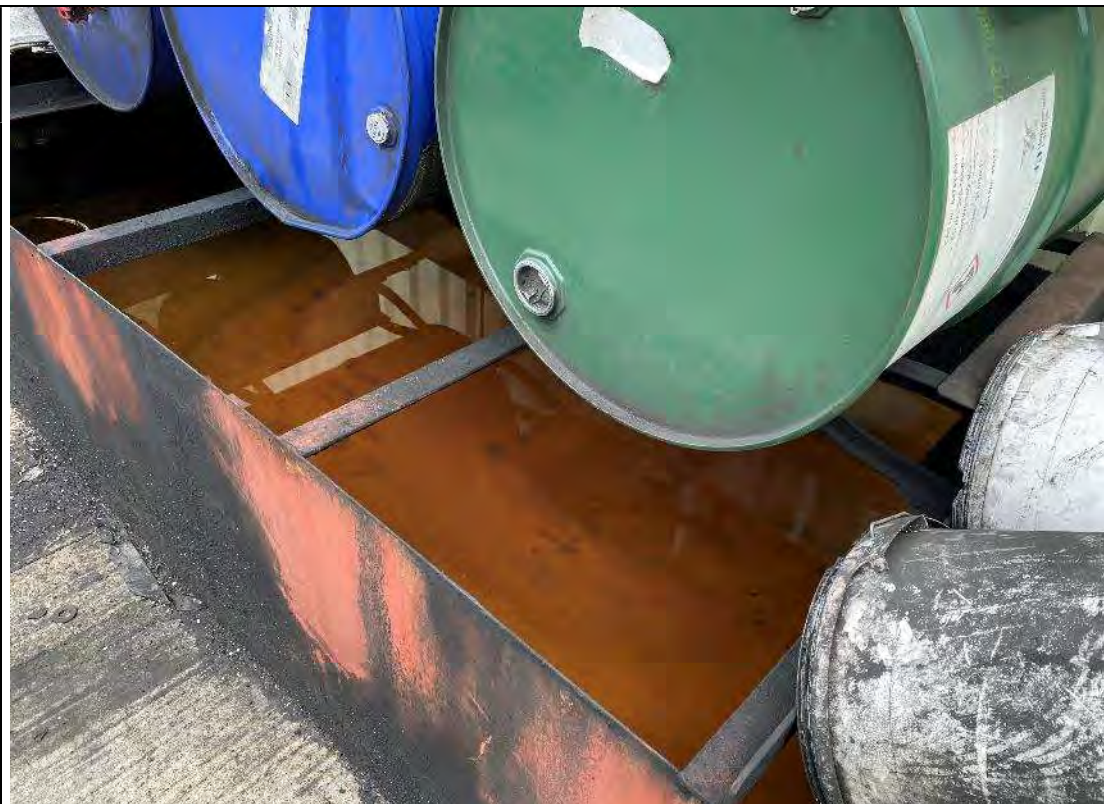
**Client Name: Global Centre of  
Rail Excellence**
**Site: GCRE (Onllywyn Washery)**
**Project No.  
5209796**
**Photo No.**  
17

**Chemical storage (008)**

View of bund holds  
mixture of water and  
assumed hydrocarbon  
(probably gear oil)

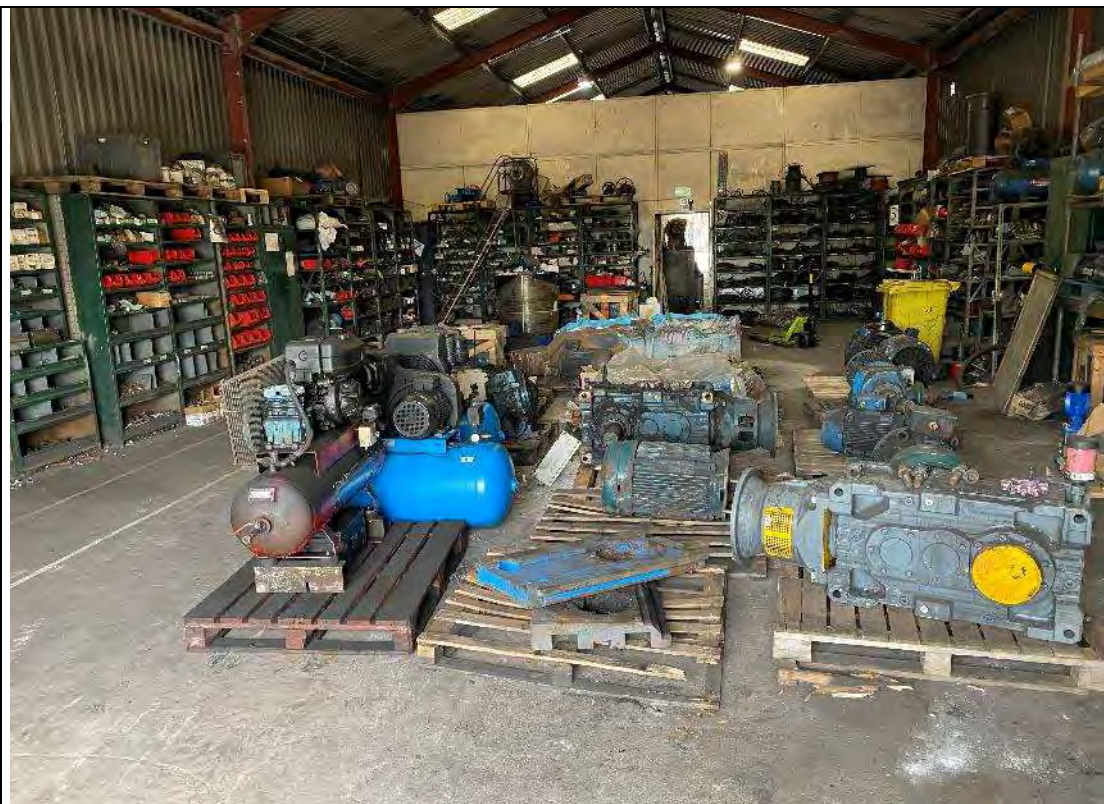
View into eastern wing of  
workshop. Floor slab  
slightly cracked with light  
staining. Machinery in  
process of being  
repaired/stored on  
pallets. . Drums of  
roofing resin, oil and  
grease outside of  
bunded containment.

Photograph aspect is  
west.

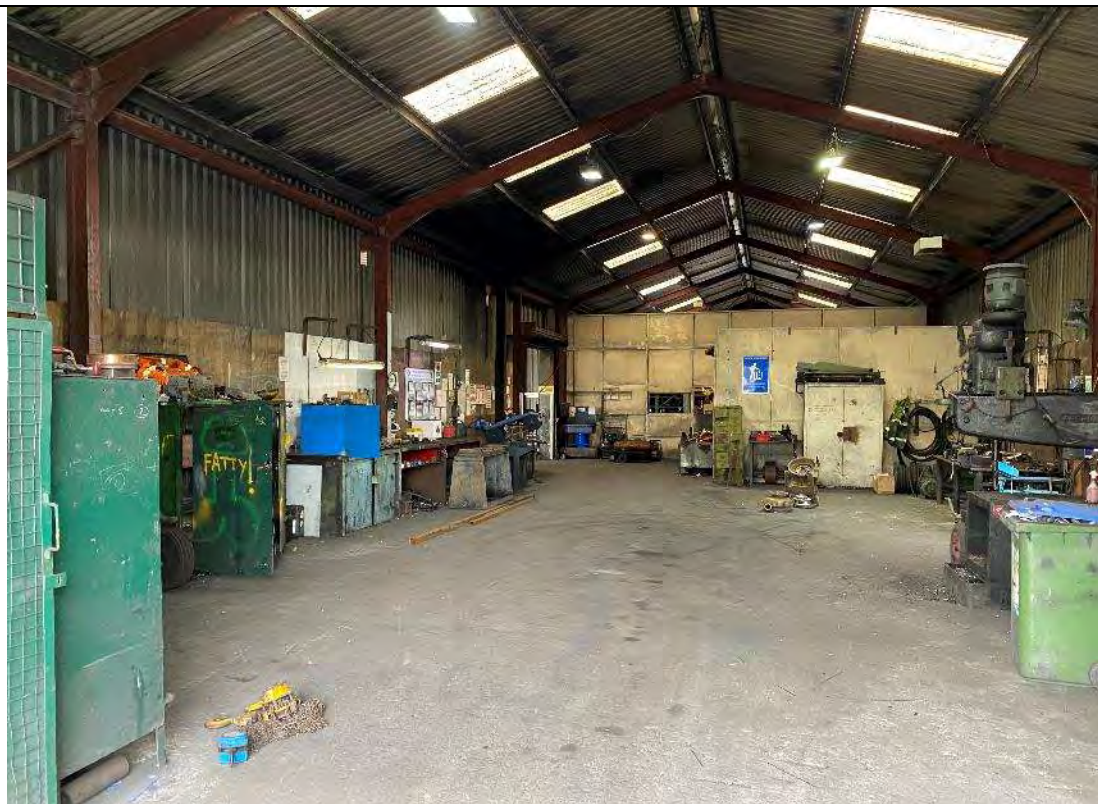
**Photo No.**  
19

**Workshop (010)**

View into western wing.

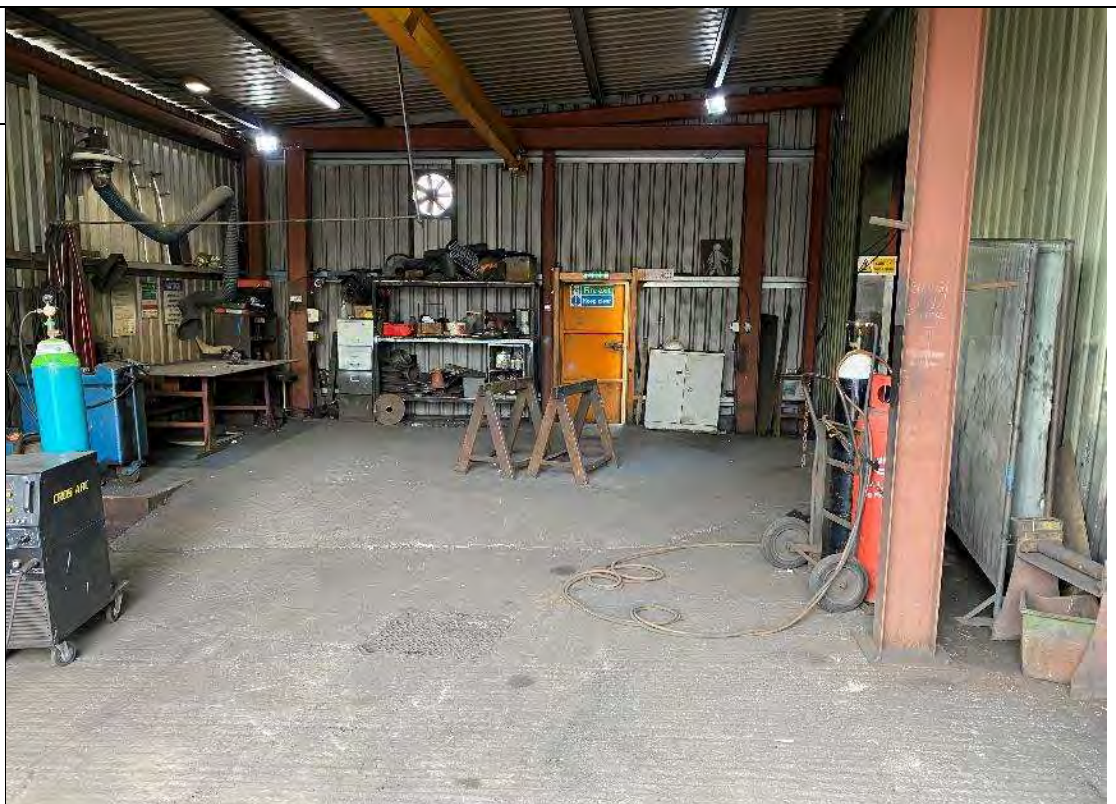
**Photo No.**  
20

**Workshop (010)**

View into northern wing, area used for welding / hot work.

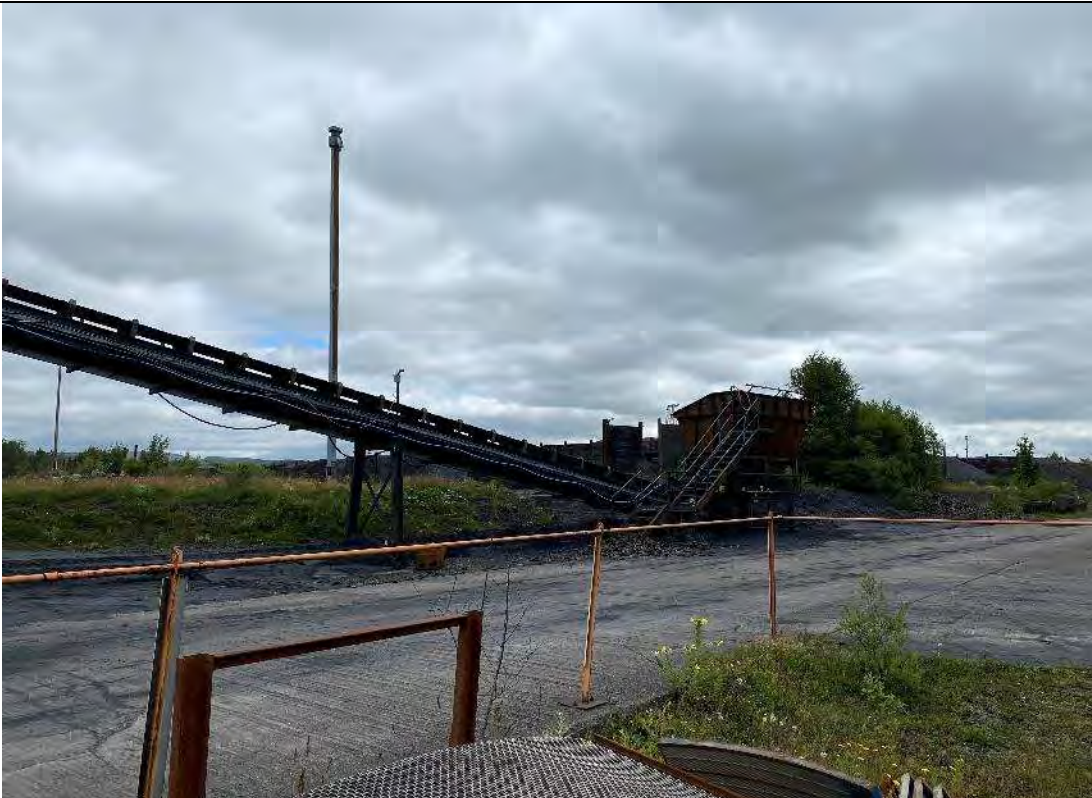
| <p><b>Photo No.</b><br/>23</p> | <p><b>Date:</b><br/>6 July 2022</p> | |

| <p><b>Washery</b></p> <p>View of screening machinery (017), access road and stockpiles beyond.</p> <p>Photo aspect is north-east.</p> | | |

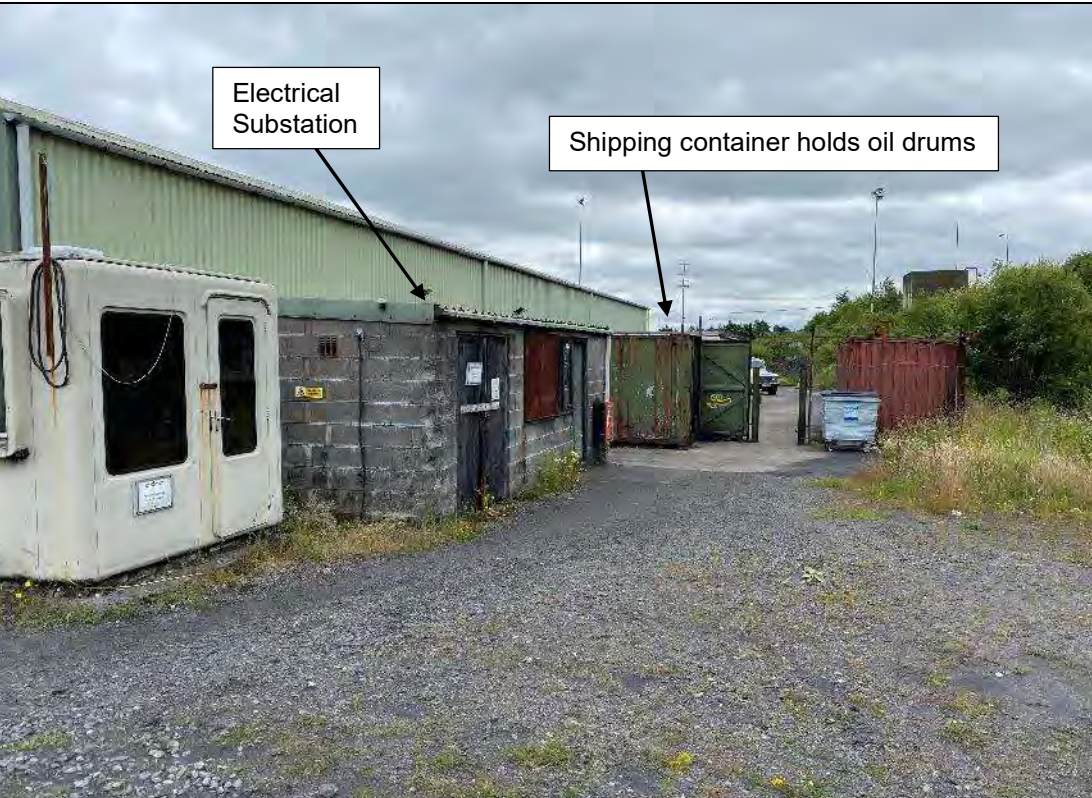
| <p><b>Photo No.</b><br/>24</p> | <p><b>Date:</b><br/>6 July 2022</p> | |

| <p><b>Exterior of Workshop (010)</b></p> <p>View of exterior storage sheds (012) and shipping container (011). Container holds banded oil drums. Electrical substation behind wooden door.</p> <p>Photo aspect is east.</p> | | |

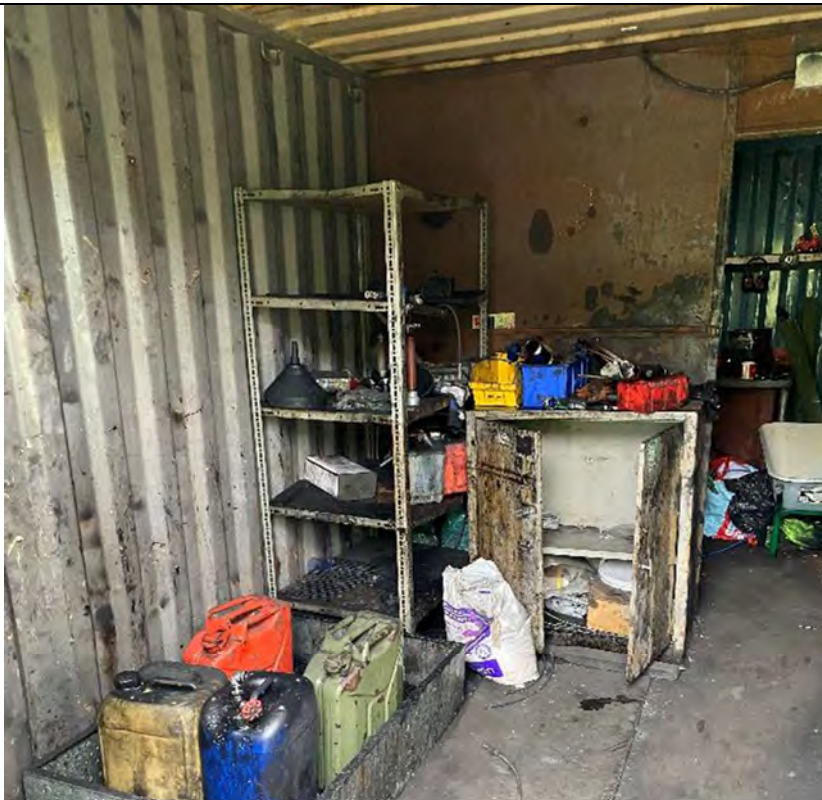
| <b>Photo No.</b><br>25 | <b>Date:</b><br>6 July 2022 | |

| <b>Shipping Container (011)</b><br><br>Contents of shipping container, used to store oil and fuel containers. | | |

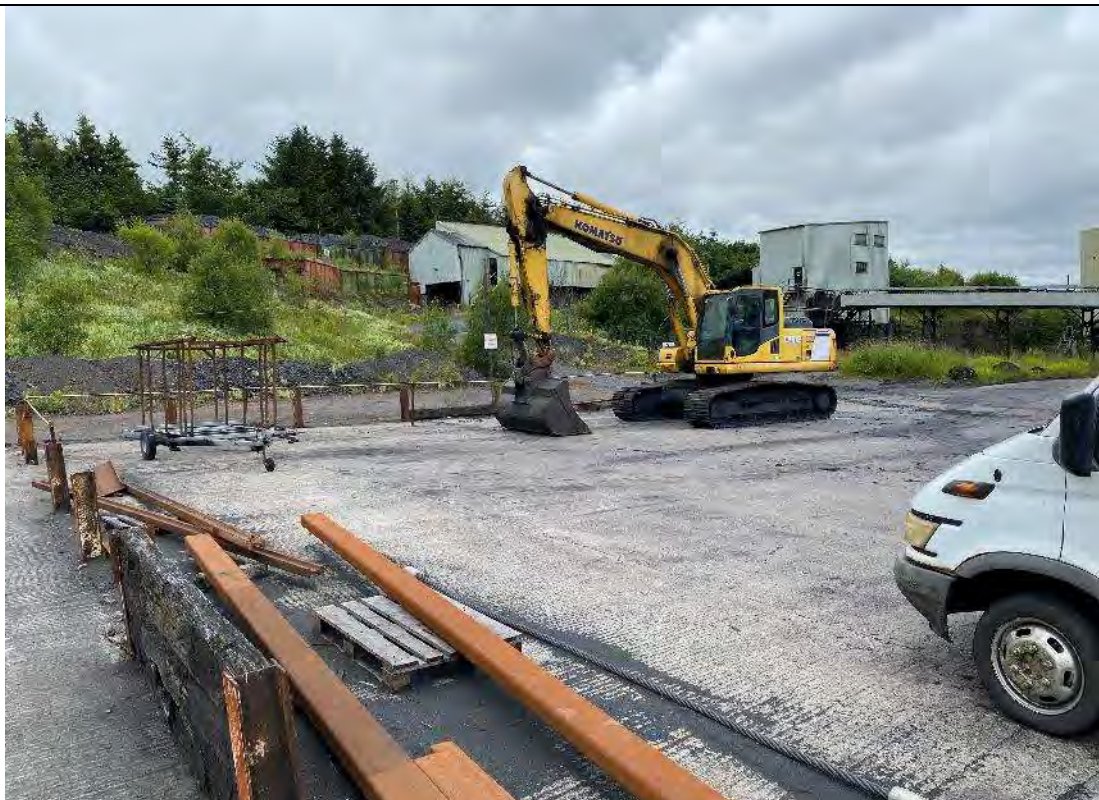
| <b>Photo No.</b><br>26 | <b>Date:</b><br>6 July 2022 | |

| <b>Washery</b><br><br>View of yard area to west of workshop.<br><br>Photo aspect is west. | | |

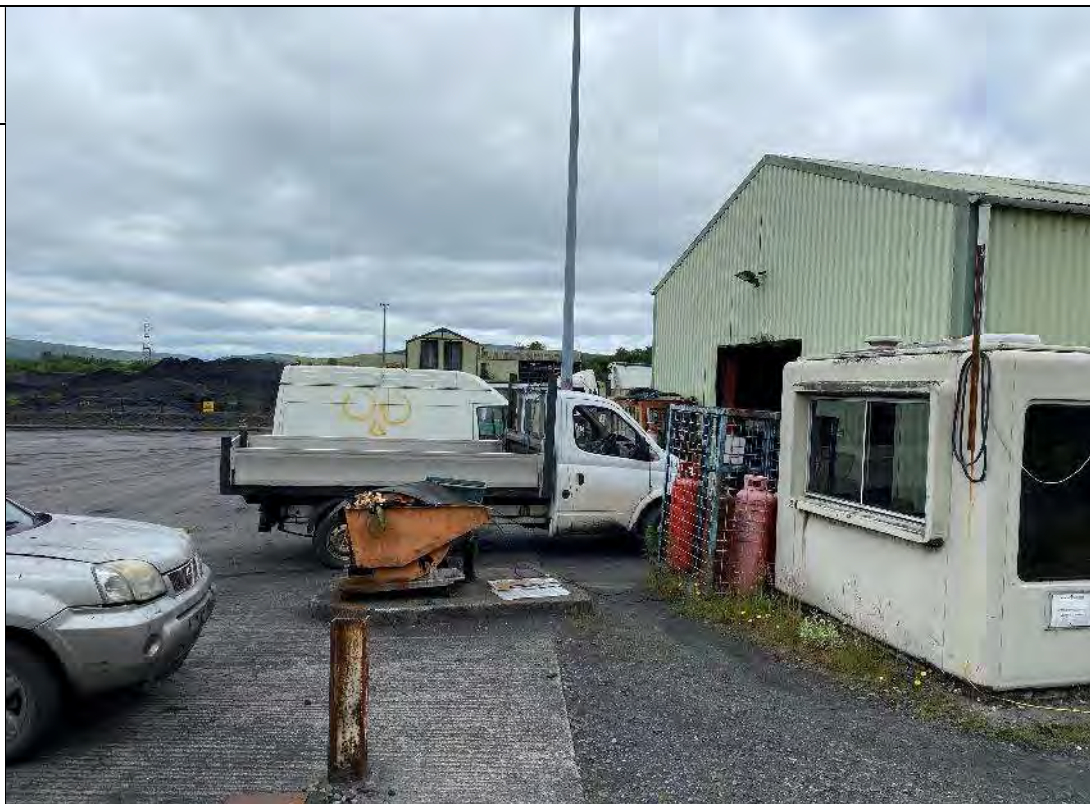
**Photo No.**  
27

**Washery**

View of exterior of workshop.

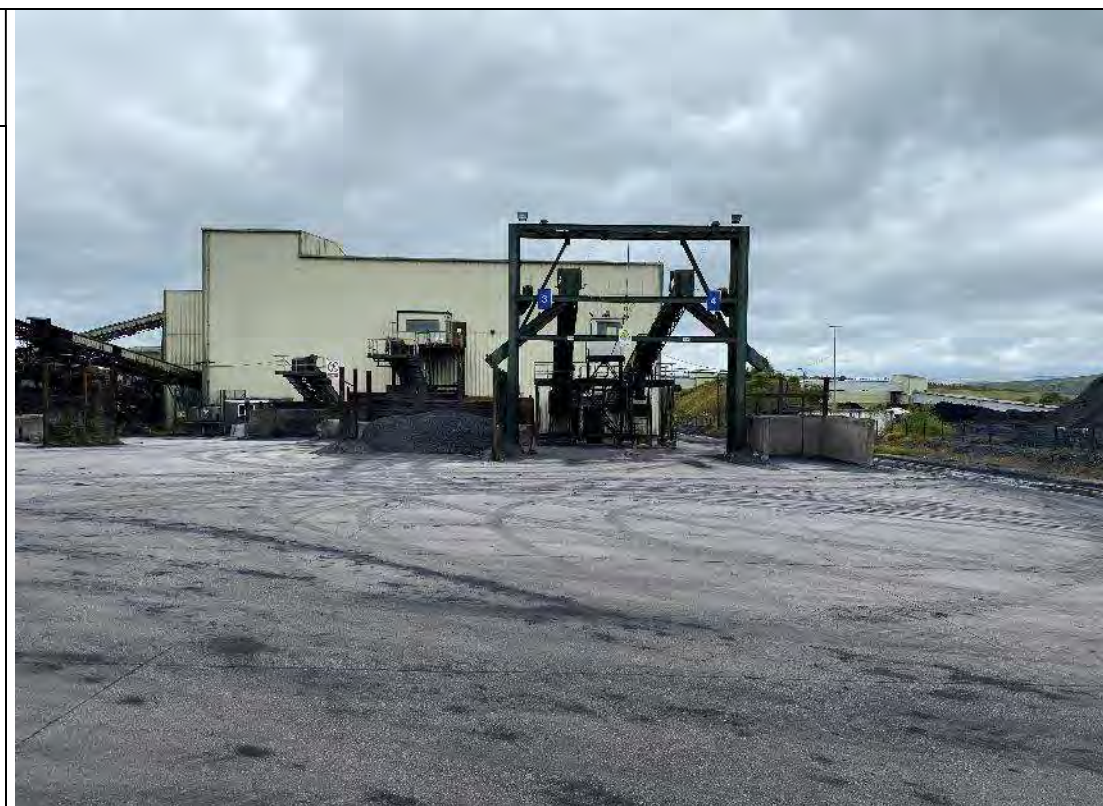
**Photo No.**  
28

**Washery (014)**

View of washery building (014) and yard.

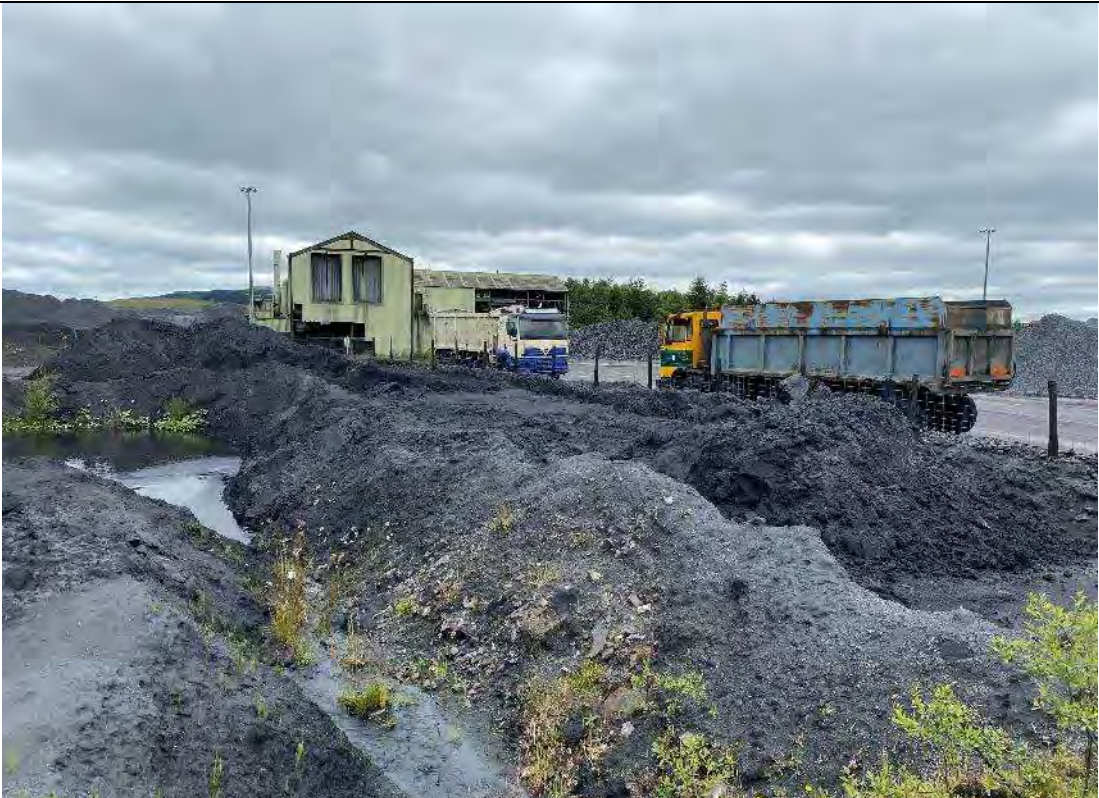
| <p><b>Photo No.</b><br/>29</p> | <p><b>Date:</b><br/>6 July 2022</p> | |

| <p><b>Washery</b></p> <p>Stockpiled coal and lagoons (015).</p> <p>The photograph aspect is north.</p> | | |

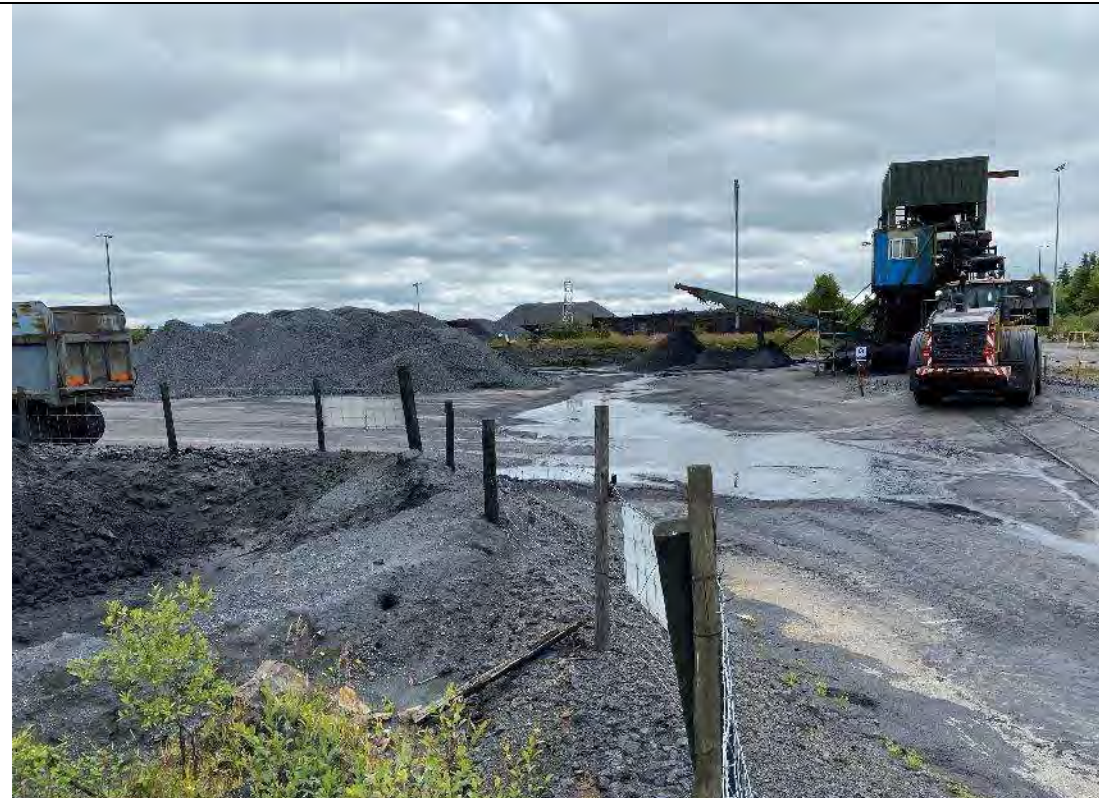
| <p><b>Photo No.</b><br/>30</p> | <p><b>Date:</b><br/>6 July 2022</p> | |

| <p><b>Washery</b></p> <p>View of screening machinery (017) and stockpiled coal (016).</p> <p>The photograph aspect is east.</p> | | |

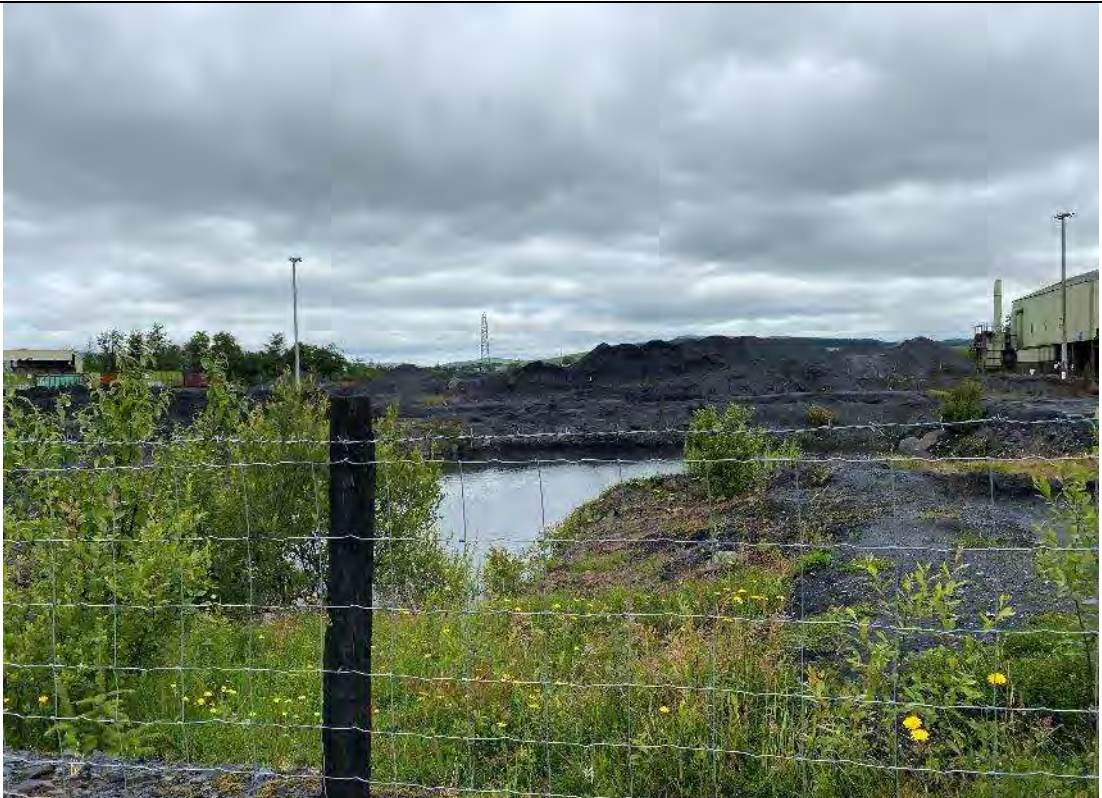
| <b>Photo No.</b><br>31 | <b>Date:</b><br>6 July 2022 | |

| <b>Lagoon (015)</b><br><br>View of the lagoon and stockpiled coal beyond.<br><br>The photograph aspect is north. | | |
